Remedial Action Engineering Control Inspection Reports

**SUBJECT: SITE 156
BOILER ROOM ENGINEERING CONTROL
SIX MONTH SUMMARY REPORT – JUNE 2018**

SITE: 156

LOCATION: Boiler Room, Building 2, 270-280 Louis Muñoz Marin Boulevard, Jersey City, NJ

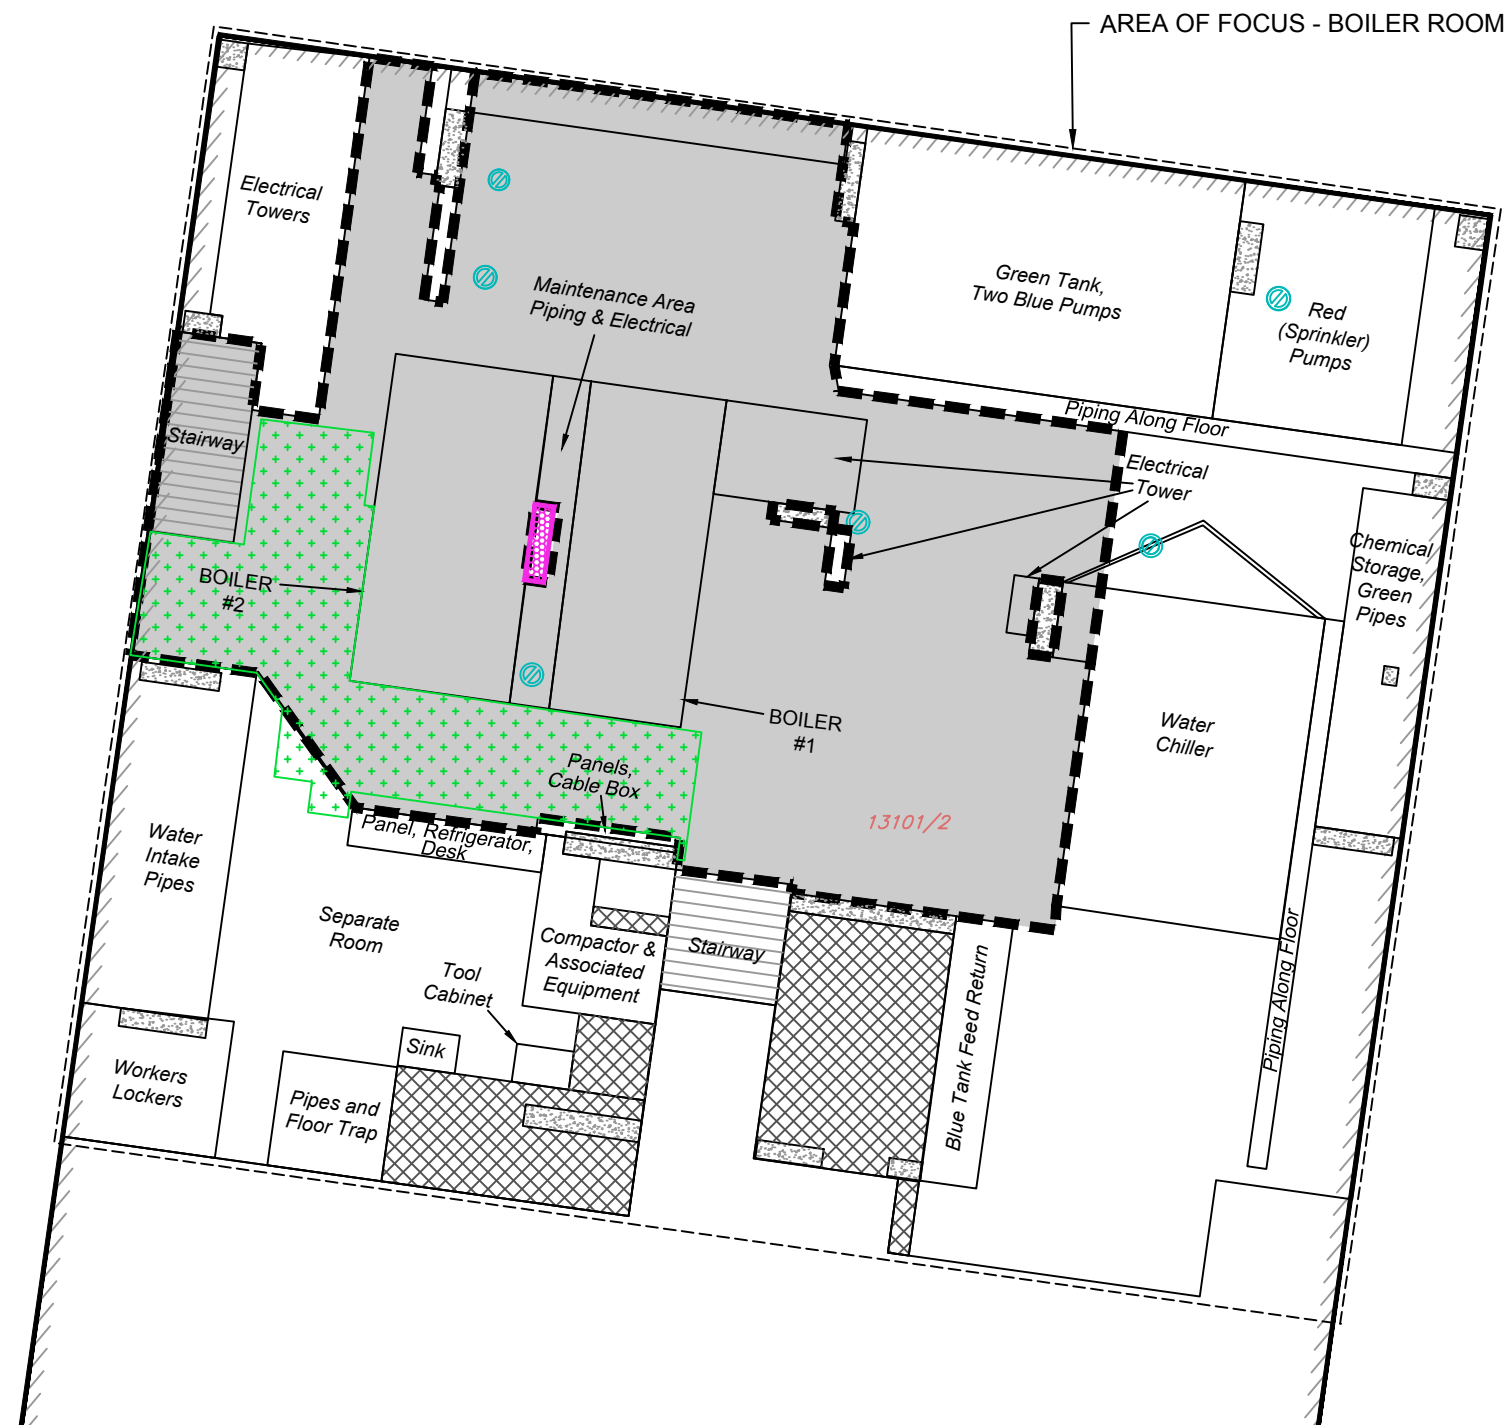
Figure 1

**SITE 156
 BOILER ROOM
 ENGINEERING CONTROL**

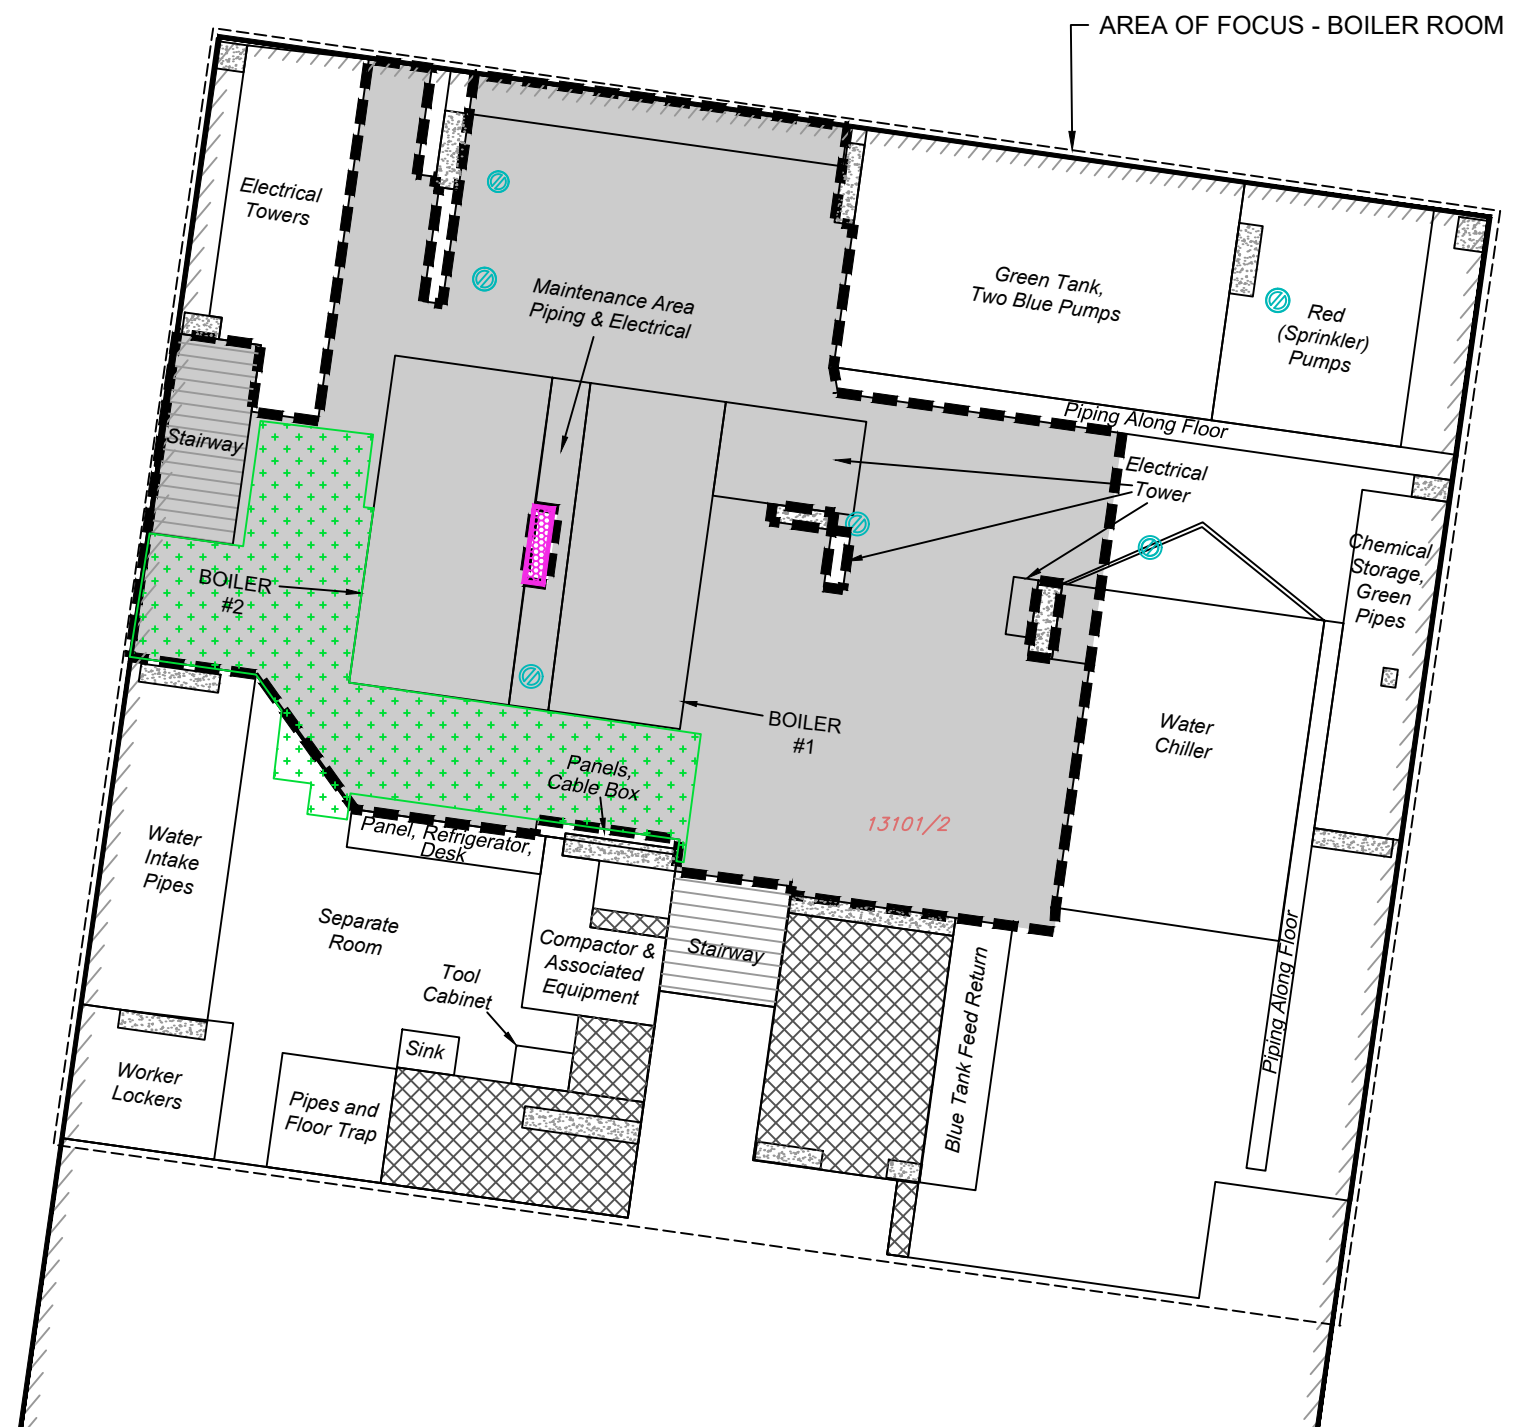
Figure 1

**SITE 156
BOILER ROOM
ENGINEERING CONTROL**

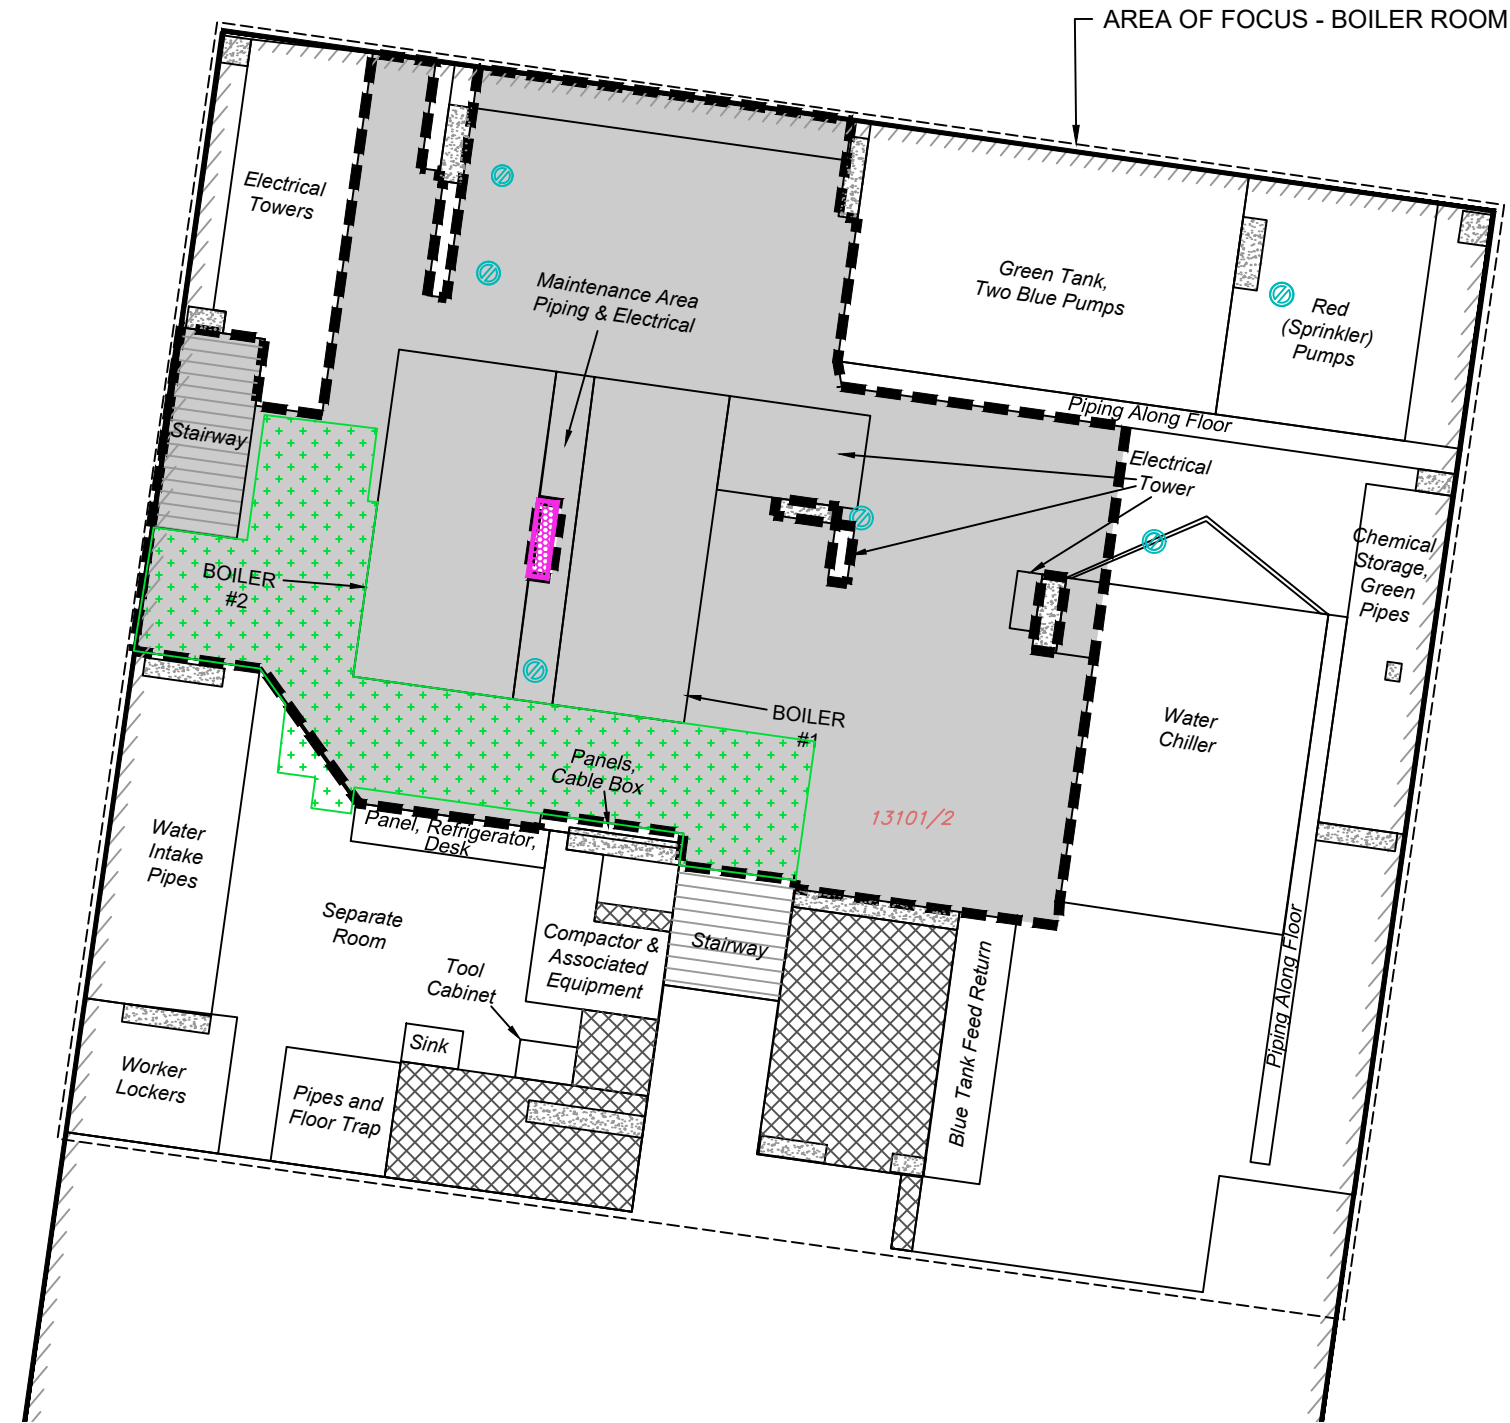
Figure 1

**SITE 156
BOILER ROOM
ENGINEERING CONTROL**

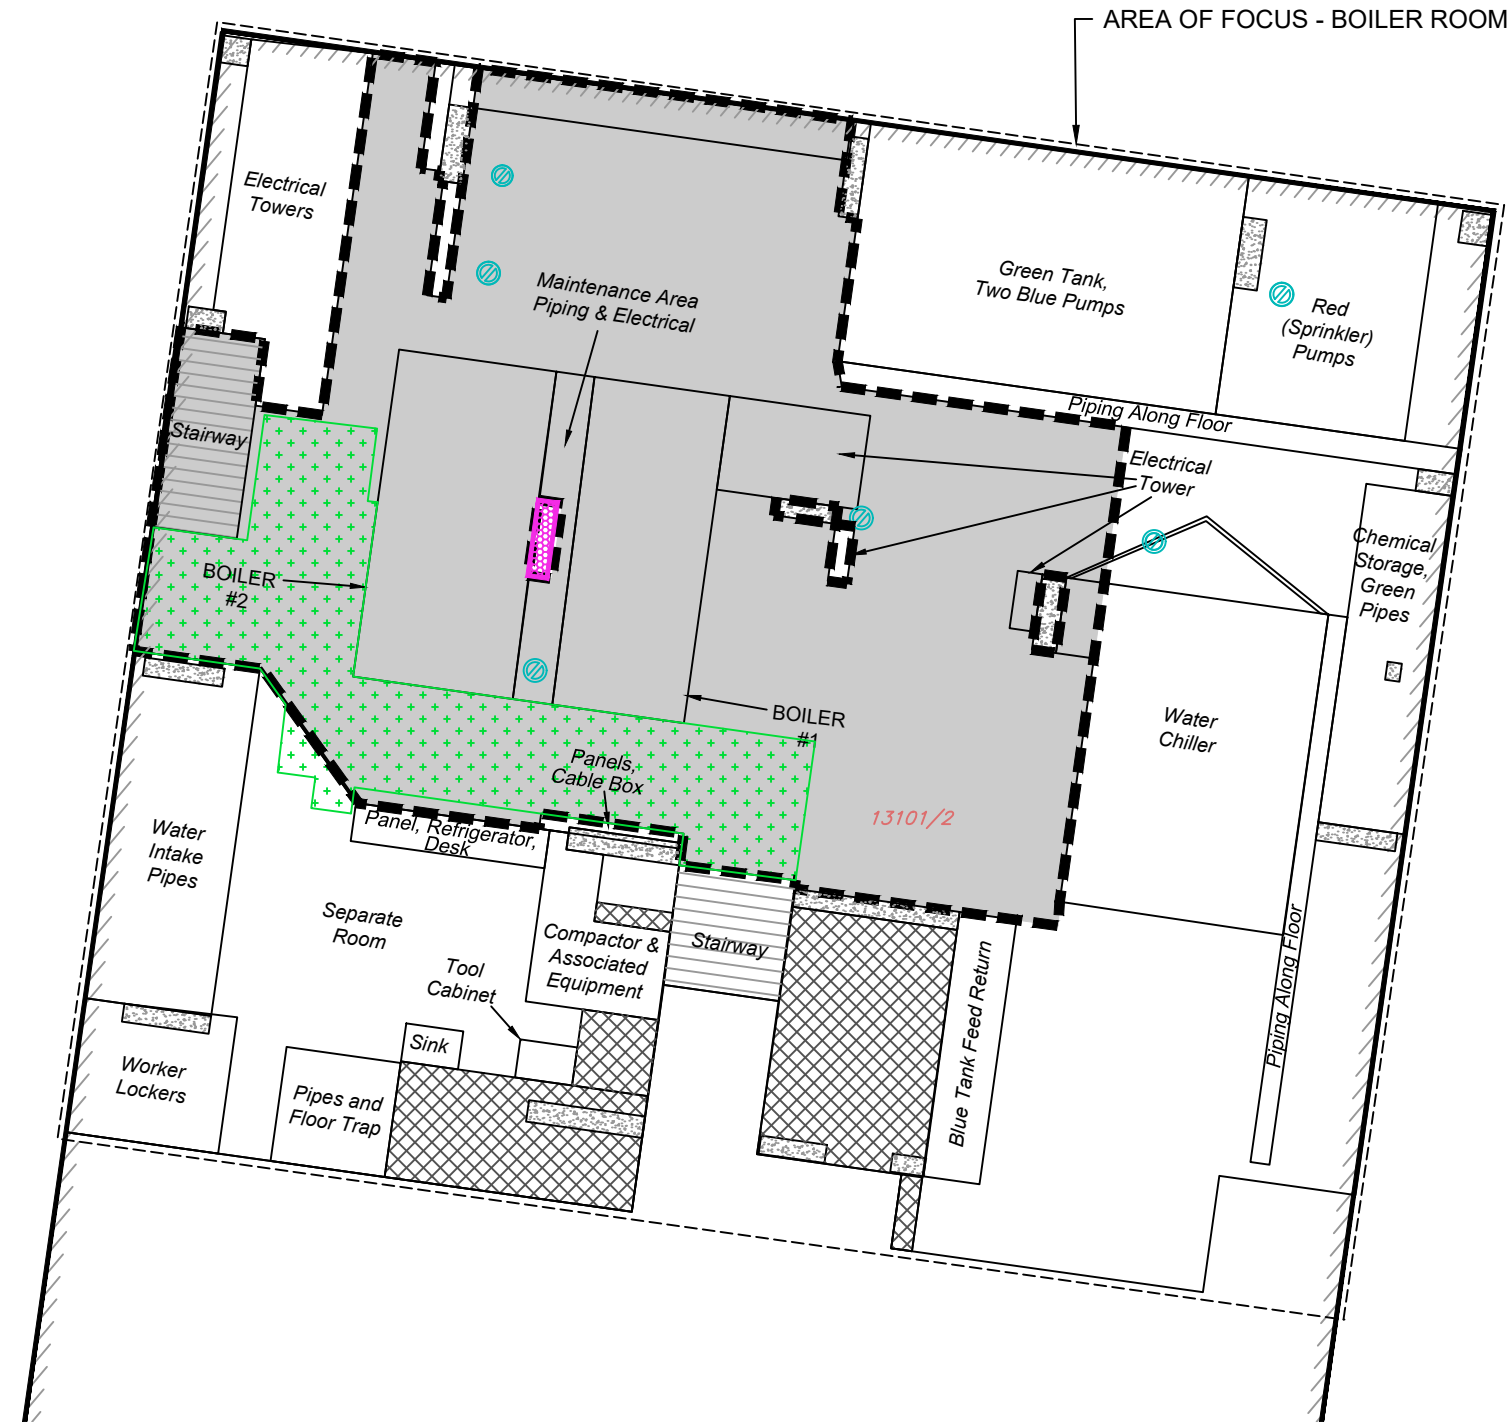
Figure 1

**SITE 156
BOILER ROOM
ENGINEERING CONTROL**
