Technical Memorandum: 100 Forrest Street Proposed Work Plan

Re: 100 Forrest St. Proposed Work Plan
Garfield Avenue Remediation
Jersey City, NJ
MRCE File 11972A

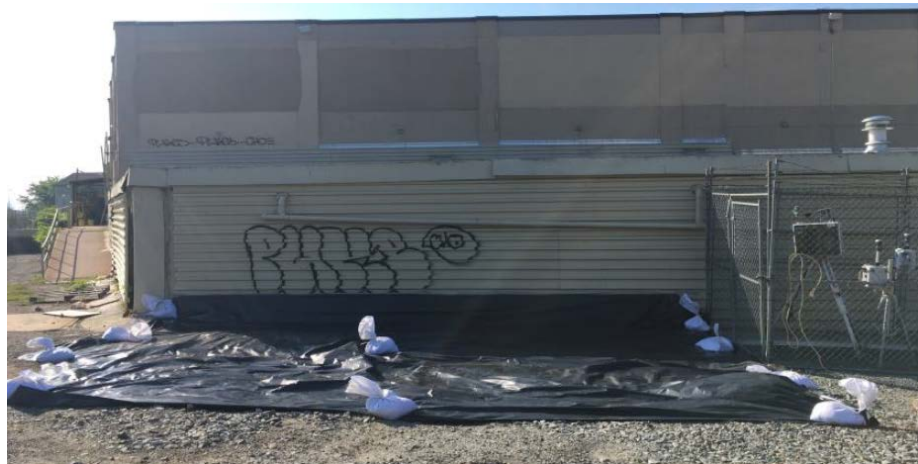
On Thursday, May 18, 2017 Entact placed a plastic liner over the ground surface west of the 100 Forrest St. exterior wall and weighted it down with sand bags in efforts to test if minimizing stormwater infiltration from rain events prevented water from leaking into the space, as shown on the photograph below.

Since placement of the plastic liner, 0.6" of rain fell on May 22 and May 25, plus more than 1.3" on June 17 and 19th. No leakage was reported to have occurred during these rain events which is promising and supports our recommendation to provide a more permanent surface seal in this area.

- 1) Maintain the Temporary Plastic until Restoration in this area: Entact will maintain the plastic liner in its current configuration to the extent practical until surface restoration occurs in this area which is scheduled for late June/early July. Surface restoration will include placement or replacement of asphalt or a similarly or equally semi-impervious surficial protective layer immediately west of this area, so the plan would be to extend the surface restoration to the building line.
