Remedial Investigation Report/Remedial Action Work Plan/Remedial Action Report, Final Building No. 2 – Boiler Room Subslab Soil and Interior Concrete Surfaces (AOC 3) PPG, Jersey City, New Jersey

Appendix I

Feasibility Study Reports -Mueser Rutledge Consulting Engineers

> Re: Removal of Boiler Room Structural Slab Site 156 – Metropolis Towers Boiler Room 270 and 280 Louis Munoz Marin Boulevard Jersey City, NJ MRCE File 11857

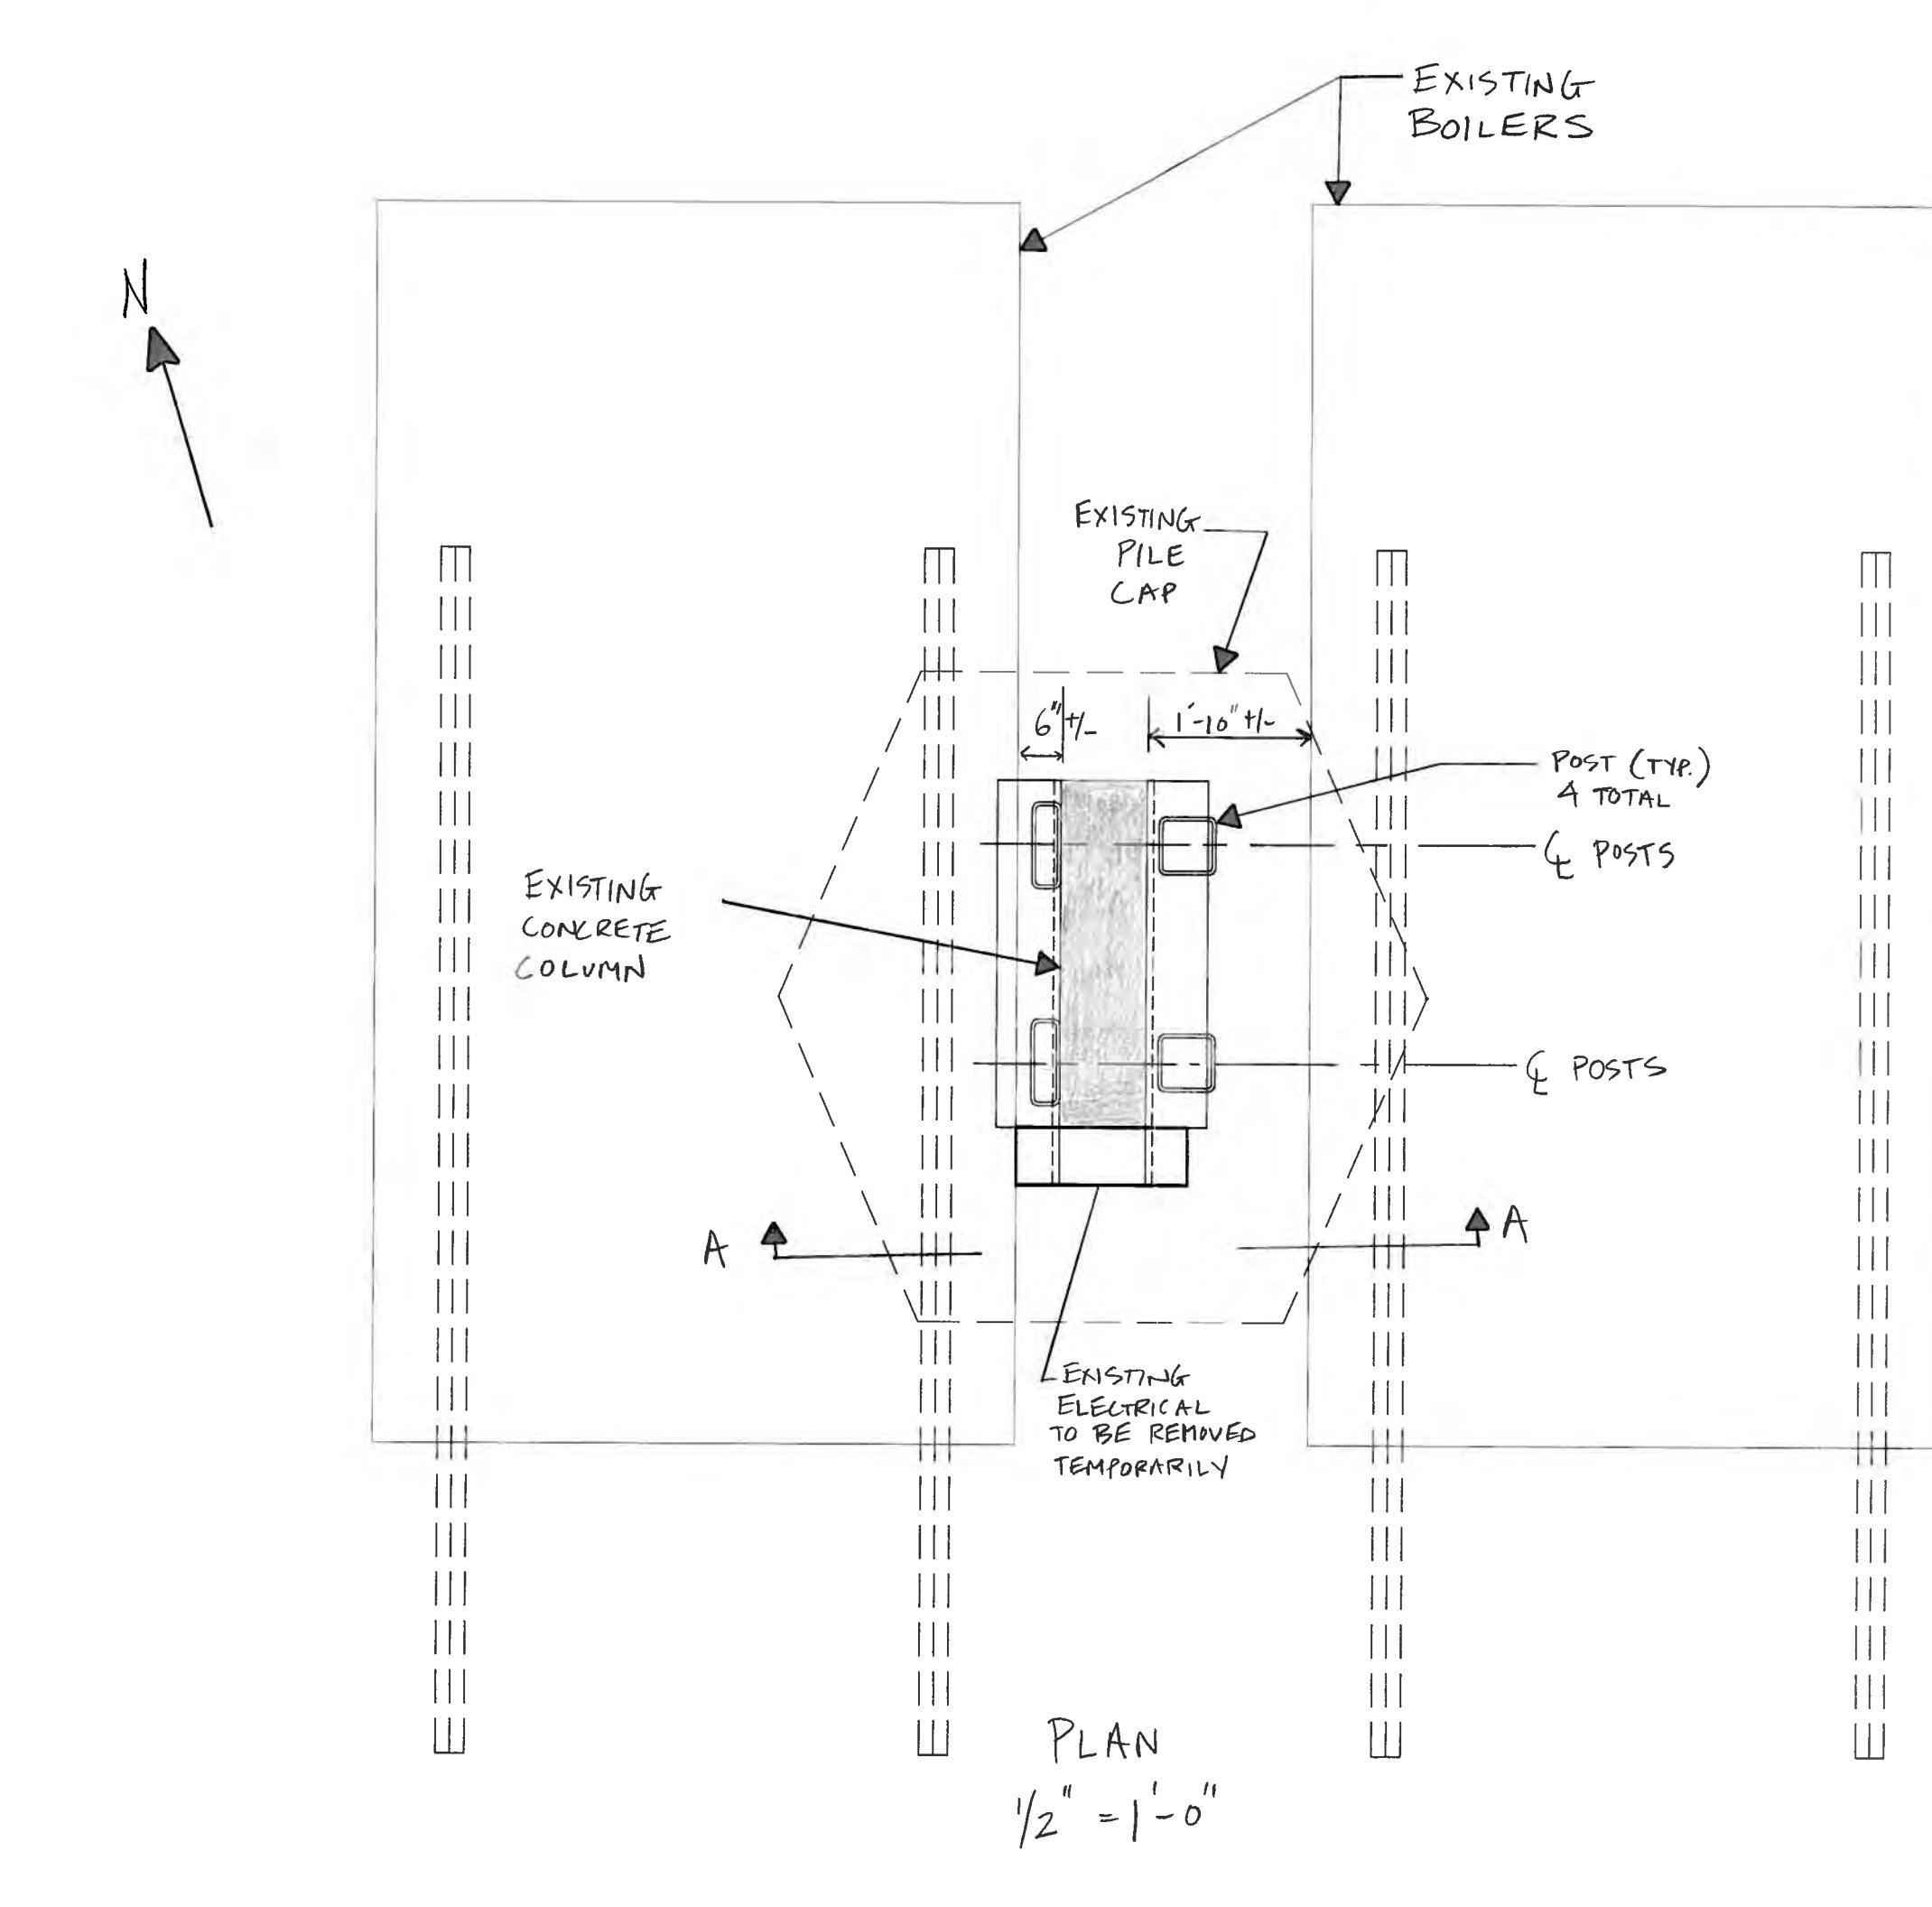
SK-3

Alternative 2: Remove and replace exposed contaminated column and slab concrete (boilers remain in place but are temporarily supported and jacked)

Not shown: Jack boilers to transfer load away from current framing system and demolish and replace slab in kind per sequence to be determined.

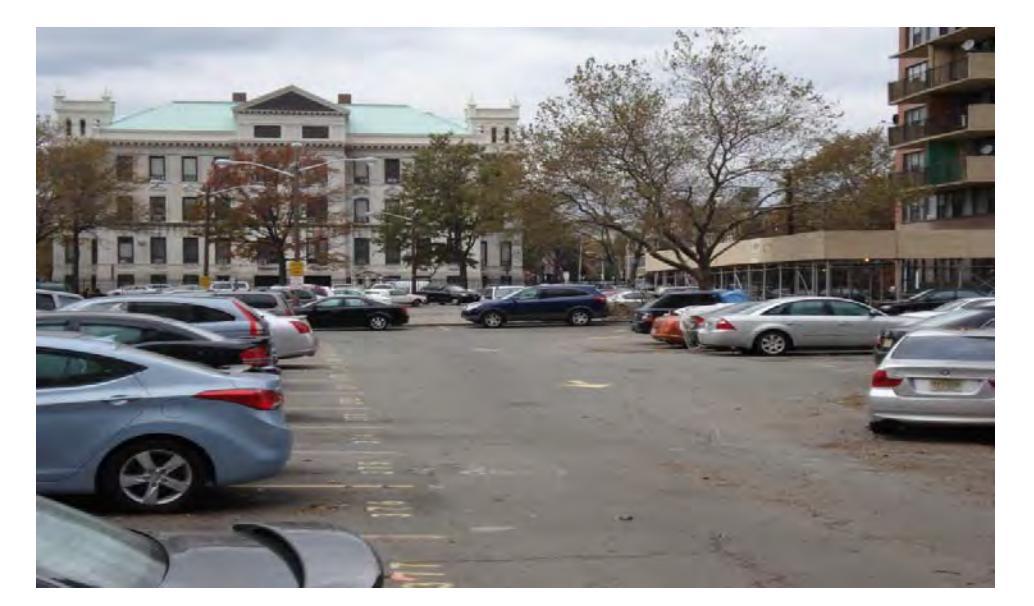
#### Water Damaged Vehicles in Parking Lot

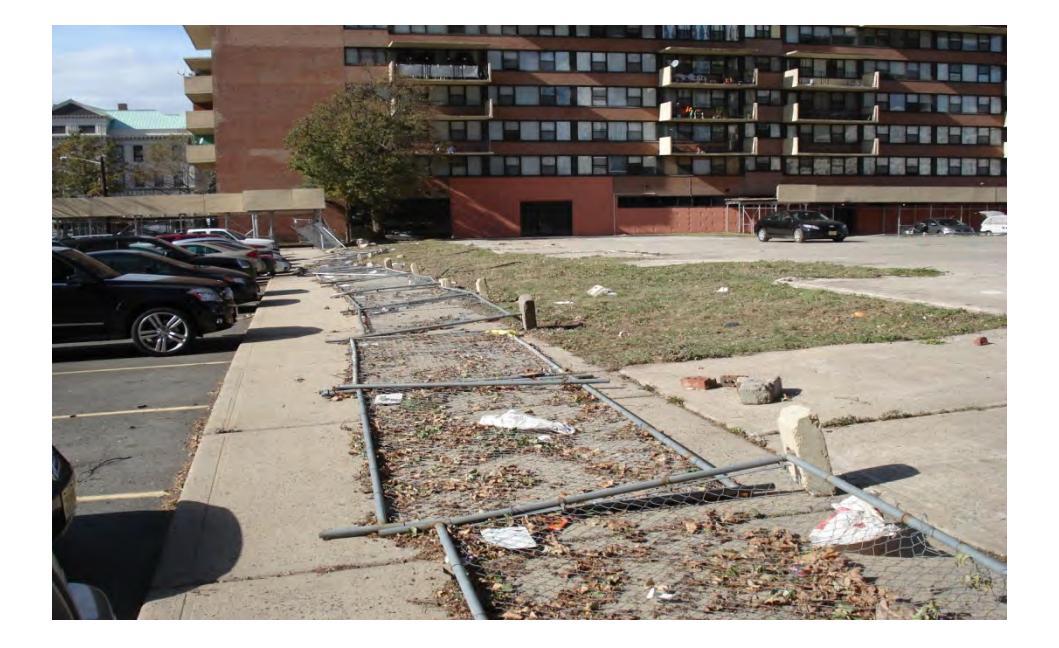
# Damaged Fence Surrounding IRM Concrete Area

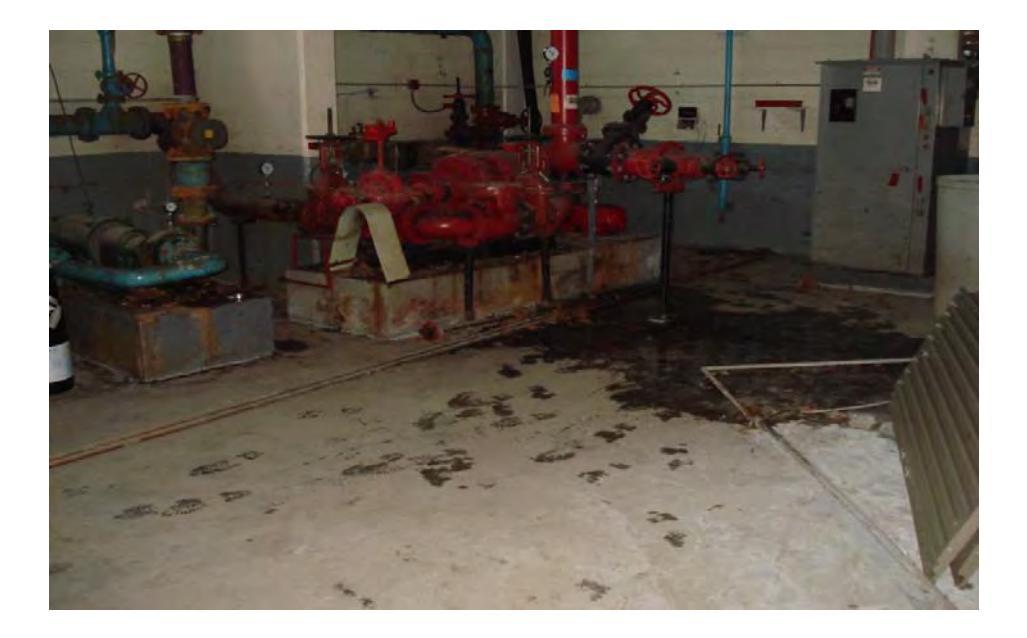
#### Flood Water in Basement

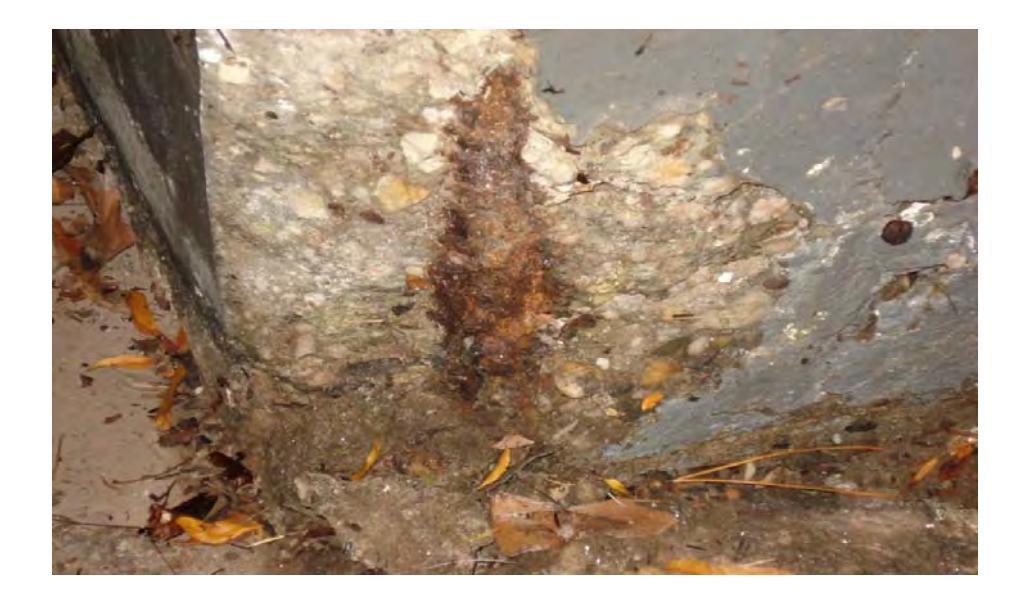
#### **Concrete Column and Potential Chrome Bloom**

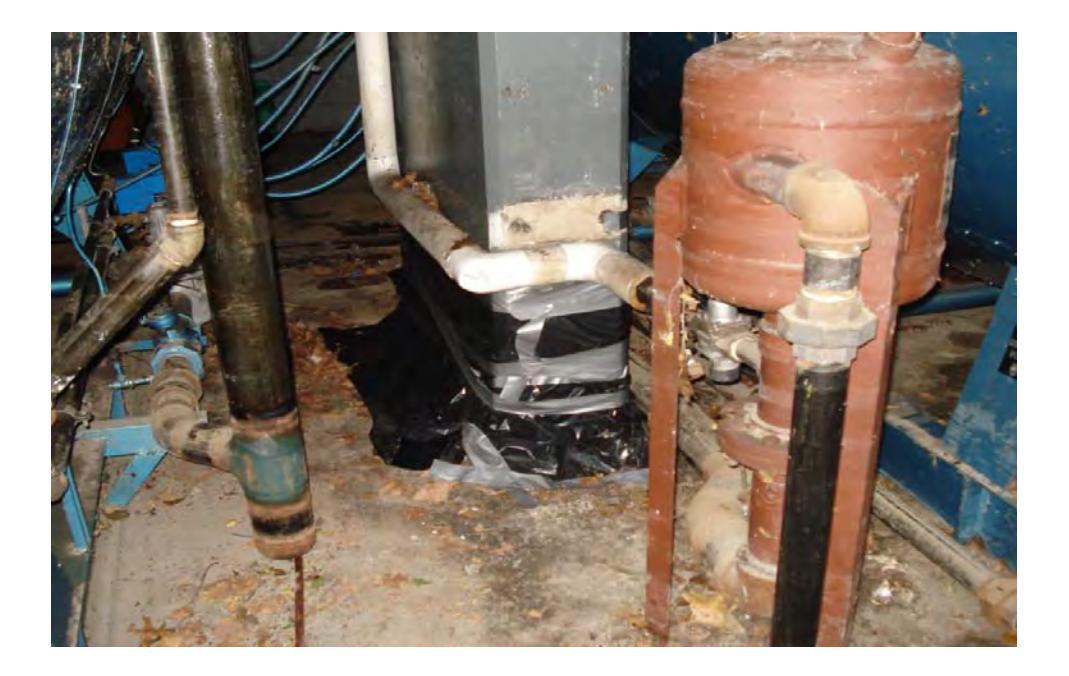
**Concrete Column with Temporary IRM Installed**
