Prepared by:
AECOM
Piscataway, NJ
60493065.29
July 2018

Remedial Action Report – Soil Area of Concern (AOC 1) Final

Hudson County Chromate Site 156
Metropolis Towers
270-280 Luis Munoz Marin Boulevard
Jersey City, New Jersey
NJDEP Program Interest Number: G000008770
Case Tracking Number: 104063

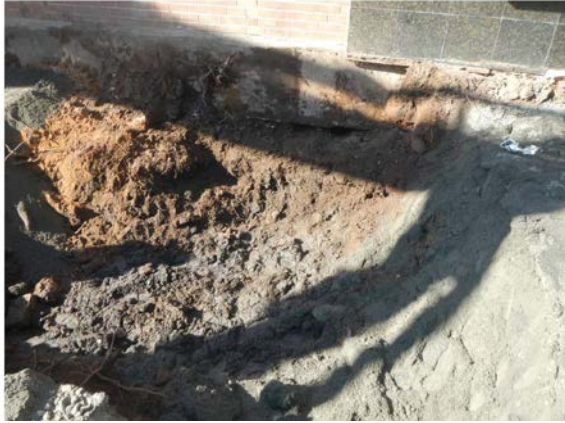
PHOTO 1 - Grid J1, CCPW Removed

The Layout Area 3 as-built survey does not appear to accurately depict the excavation along the building. The as-built contours are shallow compared to the elevations documented in daily summary reports. In the January 15, 2014 daily summary report included in the memorandum entitled *PPG Site 156 (Metro Towers) Scope of Work and Technical Rationale for Supplemental Remedial Investigation – Soil and Groundwater Sampling*, dated November 16, 2015 (AECOM, 2015c) (**Appendix A**), AECOM documented that ENTACT excavated in grid J1 (where PE-81 is located). CCPW was observed along the slope of the excavation in J1 adjacent to Building 1. J1 was excavated to a depth of approximately 8 ft bgs. The surface elevation at PE-81 is 8.2 ft NAVD 88. The excavation extended below the sample at PE-81 collected from 5.2 to 4.7 ft NAVD 88 to an elevation of 0.2 ft NAVD 88. The excavation in grid J1 adjacent to Building 1 is documented in photos from the February 11, 2014 daily summary report (AECOM, 2015c) and is shown in **Photo 1** and **Photo 2** below.

The February 11, 2014 daily summary report stated that no visible CCPW was observed under the building in Grid J1. For reference, the bottom of the building grade beam was surveyed at a location less than two feet from boring PE-81. The elevation of the bottom of the building grade beam at that location is 5.7 ft NAVD 88.
