### **6.2.2 Visible CCPW Along Building 1**

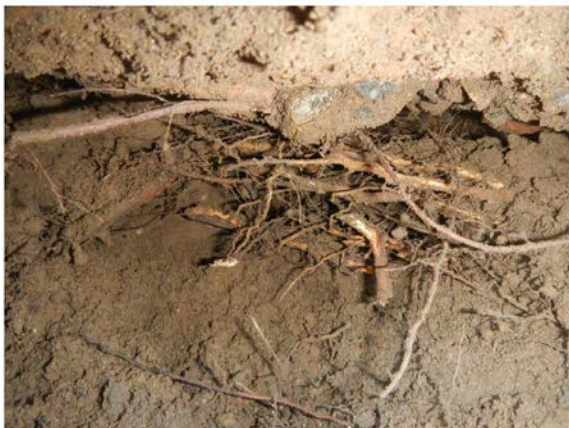
**PHOTO 2 - Grid J1, Under the Grade Beam**

The February 11, 2014 daily summary report stated that no visible CCPW was observed under the building in Grid J1. For reference, the bottom of the building grade beam was surveyed at a location less than two feet from boring PE-81. The elevation of the bottom of the building grade beam at that location is 5.7 ft NAVD 88.

In addition, pre- and post-excavation compliance samples adjacent to this boring location, comprised of the nearby bottom samples I1-UB and PE-12, and sidewall sample J1-SW (as depicted on **Figure 4A**), demonstrate that concentrations of Cr<sup>+6</sup> in the soil in the vicinity of boring PE-81 are less than the CrSCC for Cr<sup>+6</sup> of 20 mg/kg.
