Air Monitoring Plan Amendment 08

Client: PPG Industries	Amendment No.: 08 – Site 186 Excavation
Location: Jersey City, NJ	Date: May 30, 2013
<p>Amendment Description:</p> <p>This Air Monitoring Plan (AMP) amendment describes Air Monitoring to be performed at Site 186 during remedial activities at that site. The Garfield Avenue Sites AMP dated May 2011 was used as a basis for Air Monitoring at Site 186 in accordance with the Remedial Action Work Plan (RAWP) dated May 2013.</p> <p>Excavation of Site 186 is expected to be limited to a short duration (less than 1week); therefore, AECOM has developed a relatively simplistic yet conservative air monitoring approach to address concerns associated with fugitive emissions. AECOM will provide a two tiered approach:</p> <ul style="list-style-type: none"> • Perimeter of the Exclusion Zone Monitoring – Periodic hand-held PM₁₀ monitoring will be recorded every half hour at 4-6 locations during periods of active work. • Fence line Monitoring – Real-time continuous PM₁₀ monitoring plus 8-hour integrated sampling and analyses for Cr6 and PM₁₀ will be performed at two (2) PAM stations located in the upwind and downwind directions. <p>Monitoring as

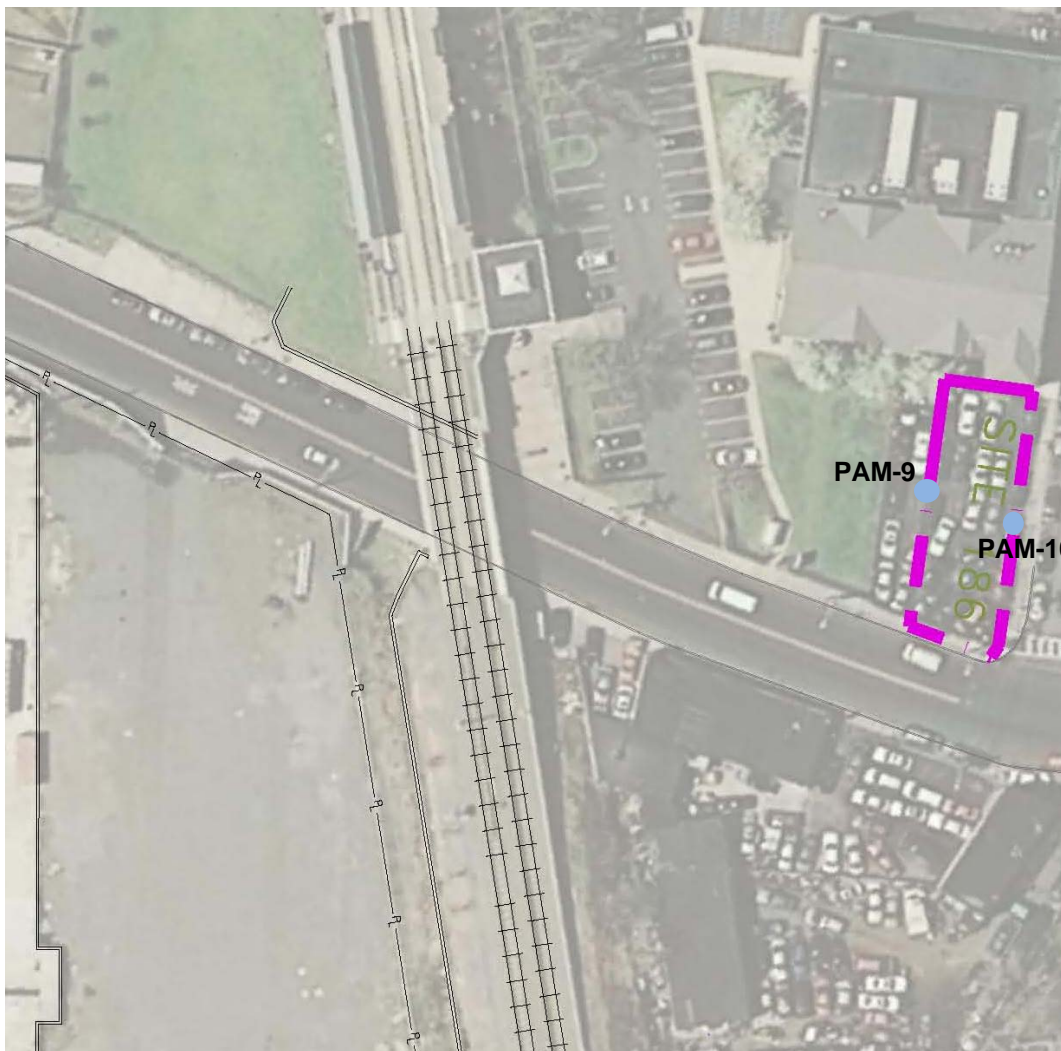
Attachment 1: Site 186 Map (8/19/13 – 8/23/13)

Fenceline Portable Air Monitoring Station (PAM)

A combination of real-time monitoring and integrated sampling was performed during periods of active work at the fenceline and the perimeter of the exclusion zone. Real-time PM₁₀ monitoring was conducted at two (2) portable air monitoring (PAM) stations along the Site fenceline. Additionally, 8-hour integrated Cr6 and PM₁₀ samples were collected daily at the two (2) PAM stations at the Site fenceline. Periodic hand-held monitoring was performed at four (4) to ten (10) locations at the perimeter of the exclusion zone. Meteorological data measured at Site 114 was used to evaluate the wind conditions during work periods.

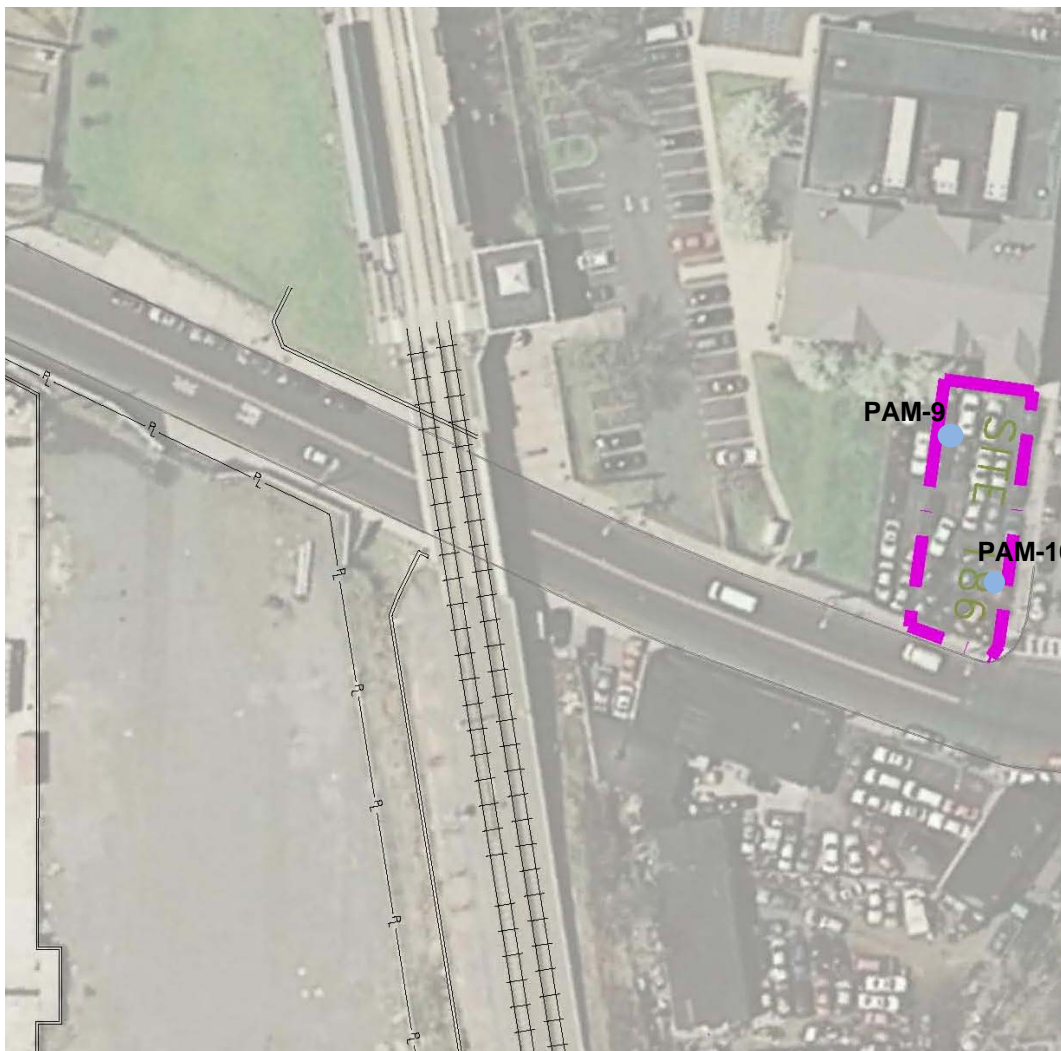
Attachment 1: Site 186 Map (9/16/13 – 9/18/13 1:00PM)

Fenceline Portable Air Monitoring Station (PAM)

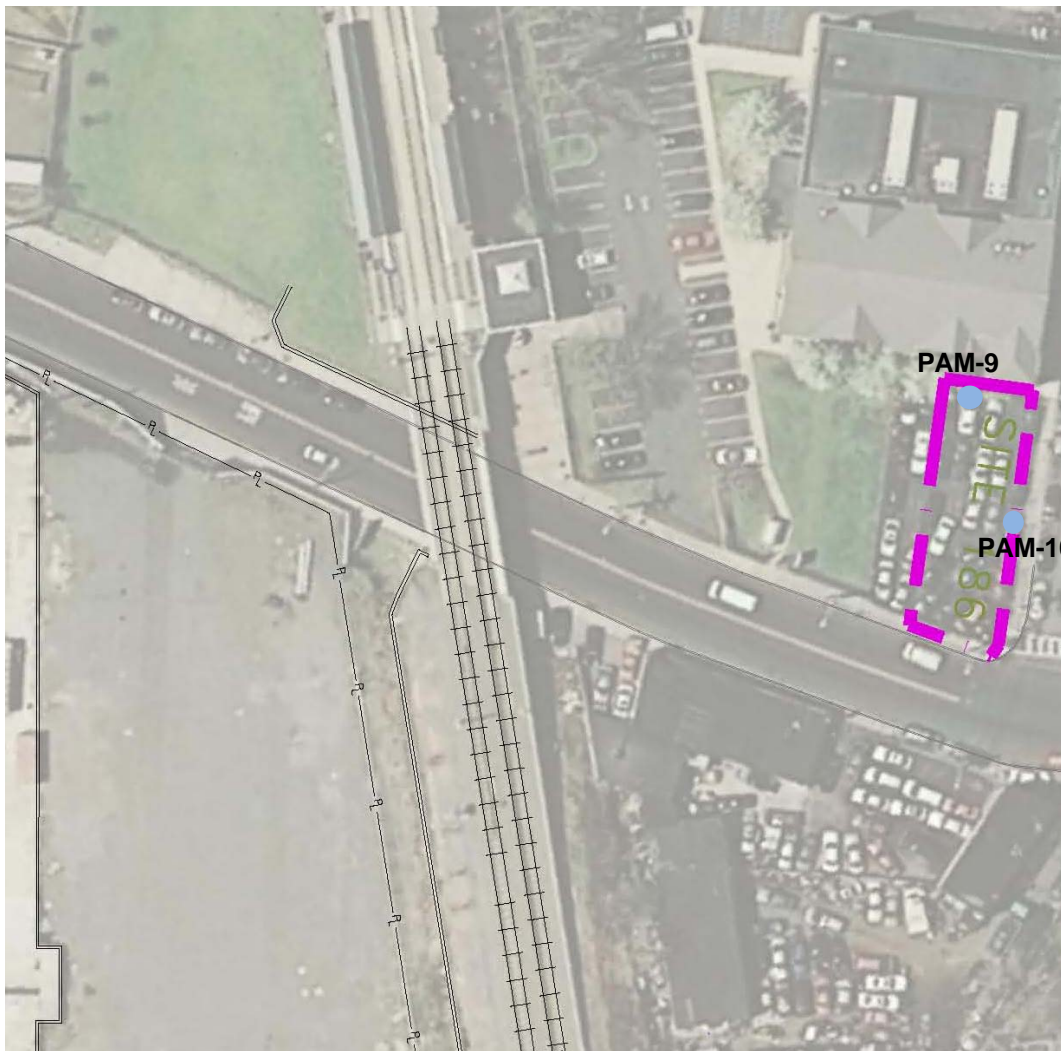
Attachment 1: Site 186 Map (9/23/13 7:30AM – 10:30AM)

Fenceline Portable Air Monitoring Station (PAM)

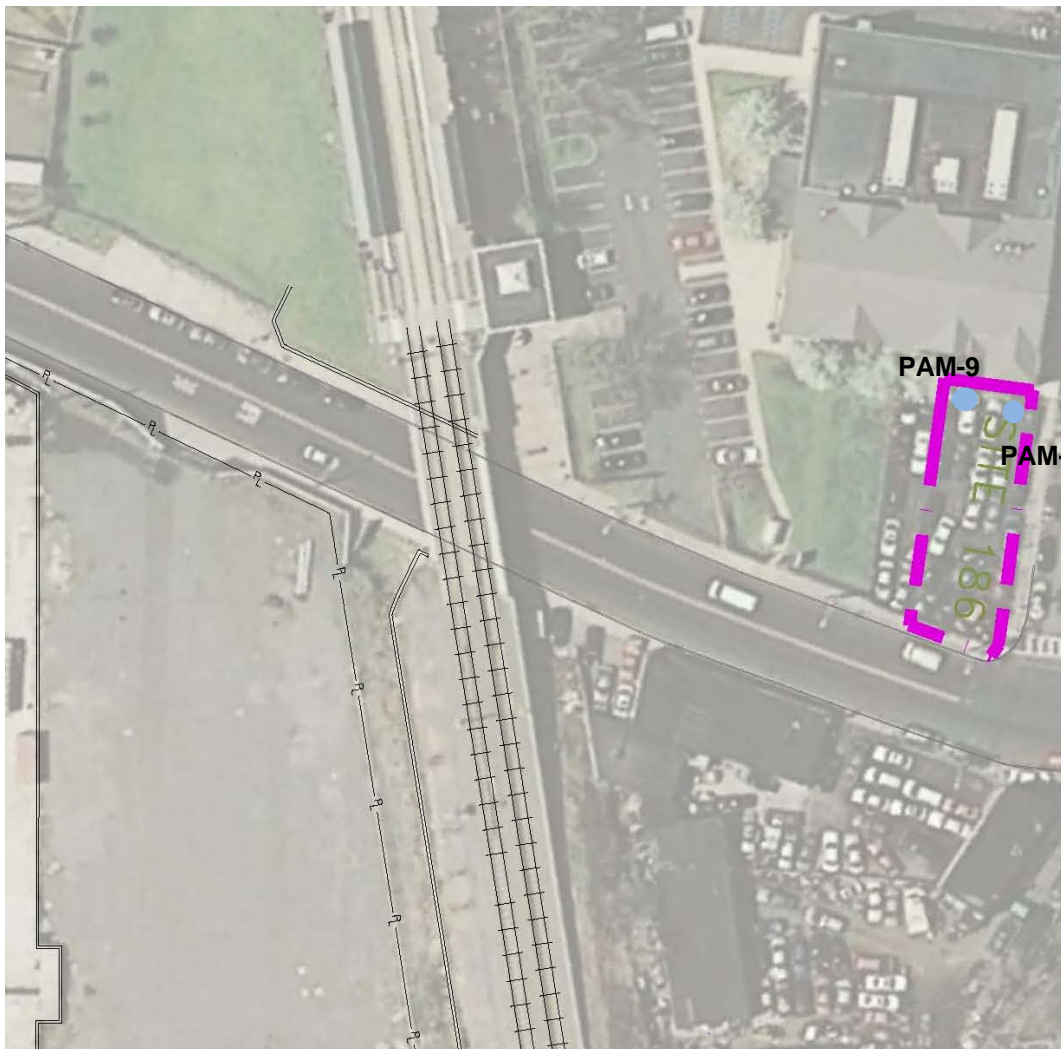
Attachment 1: Site 186 Map (9/23/13 10:45AM – 9/24/13 1:00PM)

Fenceline Portable Air Monitoring Station (PAM)

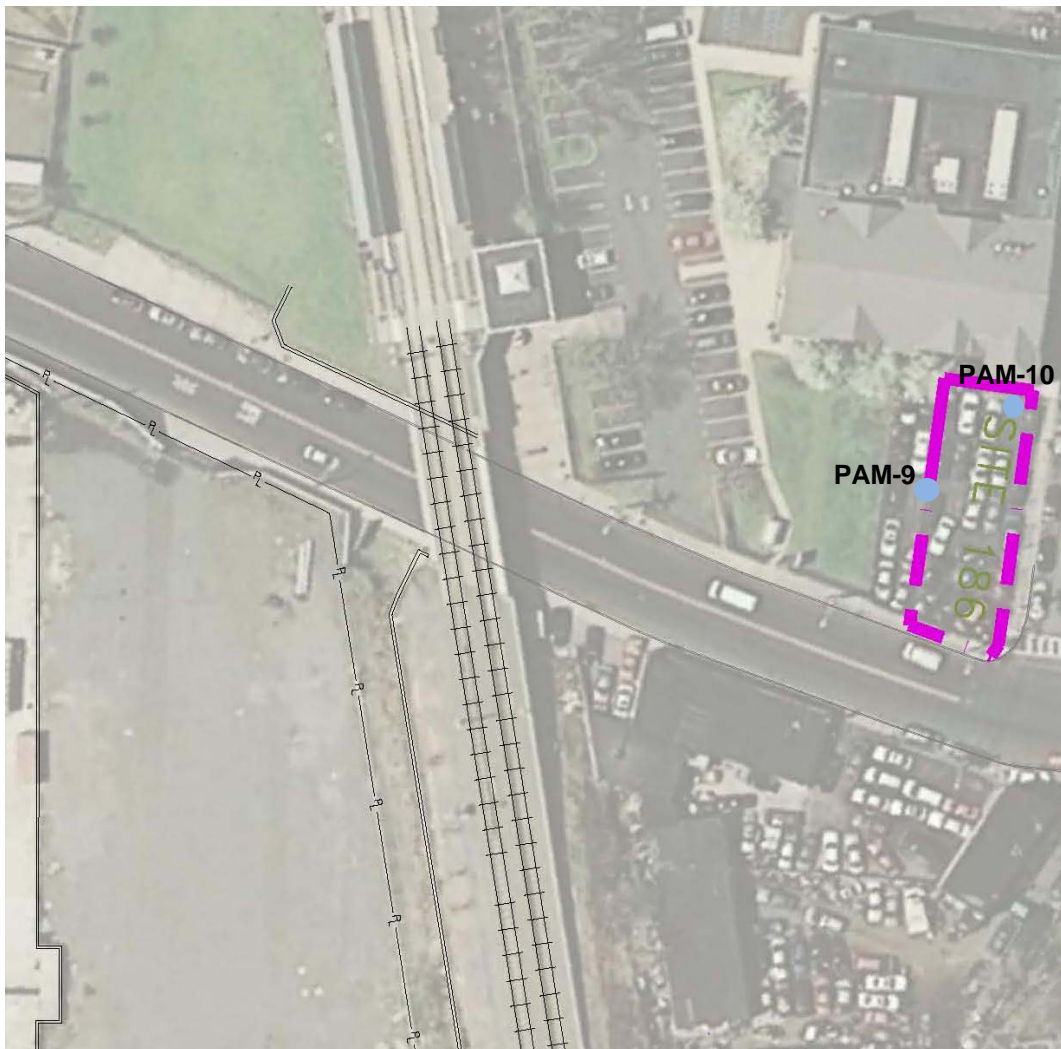
Attachment 1: Site 186 Map (9/24/13 1:15PM – 9/25/13)

Fenceline Portable Air Monitoring Station (PAM)

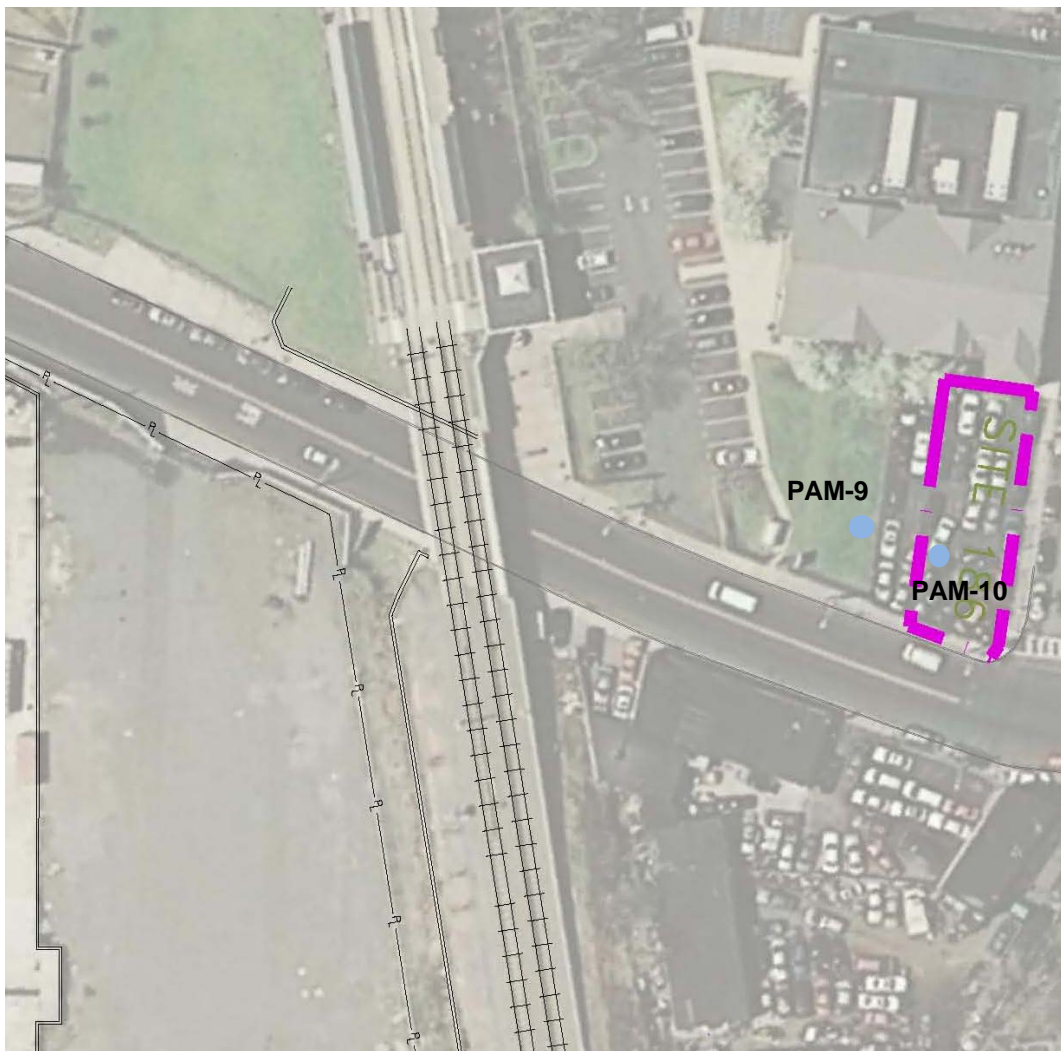
Attachment 1: Site 186 Map (10/12/13)

Fenceline Portable Air Monitoring Station (PAM)

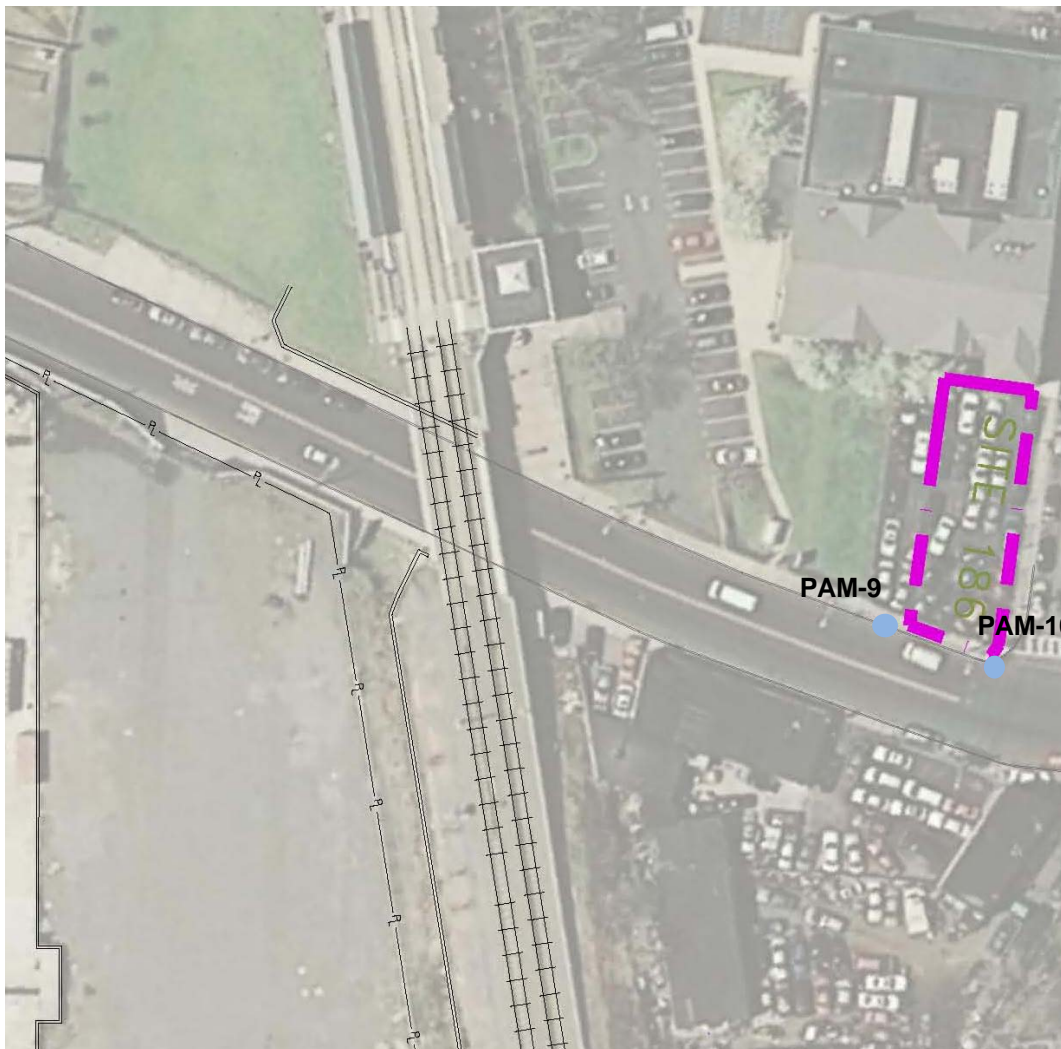
Attachment 1: Site 186 Map (10/29/13 – 10/30/13)

Fenceline Portable Air Monitoring Station (PAM)

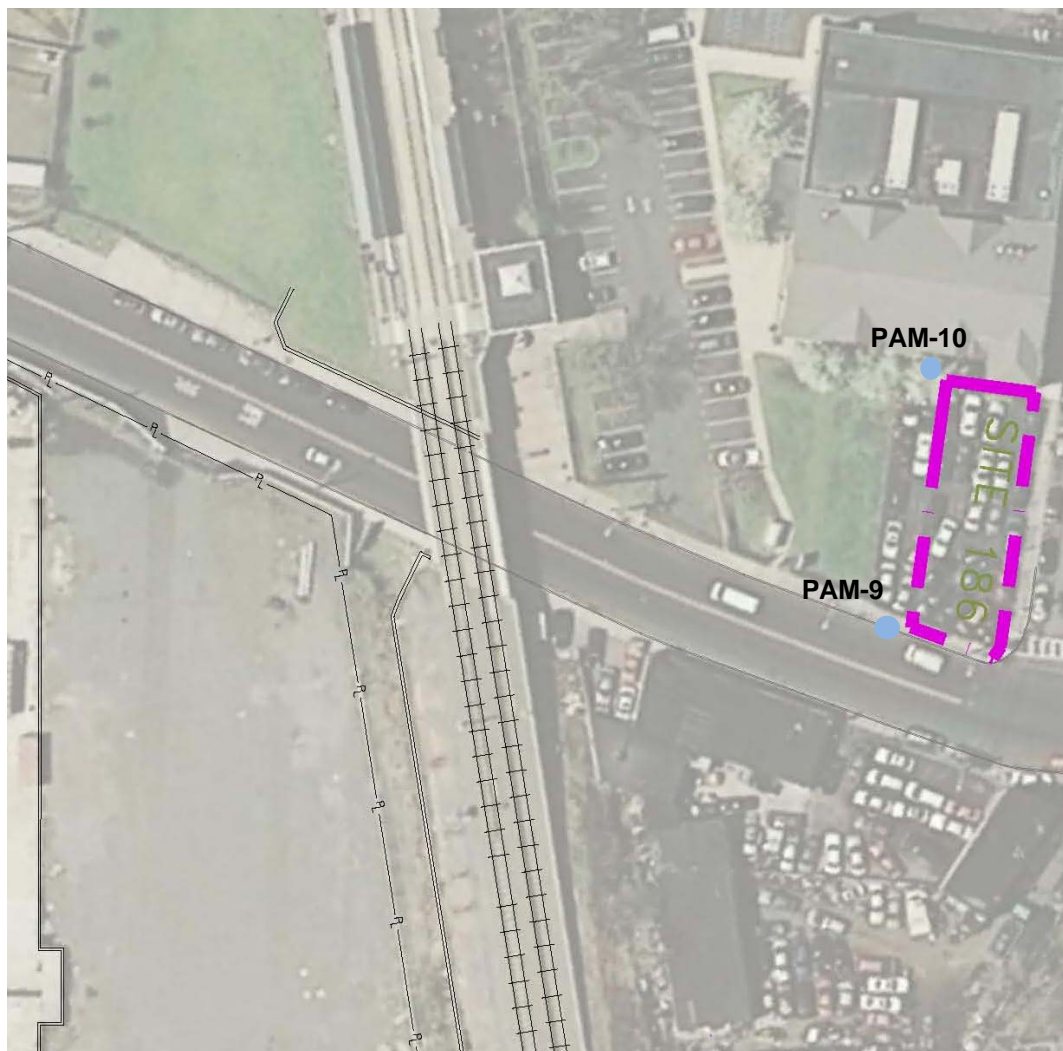
Attachment 1: Site 186 Map (10/31/13 – 11/1/13)

Fenceline Portable Air Monitoring Station (PAM)

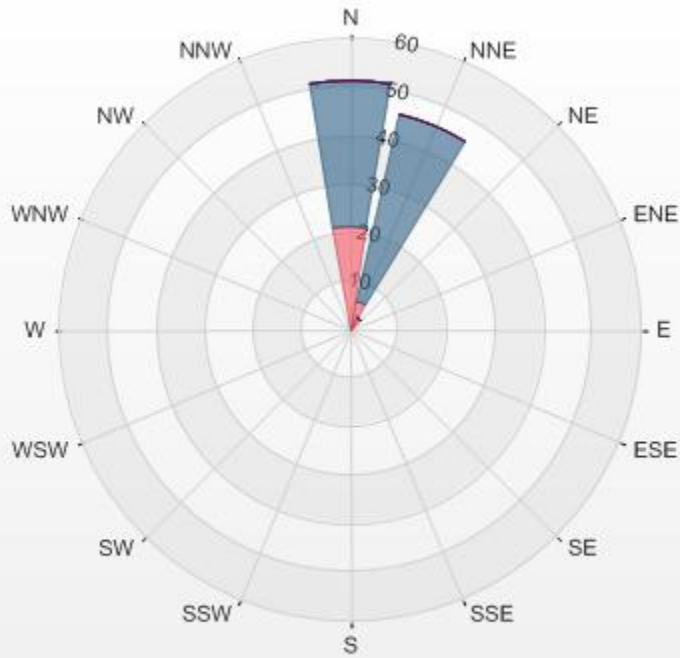
PPG MET 8/23/2013 7:00 AM - 8/23/2013 3:00 PM Calm: 0.0%

%	Icon	Classes (mph)
30		3.3-6.7
0		10.0-13.3
0		13.3-16.7
0		16.7-20.0
0		>20.0
0		0.5-3.3
70		6.7-10.0

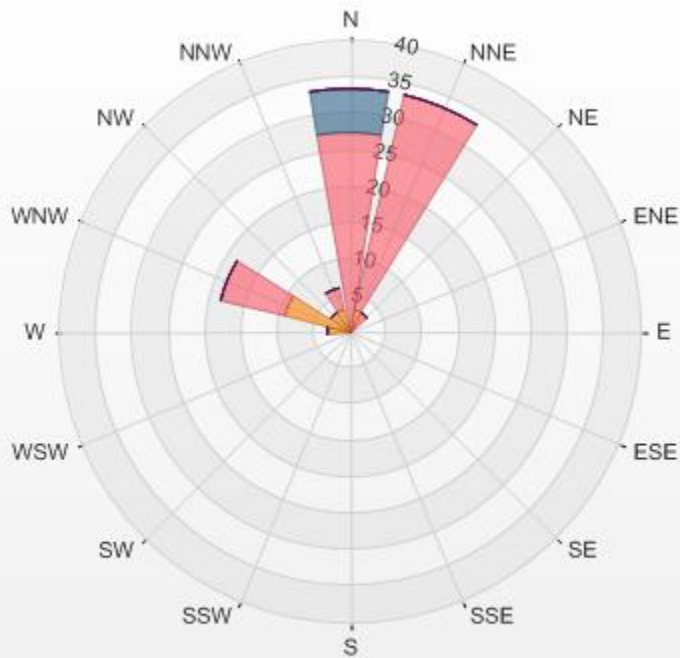
PPG MET 9/16/2013 7:00 AM - 9/16/2013 3:00 PM Calm: 0.0%

%	Icon	Classes (mph)
73		3.3-6.7
0		10.0-13.3
0		13.3-16.7
0		16.7-20.0
0		>20.0
21		0.5-3.3
6		6.7-10.0

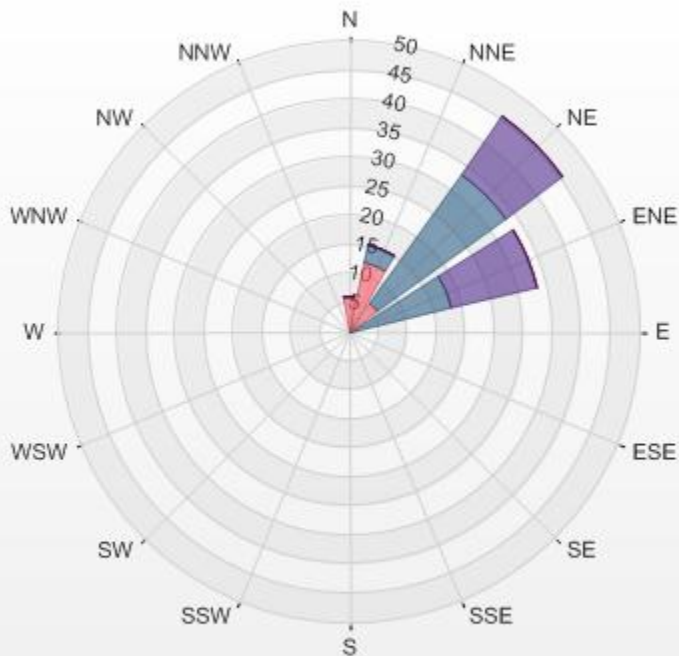
PPG MET 9/17/2013 7:00 AM - 9/17/2013 3:00 PM Calm: 0.0%

%	Icon	Classes (mph)	Count	Icon	Classes (mph)	Count	Icon	Classes (mph)	Count	Icon	Classes (mph)	Count
24	[Red]	3.3-6.7	27	[Purple]	10.0-13.3	0	[Pink]	13.3-16.7	0	[Brown]	16.7-20.0	0
0	[Orange]	0.5-3.3	48	[Blue]	6.7-10.0

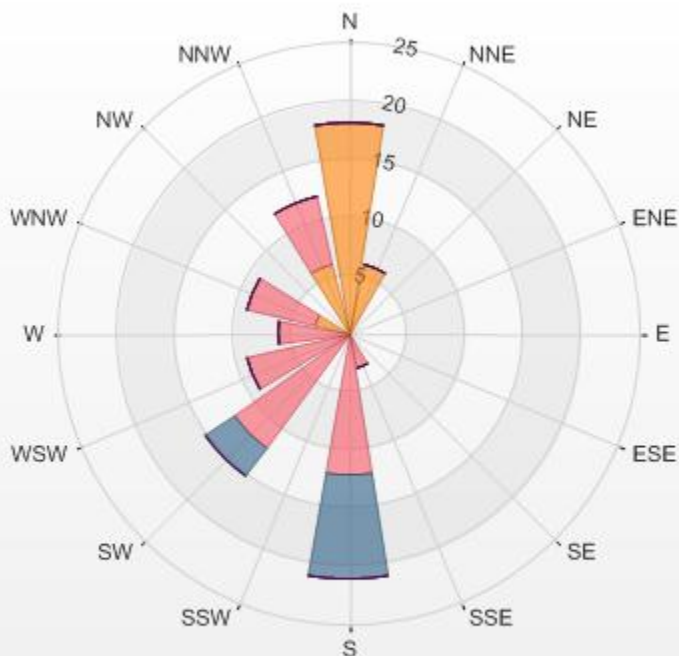
PPG MET 9/18/2013 7:00 AM - 9/18/2013 3:00 PM Calm: 0.0%

%	Icon	Classes (mph)	Count	Icon	Classes (mph)	Count	Icon	Classes (mph)	Count	Icon	Classes (mph)	Count
55	[Red]	3.3-6.7	0	[Purple]	10.0-13.3	0	[Pink]	13.3-16.7	0	[Brown]	16.7-20.0	0
33	[Orange]	0.5-3.3	12	[Blue]	6.7-10.0

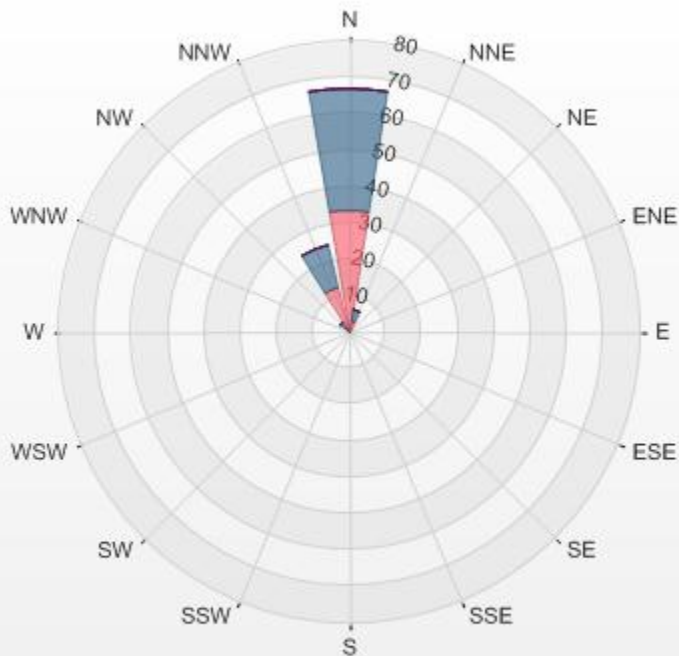
PPG MET 9/23/2013 7:00 AM - 9/23/2013 3:00 PM Calm: 0.0%

%	Icon	Classes (mph)	0	52	0	0	0	0
48		3.3-6.7	0		10.0-13.3	0		13.3-16.7
0		0.5-3.3	52		6.7-10.0	0		16.7-20.0
0		>20.0	0			0		>20.0

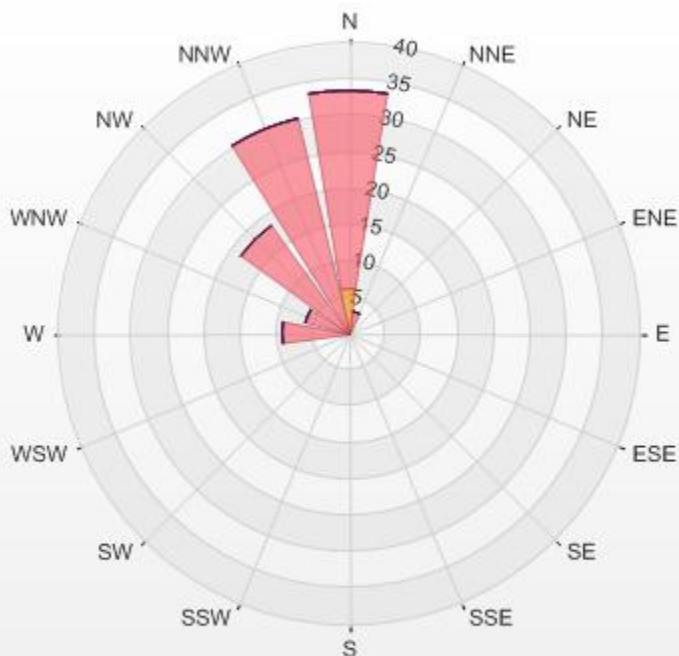
PPG MET 9/24/2013 7:00 AM - 9/24/2013 3:00 PM Calm: 0.0%

%	Icon	Classes (mph)	94	0	0	0	0	
0		0.5-3.3	6		3.3-6.7	0		10.0-13.3
0		6.7-10.0	0		13.3-16.7	0		16.7-20.0
0		>20.0	0			0		>20.0

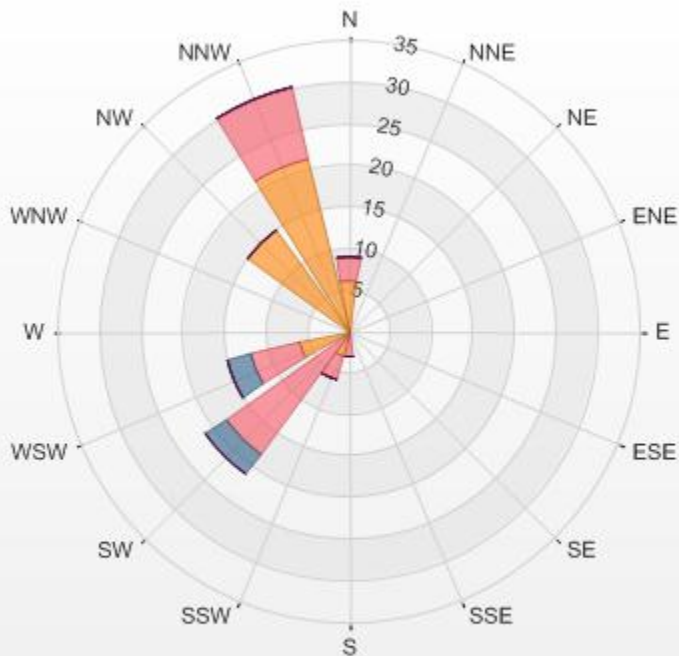
PPG MET 10/30/2013 7:00 AM - 10/30/2013 3:00 PM Calm: 0.0%

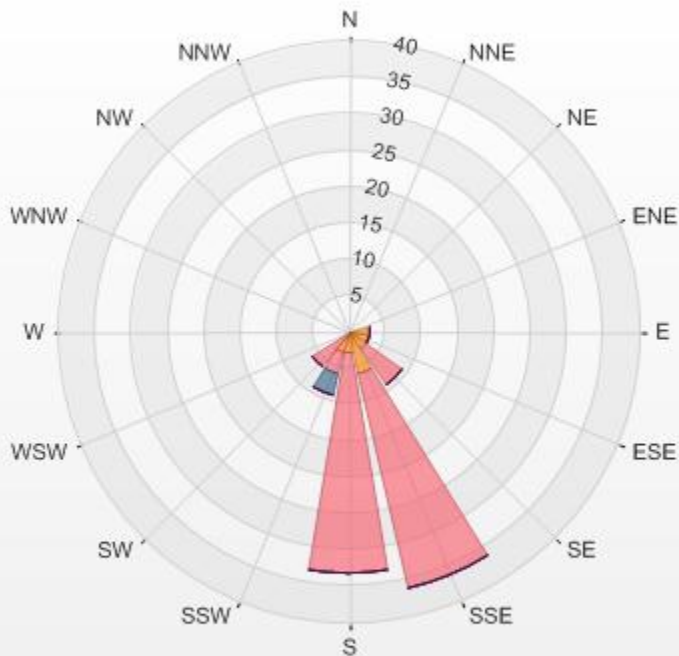
PPG MET 10/31/2013 7:00 AM - 10/31/2013 3:00 PM Calm: 0.0%
