# Memorandum

То	Thomas Gibbons (CB&I)	Page 1
CC	Keiht Prins (PPG), Mark Terril (PPG), Scott Mikaelian (AECOM)	
Subject	Site 186 RAWP Addendum - Soil Investigation/Excavation at Metropolitan Family Heath Network	
From	Alfred LoPilato (AECOM)	
Date	September 16, 2013

RE: Hudson County Chromate Site 186 - Remedial Action Work Plan (RAWP) – Proposed RAWP Addendum - Soil Investigation/Excavation at Metropolitan Family Heath Network, 935 Garfield Avenue, Jersey City, NJ

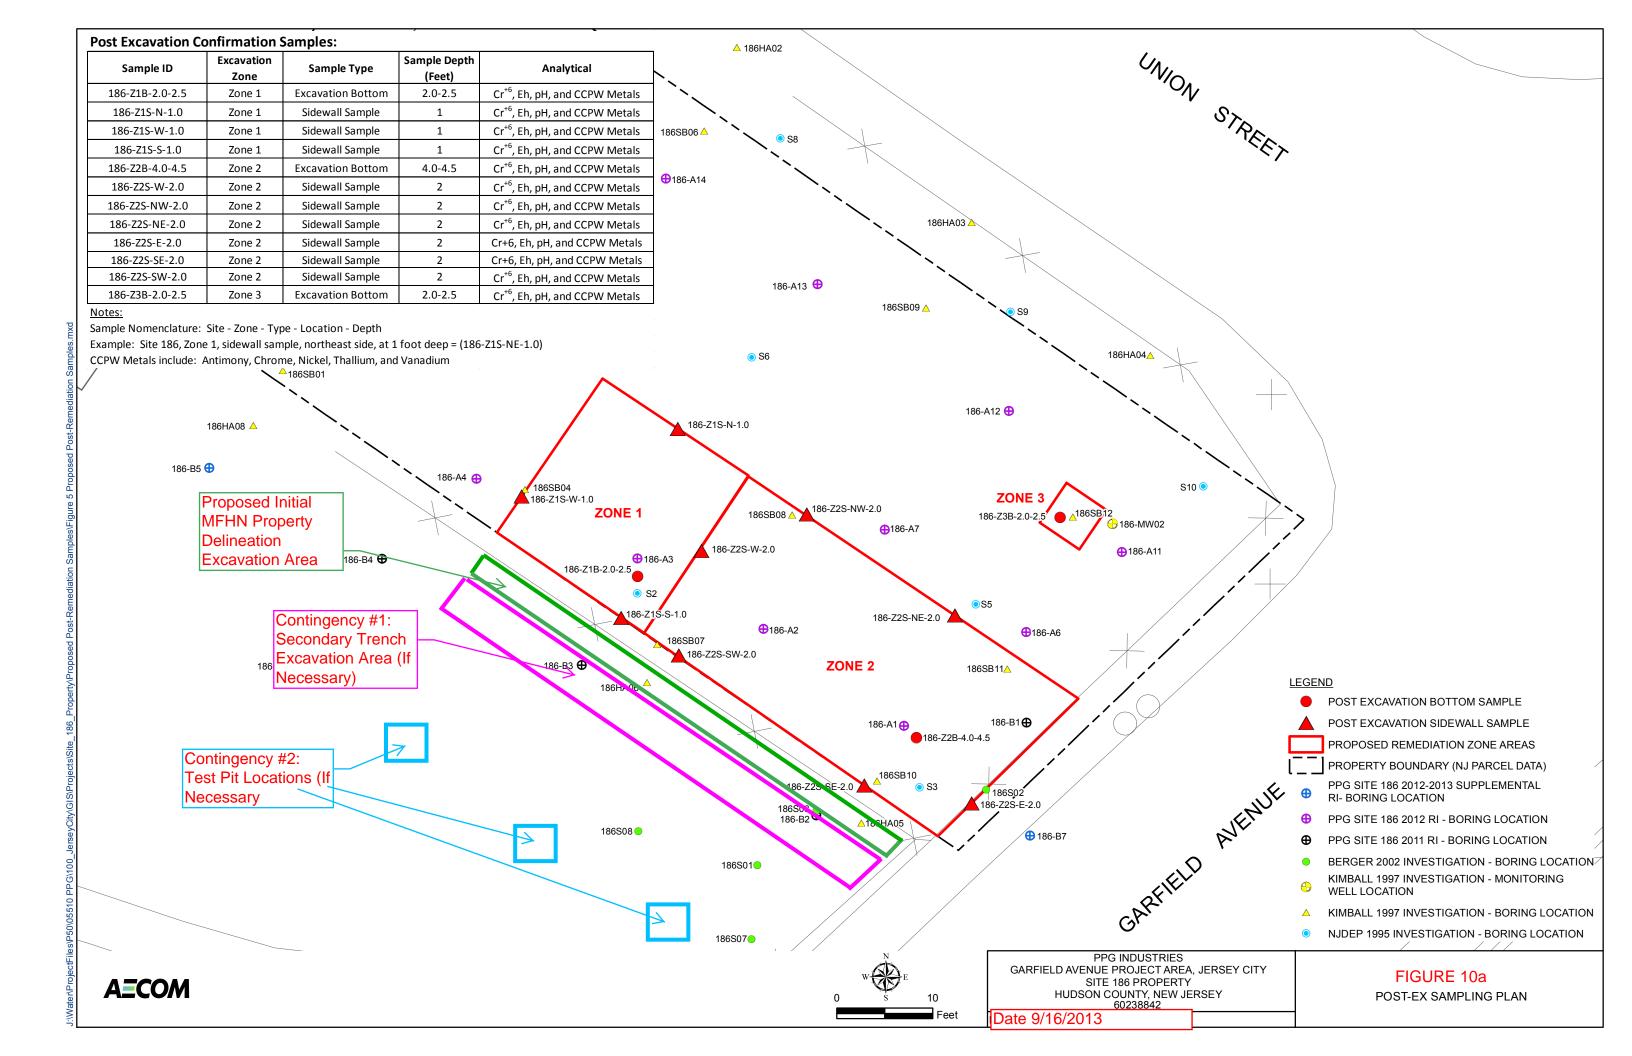
During the remedial action, NJDEP and AECOM (as remediation oversight consultants to PPG) observed visible CCPW material, at generally low concentrations (on a percentage basis), along the southern excavation sidewall adjacent to the Metropolitan Family Health Network (MFHN) property boundary (see Figure 10a attached). The material was generally observed within the top two feet of the sidewall profile, between the top of a former stone building foundation and the asphalt pavement.

To further investigate the presence/non-presence of CCPW on the MHFN side of the property boundary, PPG proposes to initially excavate a narrow trench (approximately 3-feet wide) along the property boundary, approximately 3-feet deep, starting at Garfield Avenue and continuing along the fence to the point at which CCPW was no longer observed on Site 186 (see attached Figure 10a). Access would be obtained from Garfield Avenue, through the gate near the NJ Transit bus stop, and we would utilize a small, rubber tire back hoe or miniexcavator to conduct the work to minimize disturbance to the existing grass/landscaping.
