### **Level 3 Survey Performed by Enviroscan**

**Final Report**  
**Geophysical Survey – Level 3 Utility Detection/Delineation**  
**Exterior Portions – Garfield Avenue Group Site**  
**Jersey City, NJ**  
**Enviroscan Reference Number 071117**

**Prepared For: AECOM**  
**Prepared By: Enviroscan, Inc.**  
**September 16, 2011**

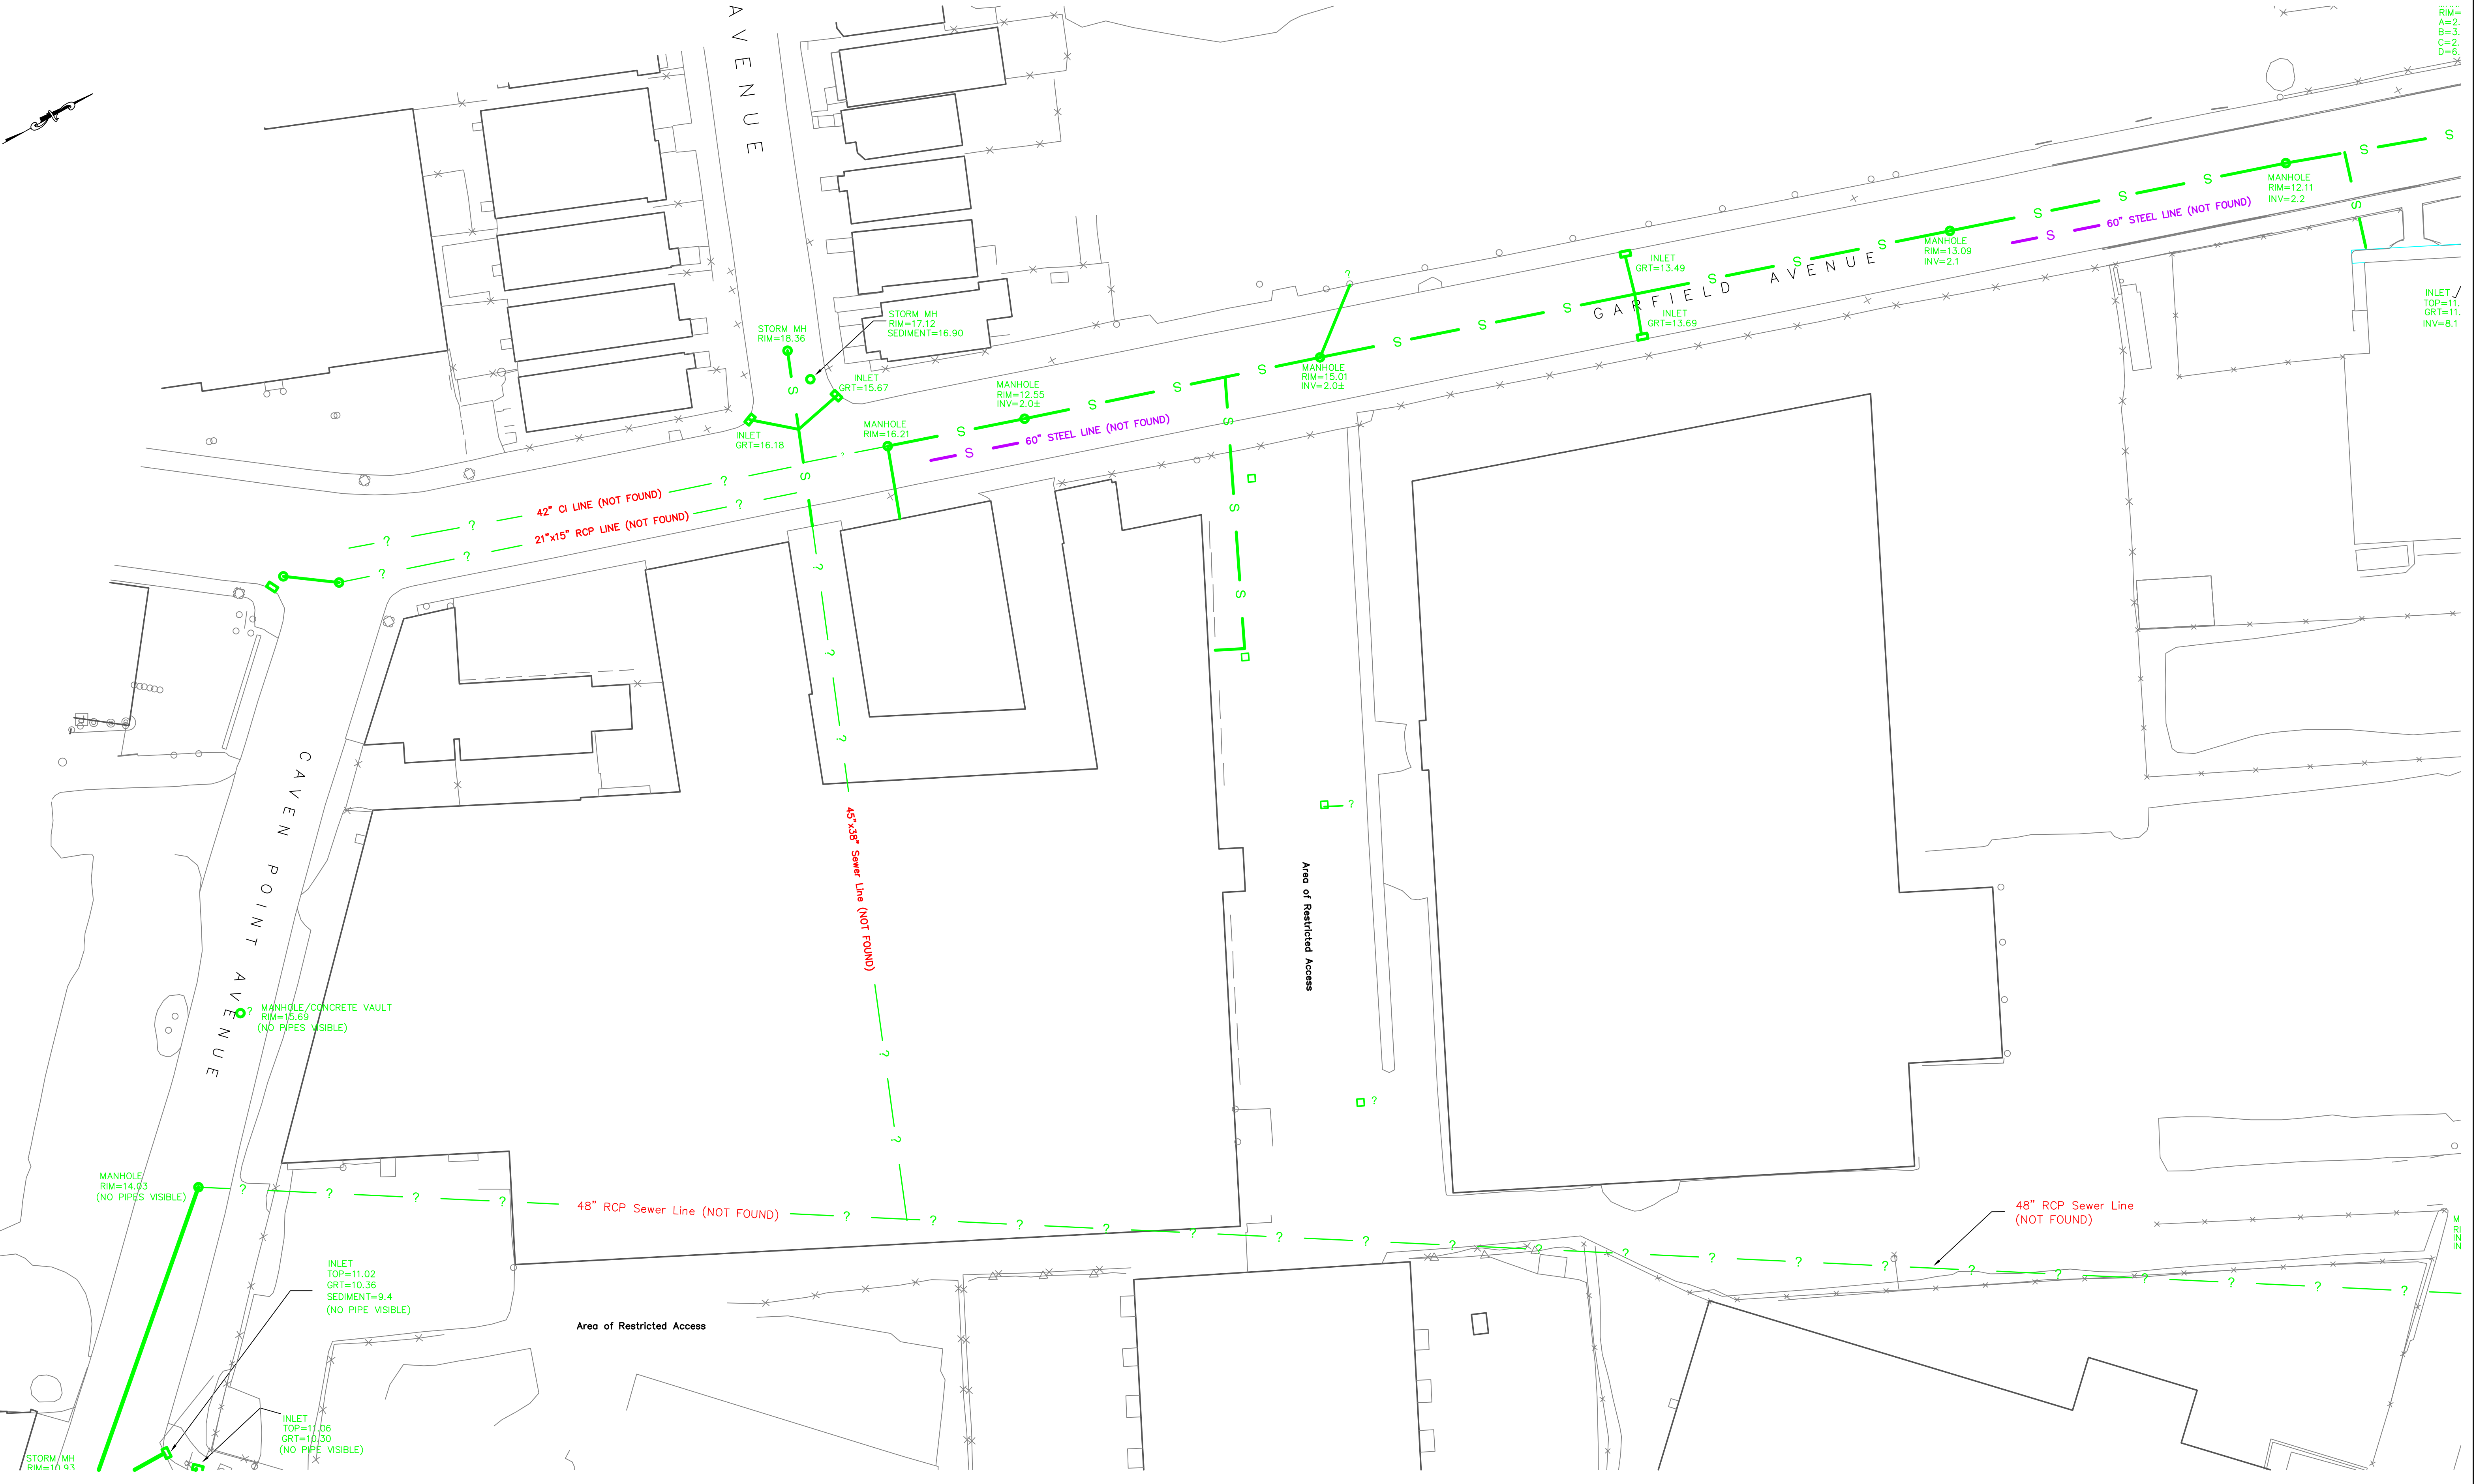
Sheet **3**  
 Drawn by: CHR  
 Approved by: FKB

Sheets 3, 5, 7, 9, and 11 show the traced shallow (i.e. less than approximately 10 feet) portions of the sewer system. Note that historical information also indicates the presence of a much deeper 96” steel line, as well as a similarly deep 60” and 78” steel line and a 36” brick line within Garfield Avenue (Sheet 3, 7, and 11). Passive scanning was able to detect the suspected 96” steel line within Carteret Avenue; however, passive scanning could not trace the 60” and 78” steel line within Garfield Avenue due to the presence of multiple utility lines that have passive signals (gas, water, electric, and communication lines). Additionally, the brick lines cannot be traced without an active source such as a tracer wire or sonde inside the line. However, the brick line appears to extend from manhole to manhole. Given the size, construction design, and other limiting factors of the steel line, placing an active source within the line does not appear to be an option at this time. The approximate location of the 60” and 76” steel line is labeled on Sheets 3, 7, and 11 between the gas and shallow sewer line along Garfield Avenue based on historical information provided to Enviroscan. Additionally, the brick lines are believed to be within the boundaries of Garfield and Carteret Avenues and appear to extend from manhole to manhole.

Please note that historical information indicates the presence of a 45”x 38” sewer line from Claremont Avenue through an existing building to a 48” RCP sewer line that extends from Caven Point to Carteret Avenue (Sheets 3 and 7). A 54” RCP sewer line is also reported to extend from the same manhole on Carteret Avenue through the Garfield Avenue Group Site to a manhole located outside the fenced area along the railroad line (Sheet 7). Access is limited in several areas along these suspected lines due to buildings, concrete pads, chain link fences, and other sources of interference. Given the size and assumed depth of these lines, it is unlikely these lines can be traced without an active source such as a tracer wire or sonde inside the line.

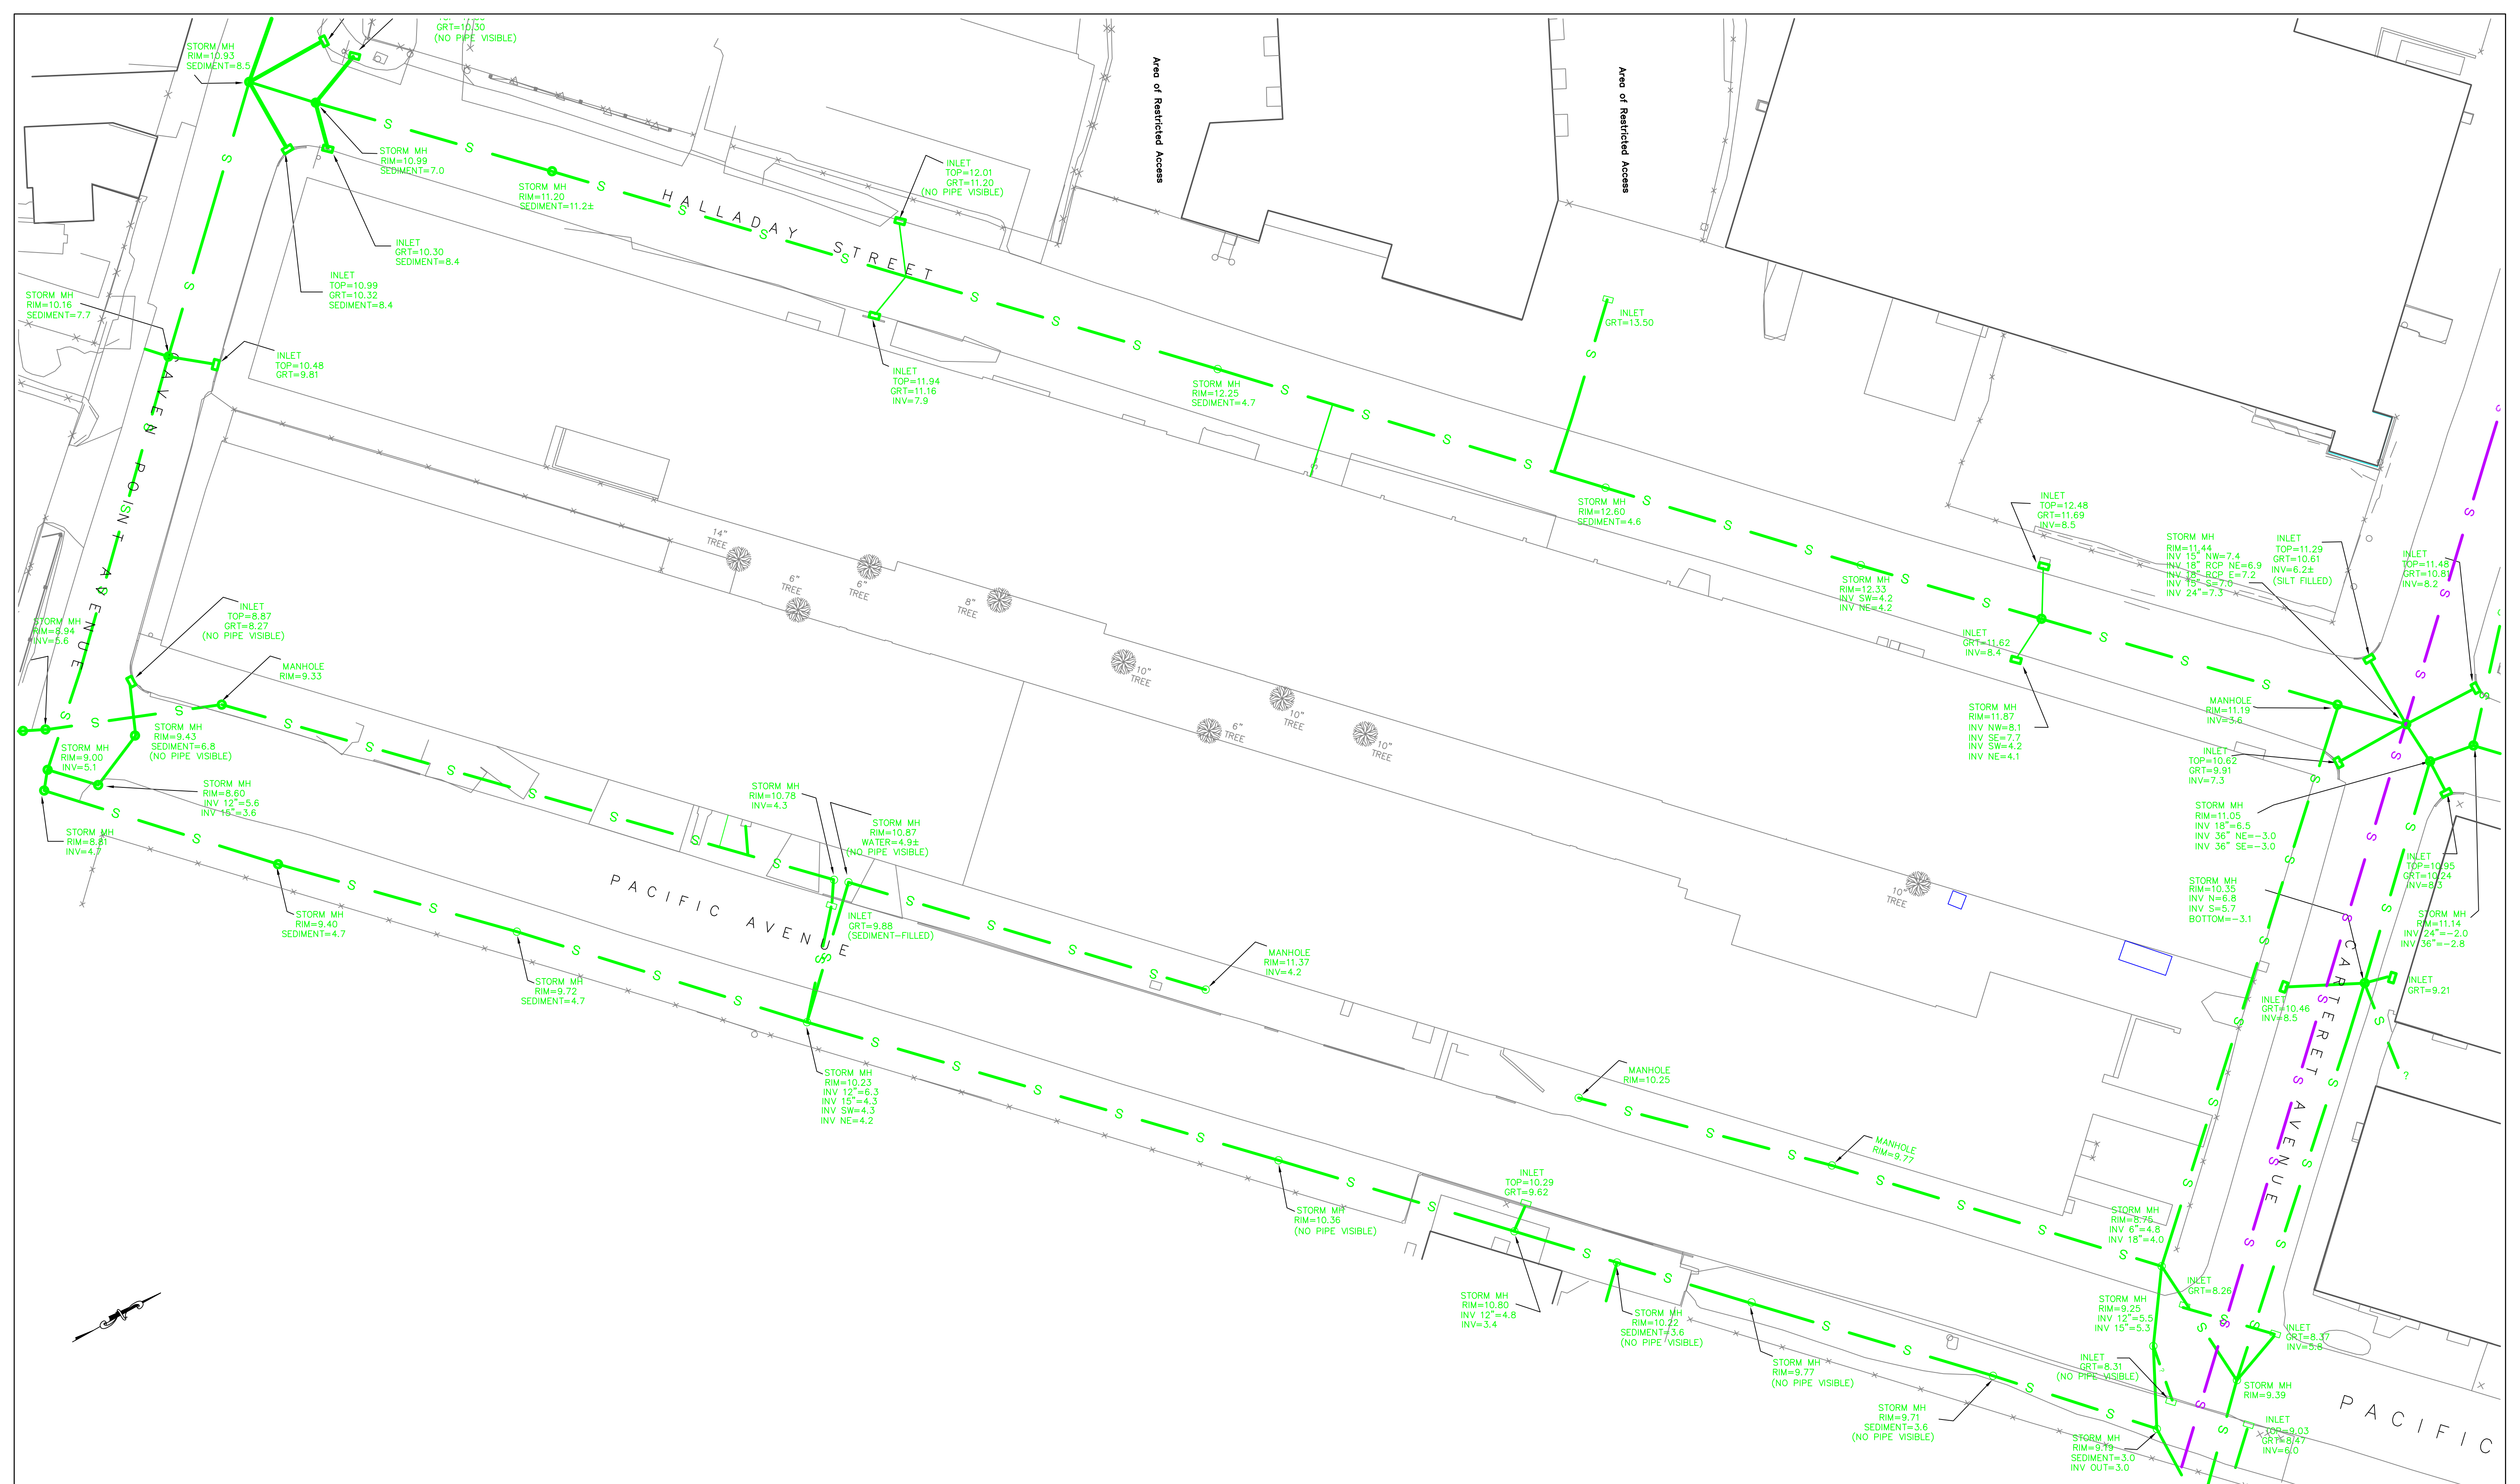
4

Geophysical Survey Results - Southwest Area Utilities			PPG Industries Sites Jersey City, NJ		Sheet
No.	Revision/Issue	Date	Project Number	Survey Start Date	Drawn by
1	071117.DWG	9/16/11	071117	08/20/11	CHR
Original Scale			1" = 30'		Approved by
					FKB

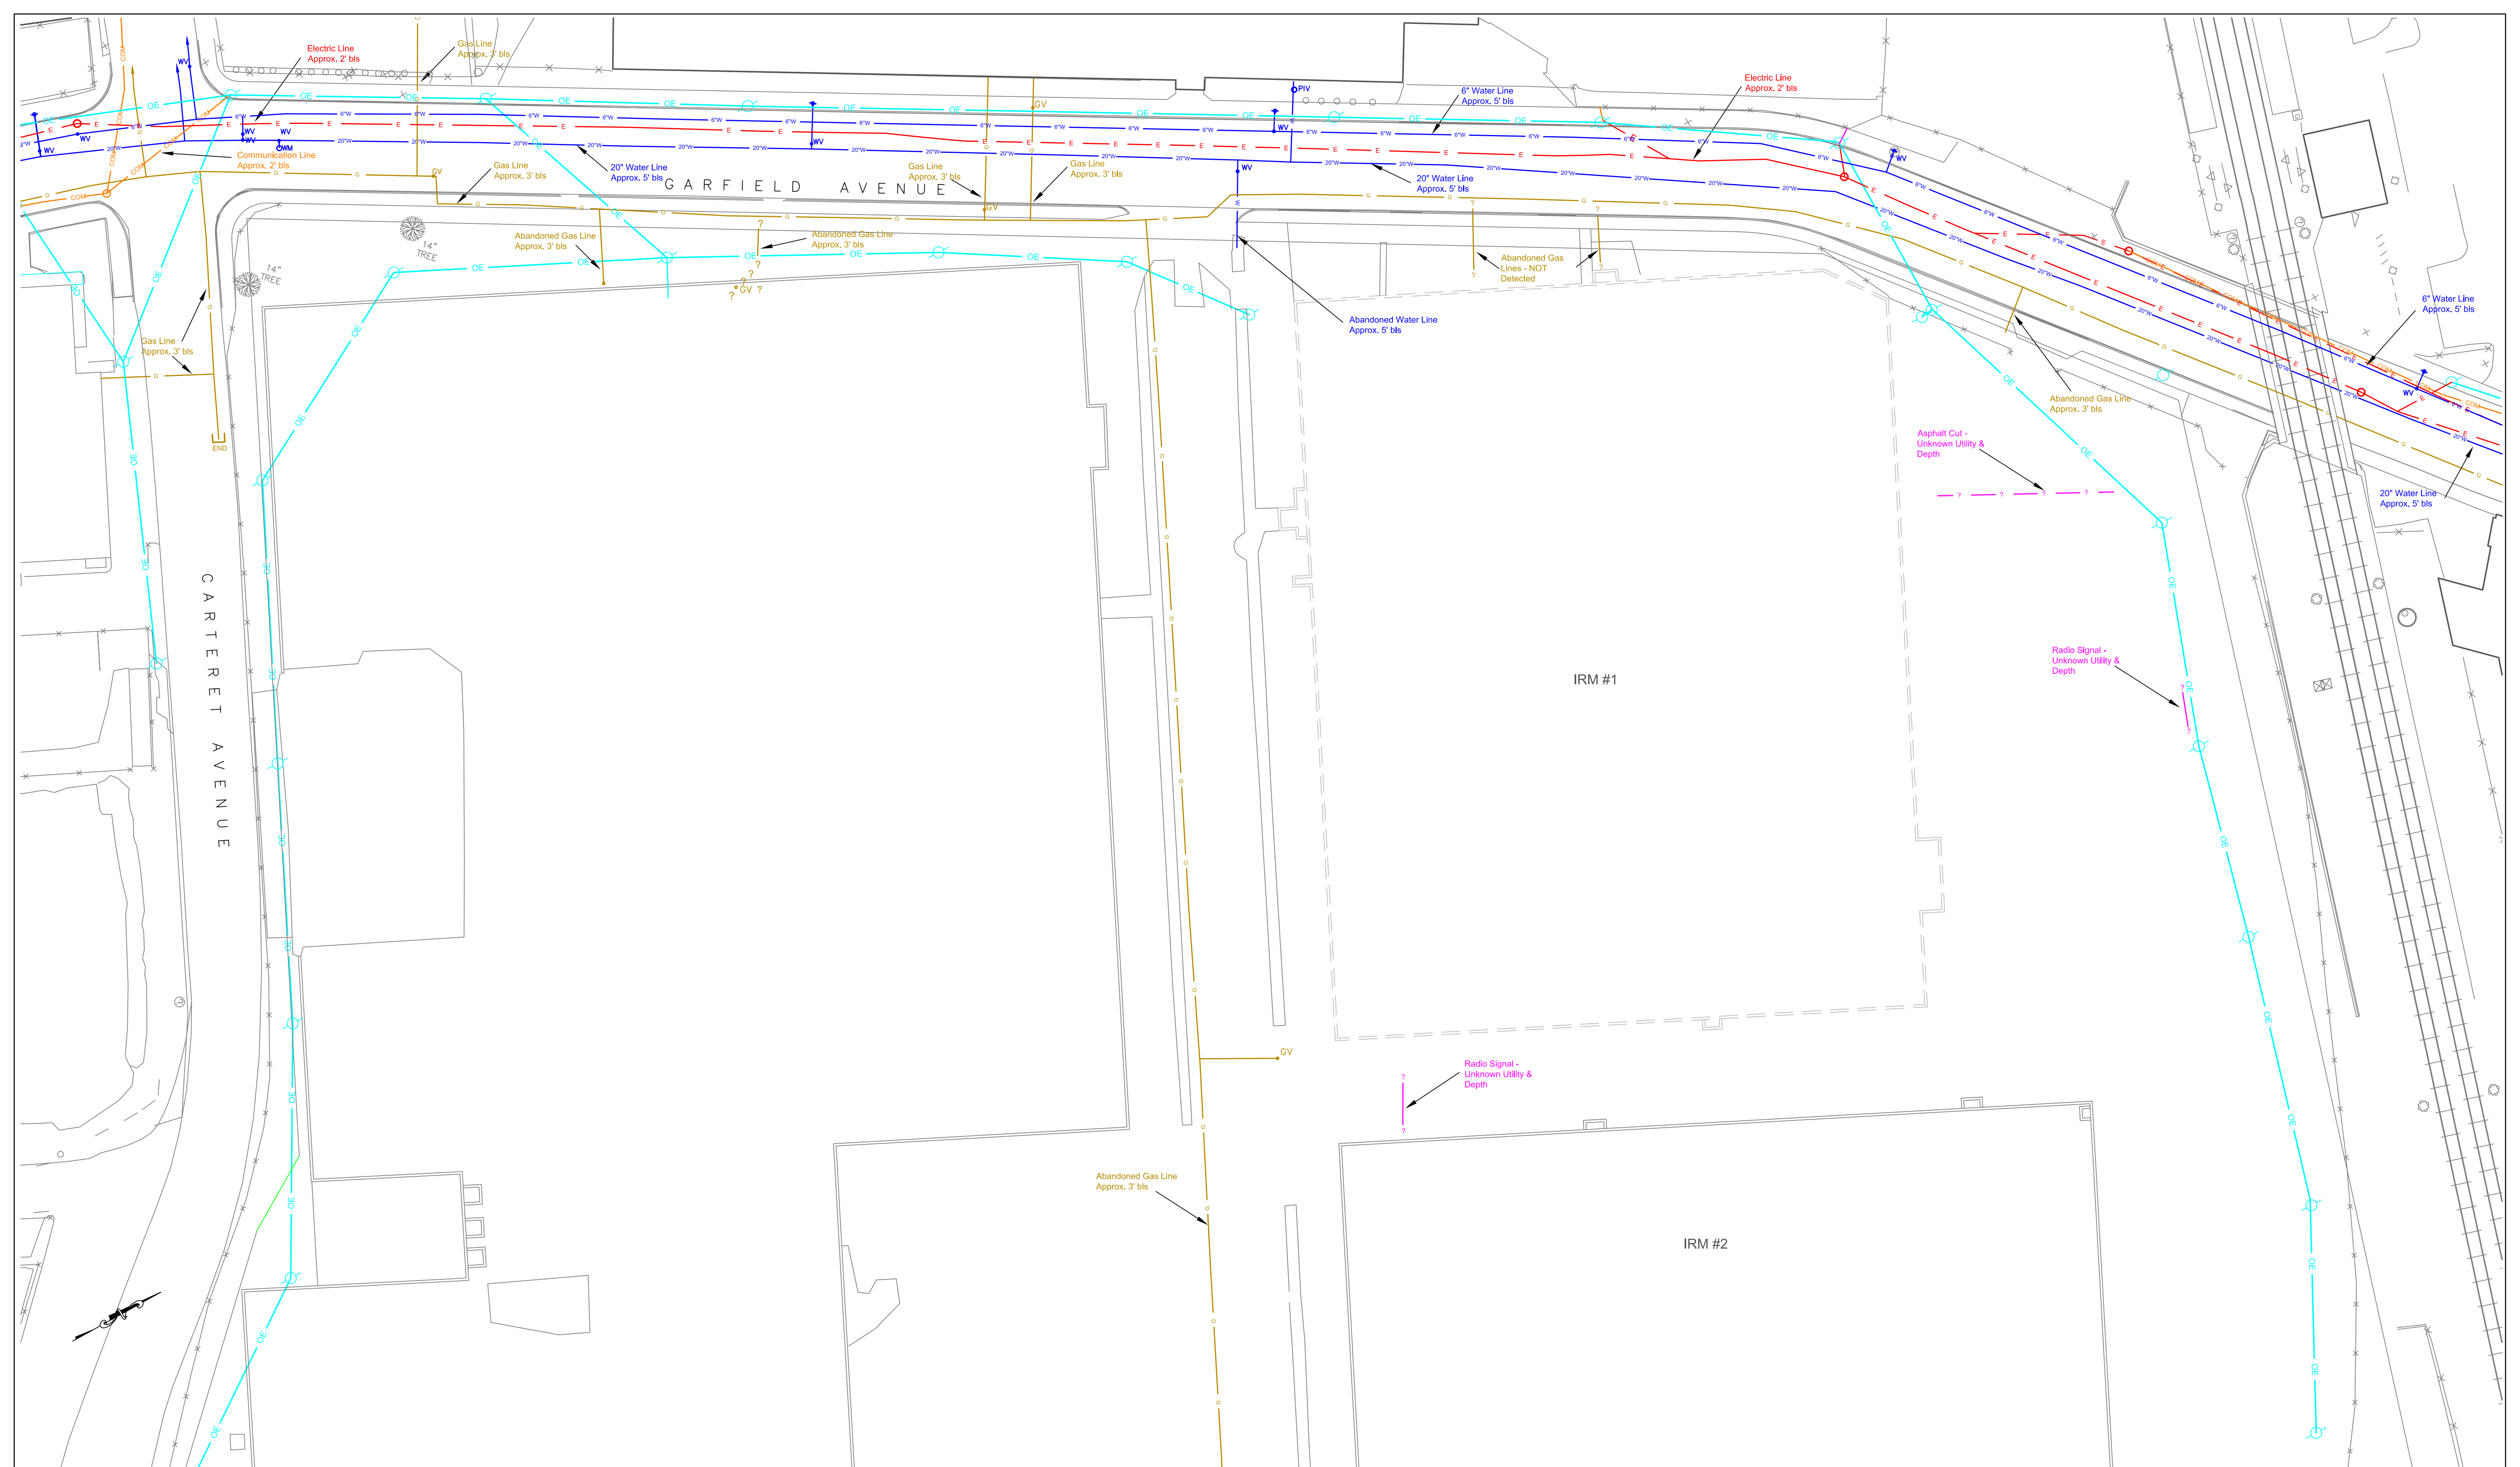
Sheet **6**

The geophysical survey detected three suspected unknown underground utilities located north and east of the former building pad in the northern portion of the site. These unknown utilities are marked with “?” on Sheet 6 and in the field. The line near the southeastern corner of the former building pad appears to be a lateral between the two former buildings, while the other two on the northern side of the pad may be abandoned utility lines that extended from the former building. Neither historical information nor the geophysical scanning in this area indicates a major active or possibly active utility line (lateral) from Garfield Avenue or the railroad line to the former building that would be in the vicinity of these unknown utility lines.

Sheet 6 shows two abandoned lateral gas lines extending from Garfield Avenue to the former building pad that were drawn on a former drawing provided by the client. The geophysical survey could not detect these laterals; however, they were placed on the figure as a precaution. Additionally, one of the two former laterals from Garfield Avenue to the existing concrete building pad (south of the removed pad) could not be traced from Garfield Avenue to the pad; however, a piece of exposed pipe in this location was energized with the RD equipment. The beginning and end of this pipe (i.e. the suspected lateral) is marked with “?” symbols on Sheet 6 and on the ground surface.

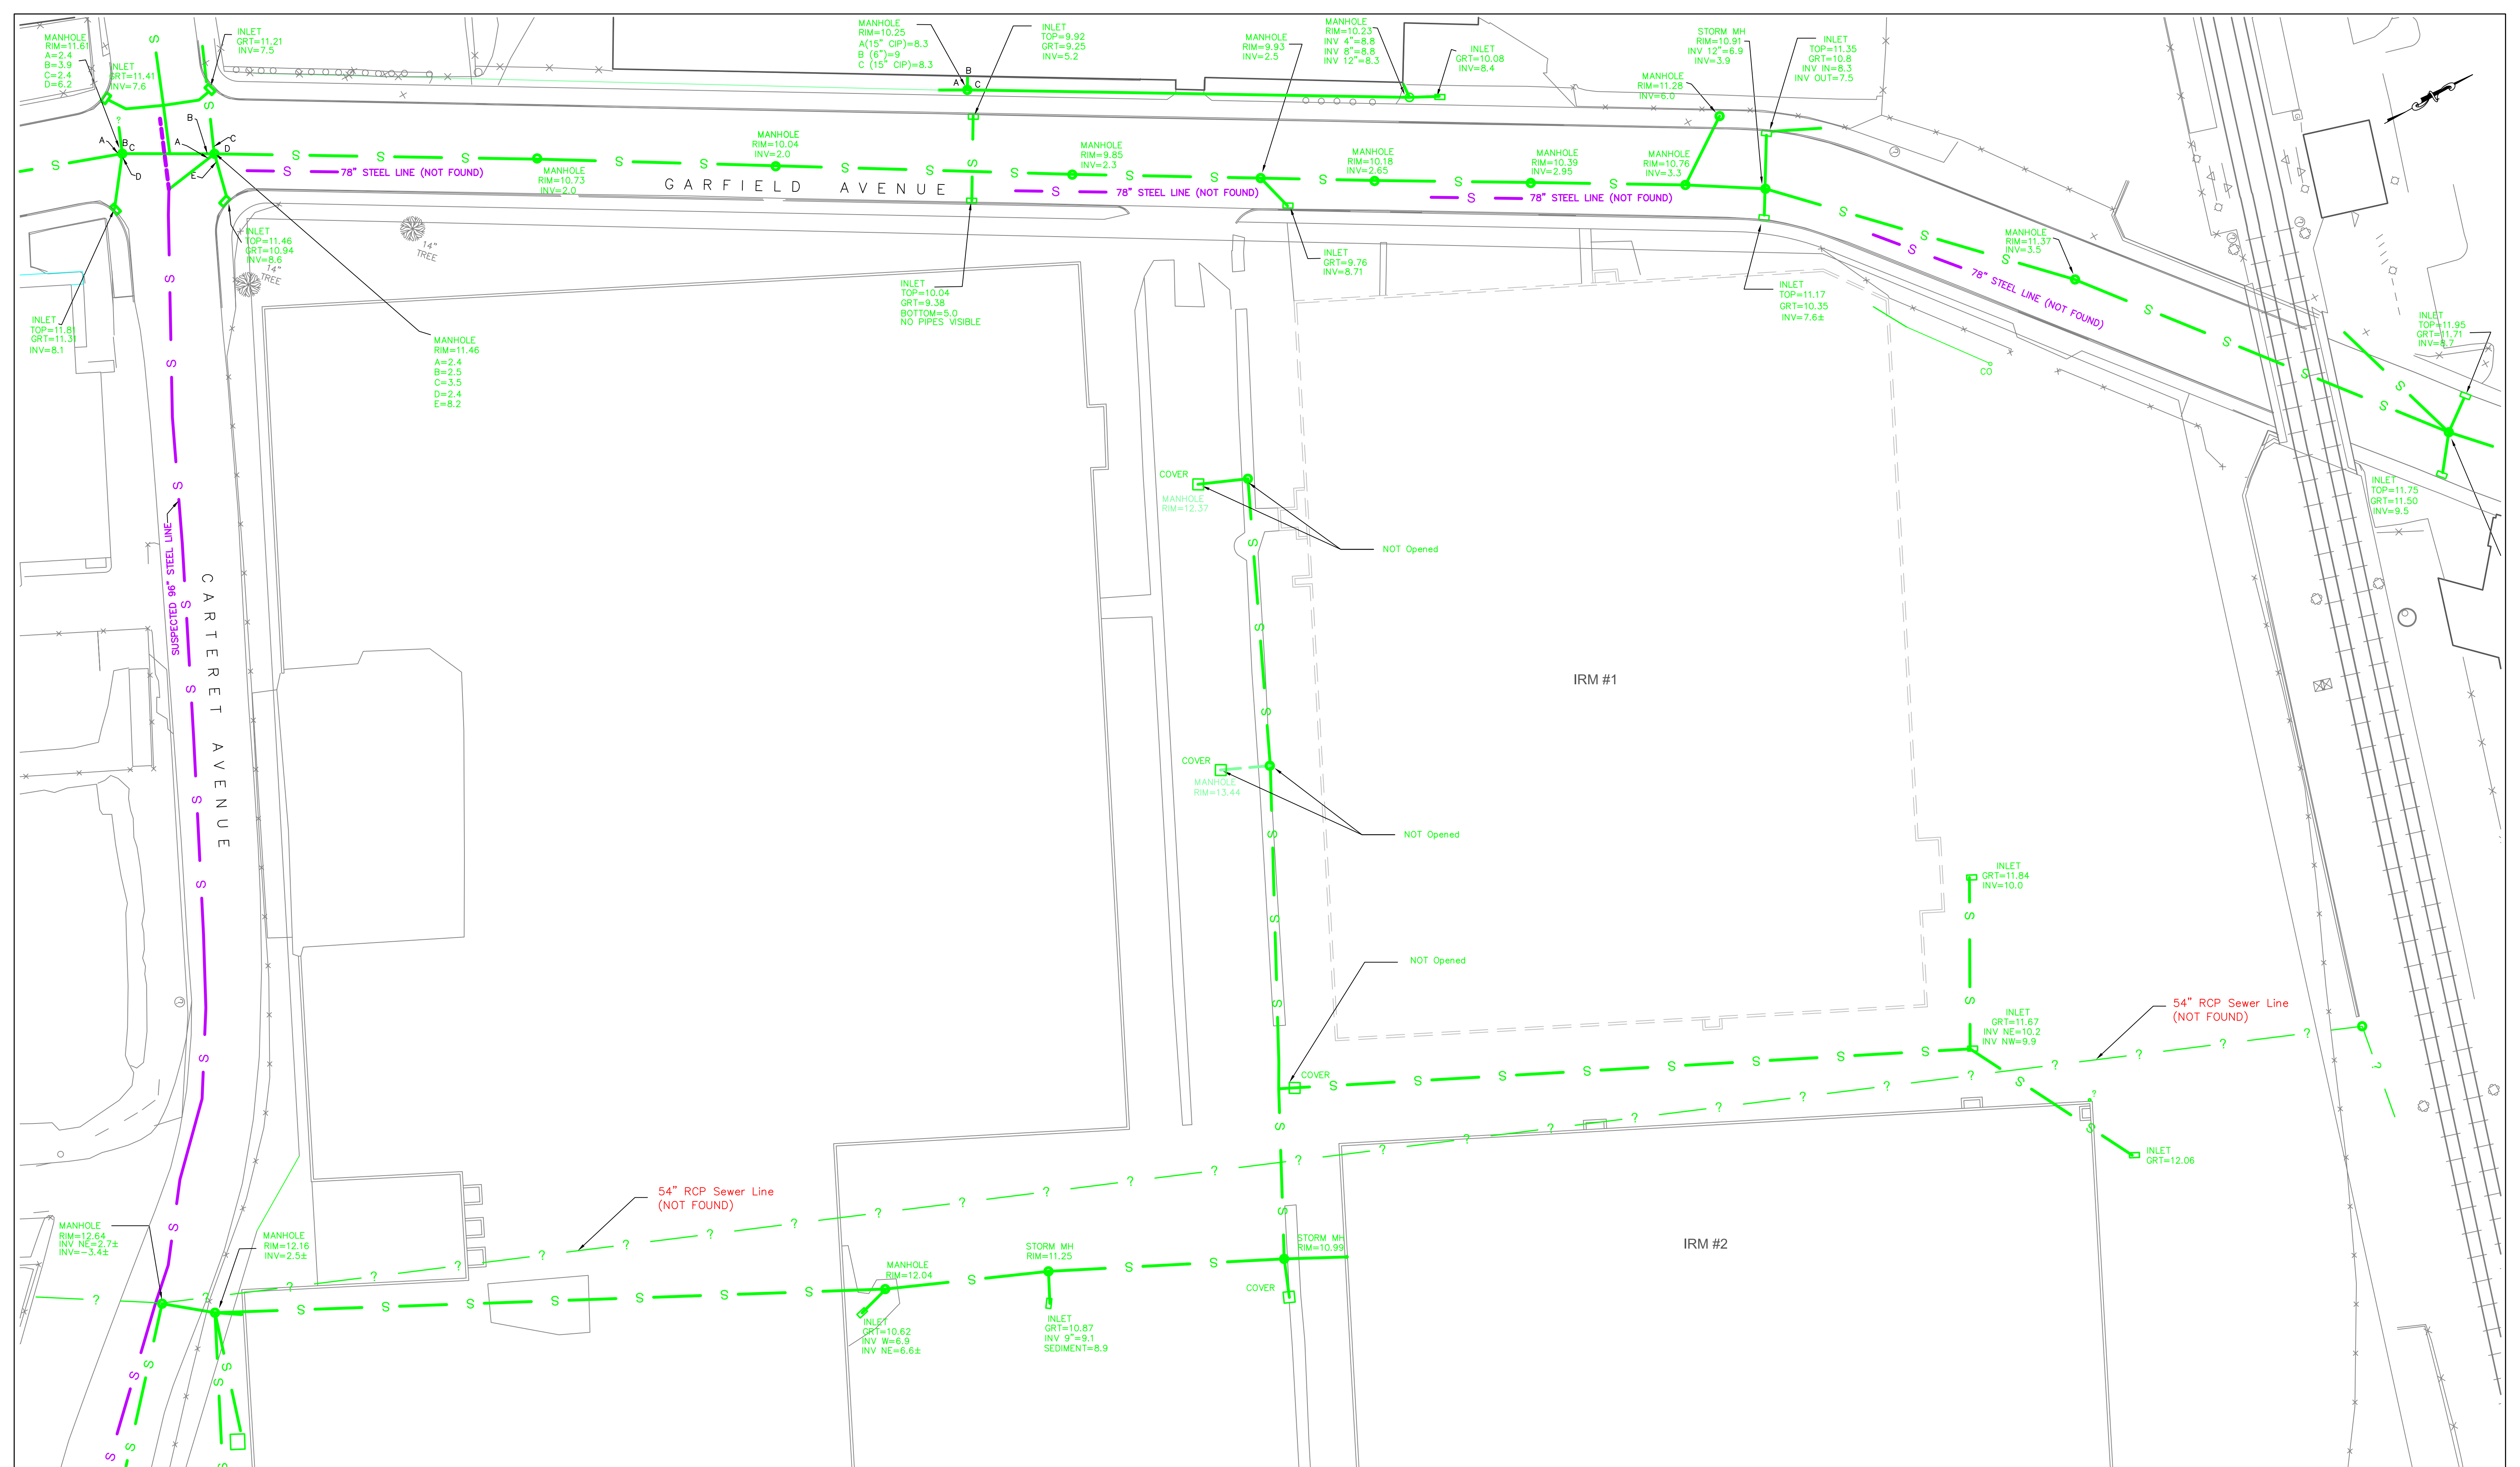
Geophysical Survey Results -Northeast Area Sewer System		PPG Industries Sites Jersey City, NJ	
No.	Revision/Issue	Date	Survey Start Date
1	071117.DWG	9/16/11	08/20/11
Project Number		Sheet	
071117		7	
Original Scale		Drawn by:	
1" = 30'		CHR	
Approved by:		PKB

Please note that no visible piping from Carteret Avenue through the Garfield Avenue Group Site was observed in the manhole located adjacent the railroad line.

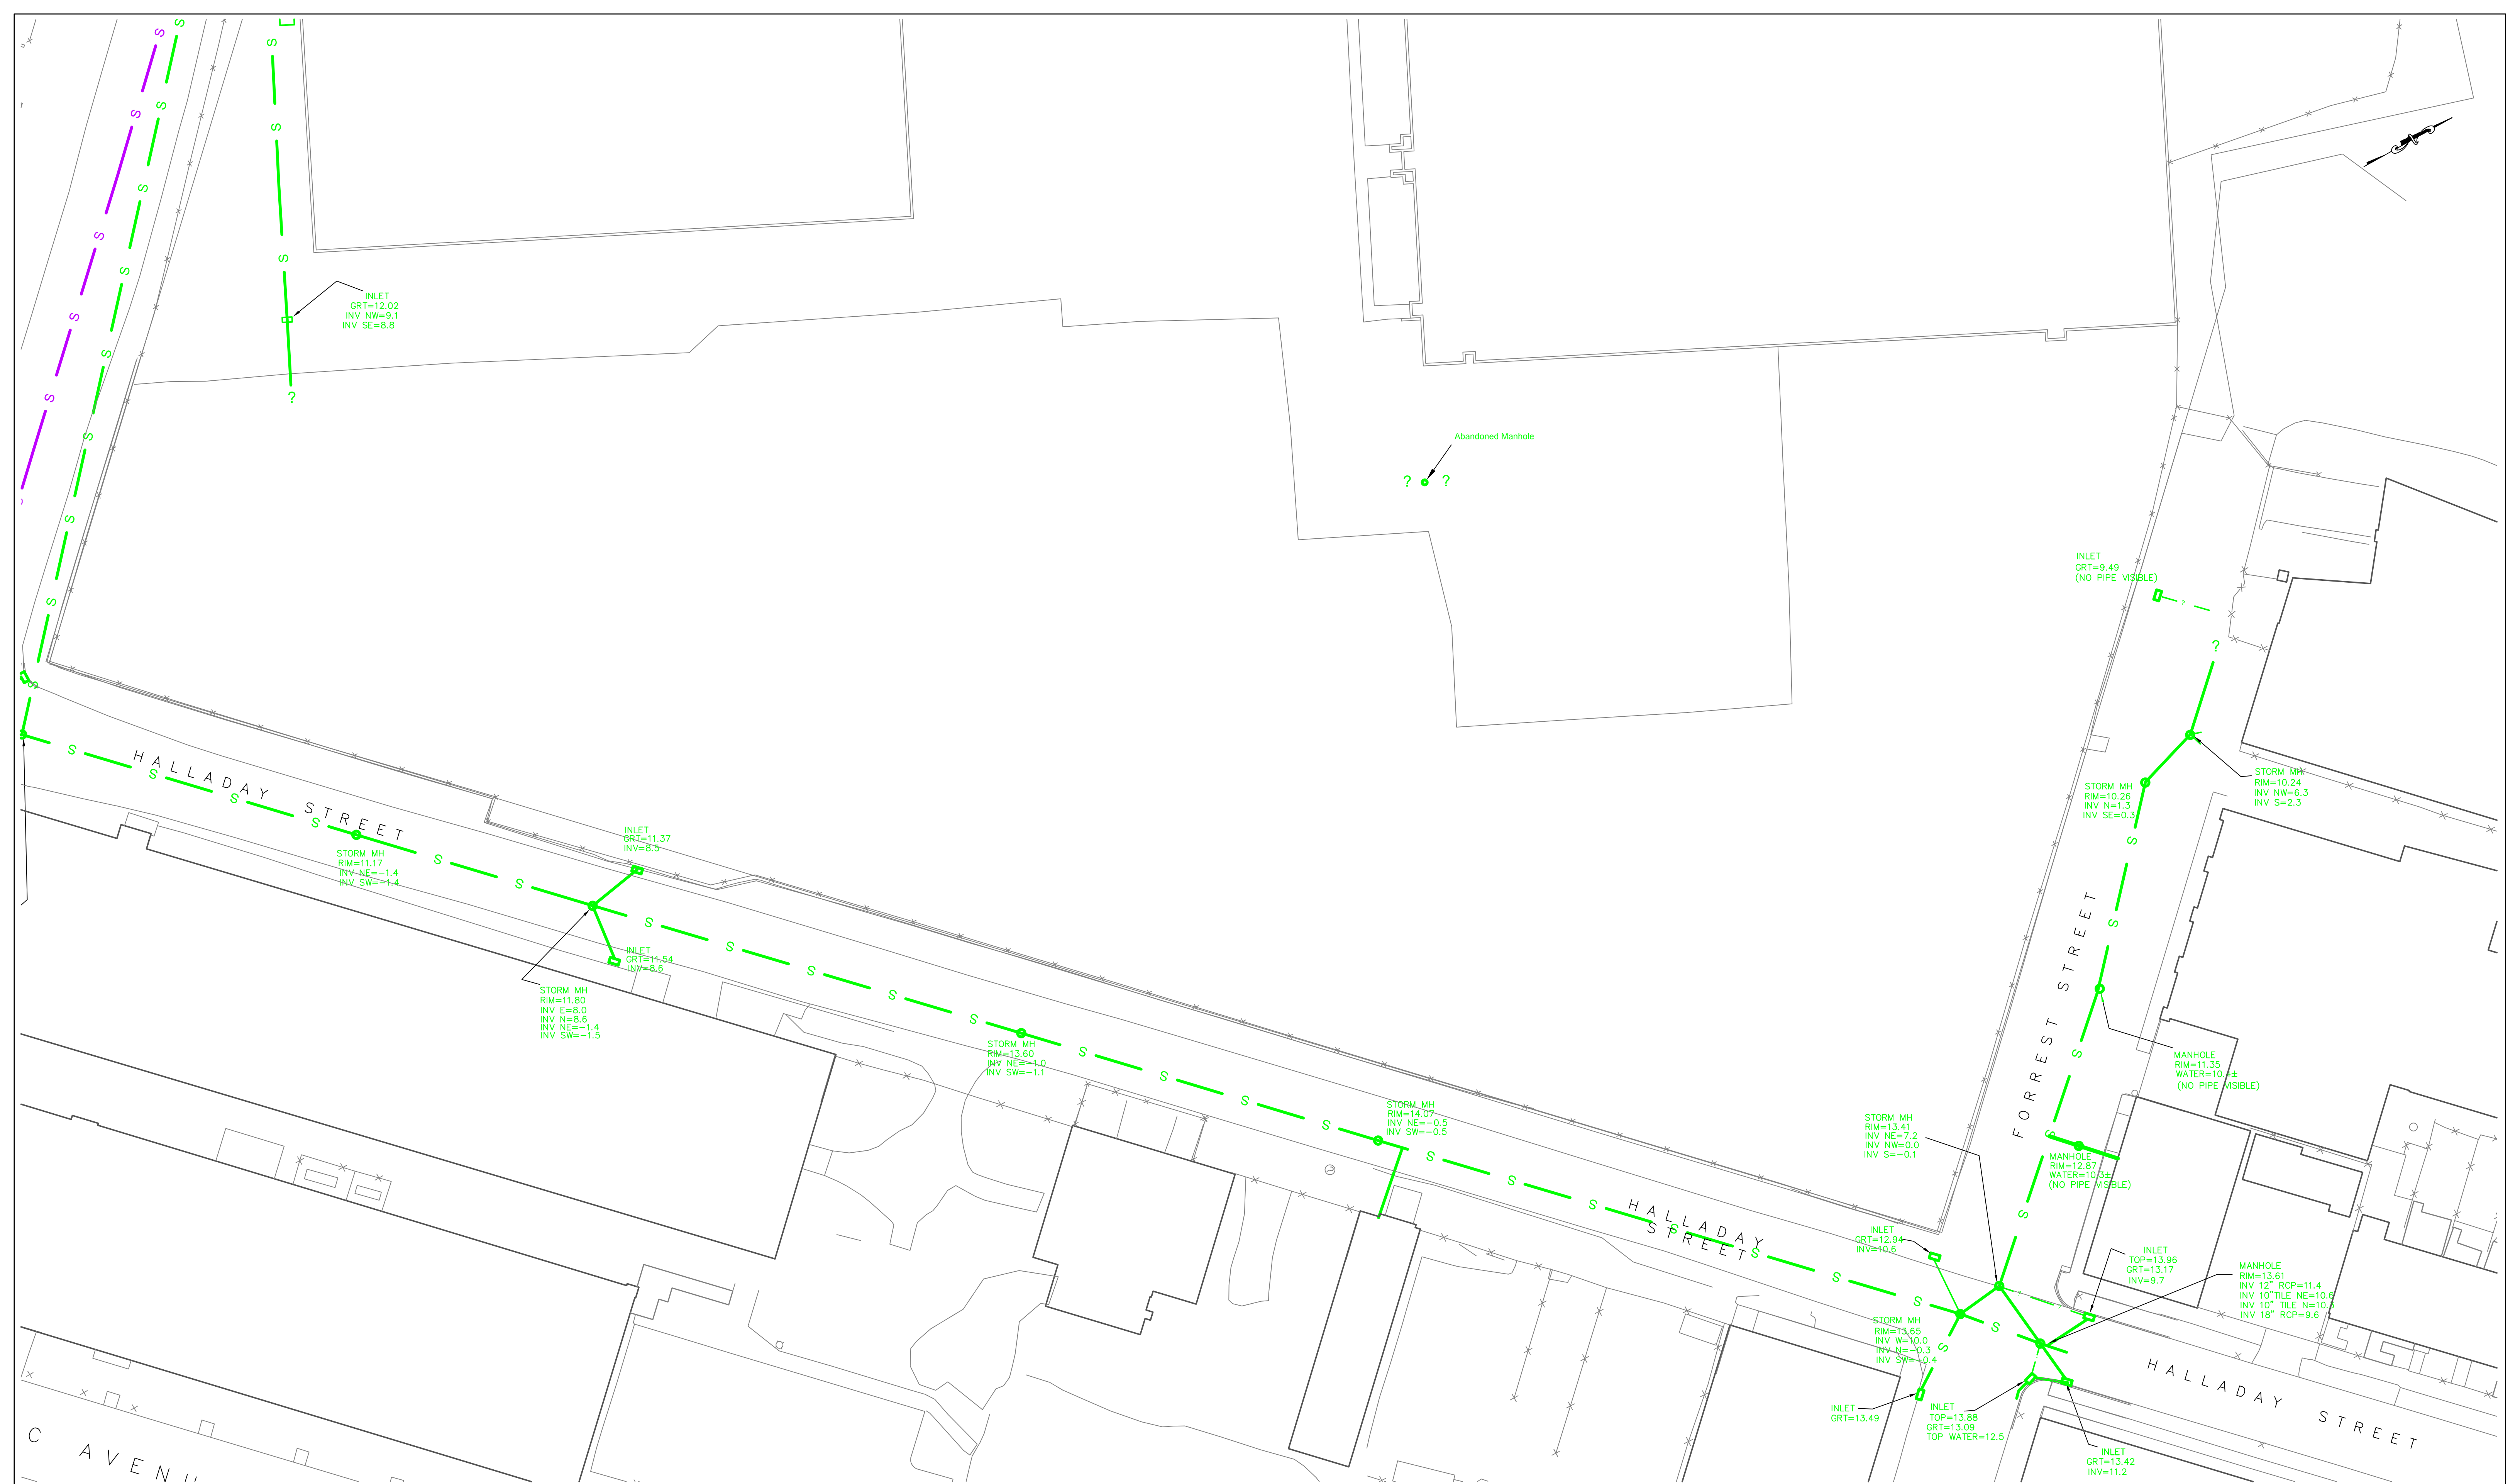
Prepared by:  <b>Enviroscan, Inc.</b> 1051 Columbia Avenue Lancaster, PA 17603 (717) 396-8922		Geophysical Survey Results - Southeast Area Utilities	PPG Industries Sites Jersey City, NJ	<b>Sheet 8</b>
Project Number 071117	Date 9/16/11	Survey Start Date 08/20/11	Drawn by: CHR	Approved by: PKB
No. 1	Revision/Issue 071117.DWG	Original Scale 1" = 30'
