### **Level 3 Survey Performed by Enviroscan**

**Final Report**  
**Geophysical Survey – Level 3 Utility Detection/Delineation**  
**Exterior Portions – Garfield Avenue Group Site**  
**Jersey City, NJ**  
**Enviroscan Reference Number 071117**

**Prepared For: AECOM**  
**Prepared By: Enviroscan, Inc.**  
**September 16, 2011**

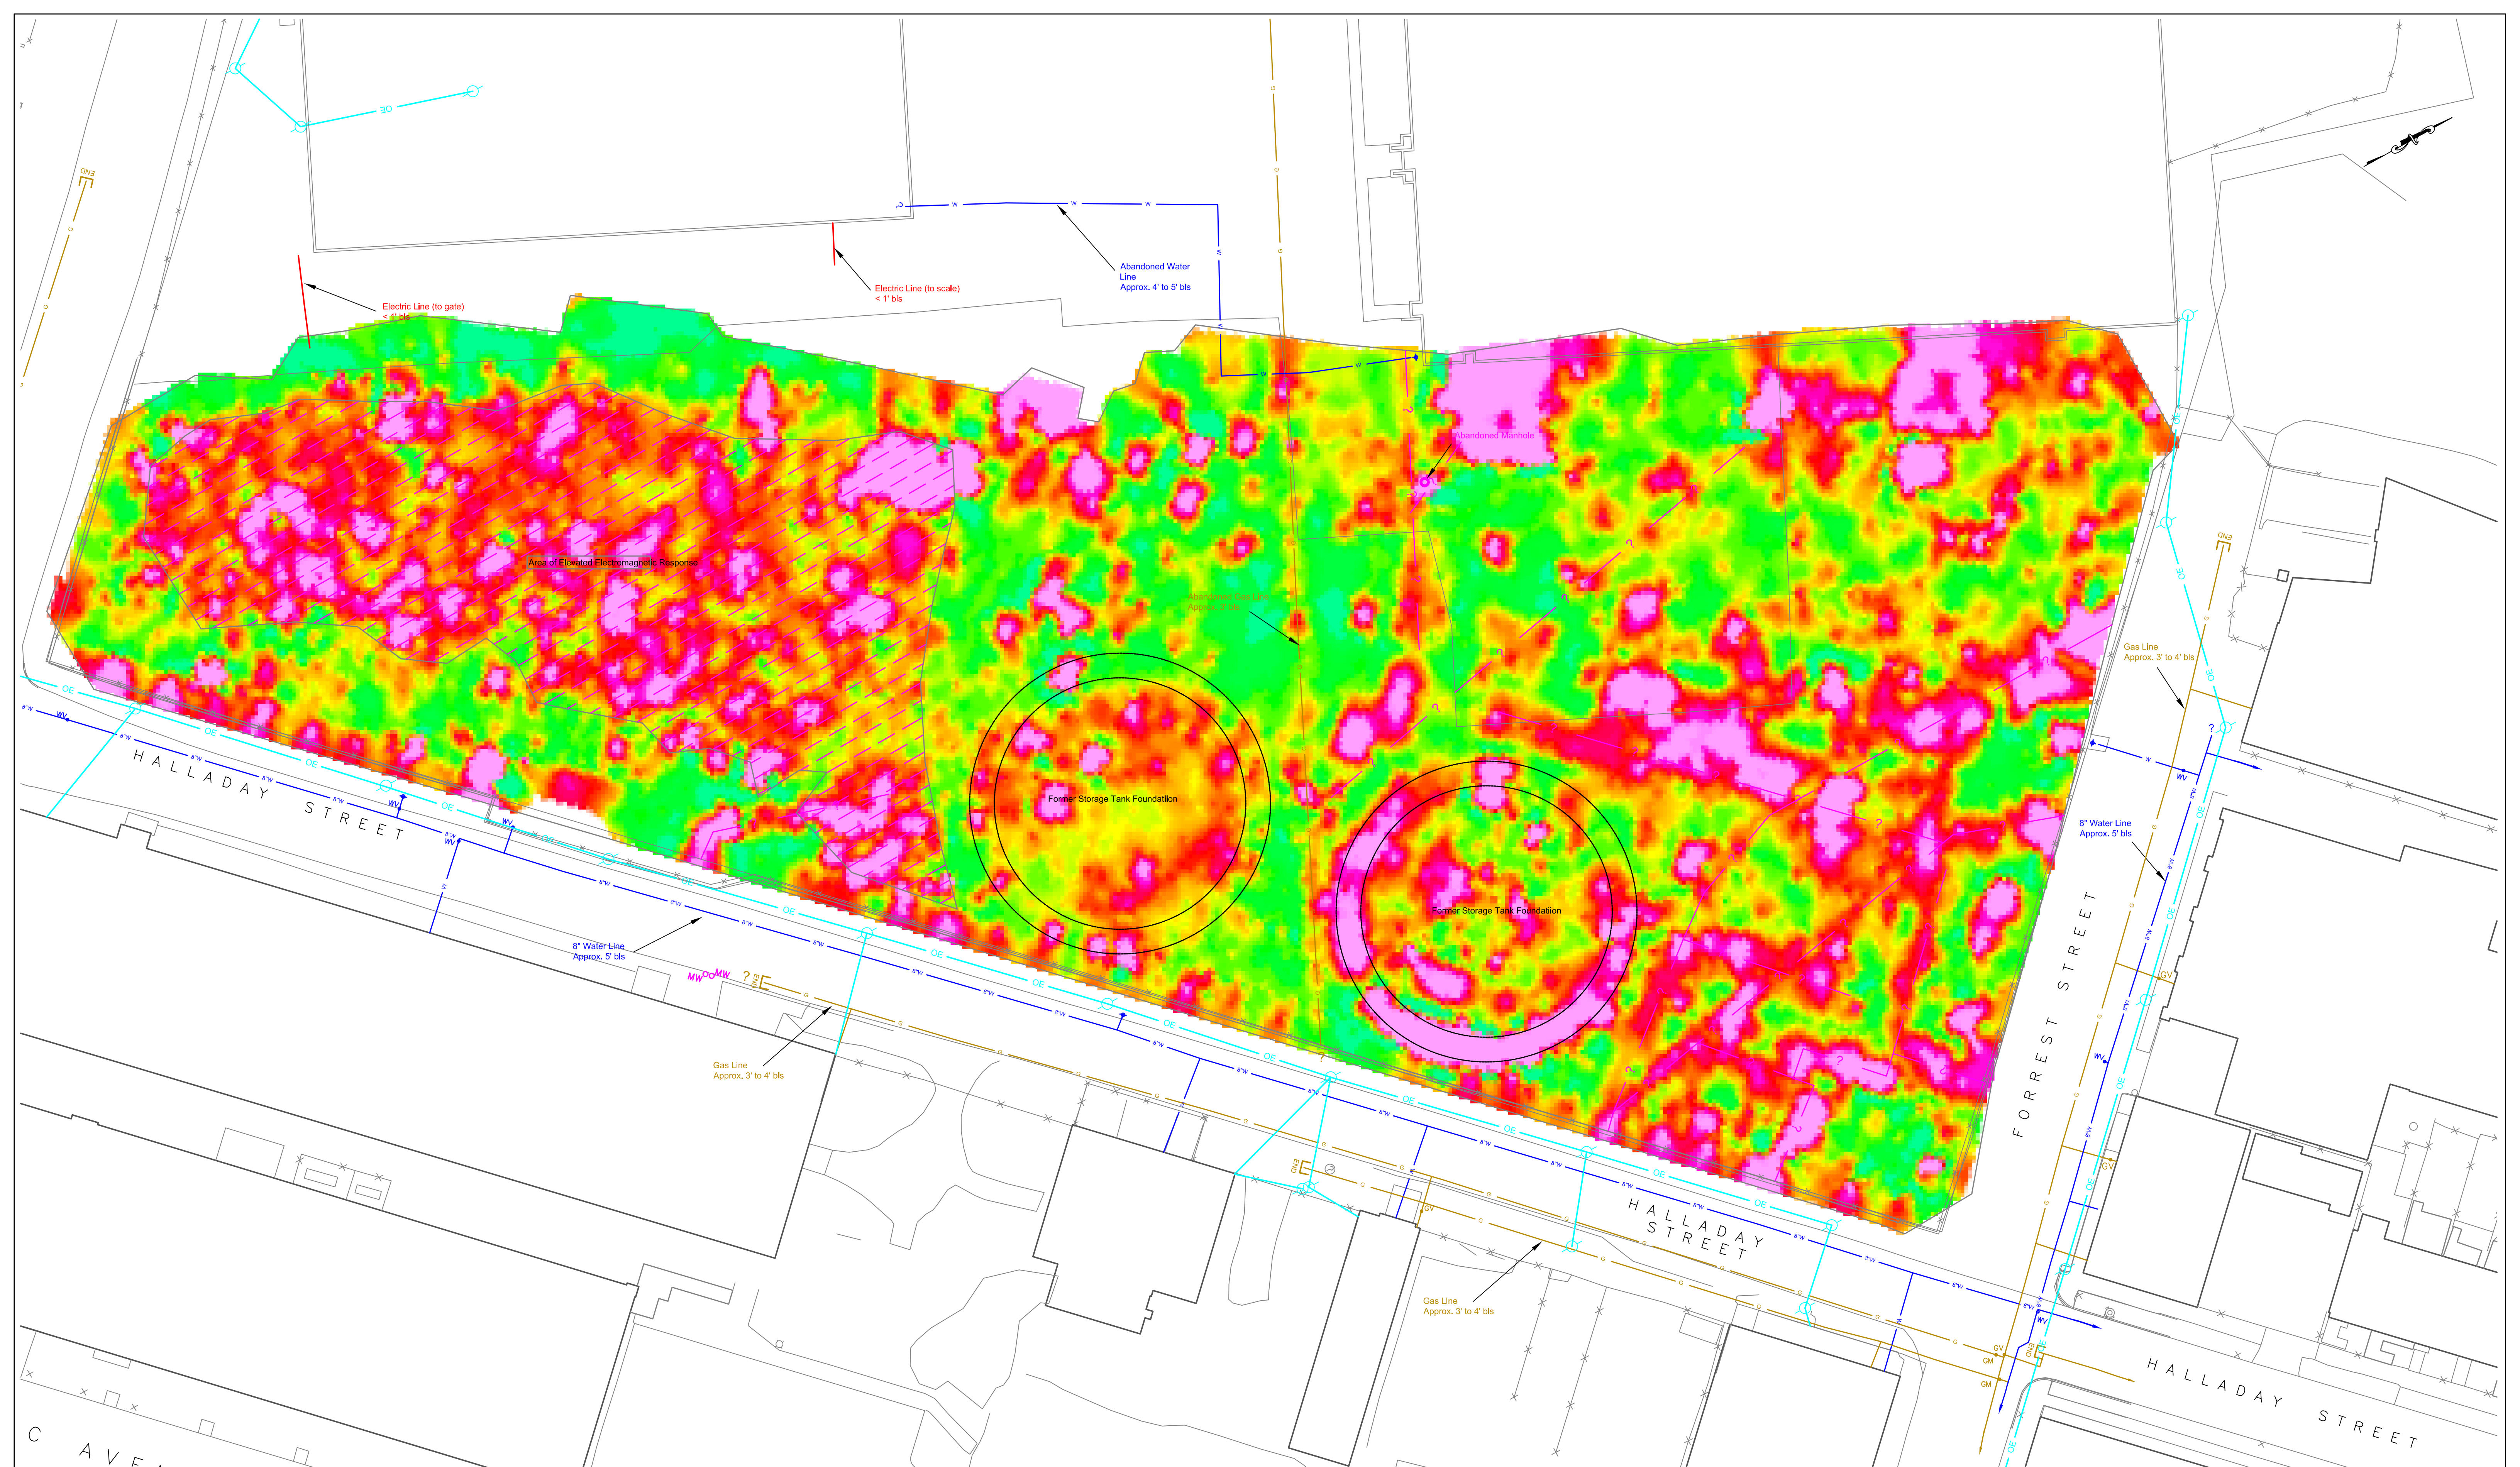
To complete the EM-61 MK2 survey, a system of profiles (at approximately 5-foot intervals) was surveyed by hand-towing the EM-61 MK2 in each survey area. Data were collected at a rate of four readings per second (for an average station spacing of approximately one foot). Location control was maintained using a Topcon GMS-110 global positioning system (GPS) receiver. The GPS positions were collected with real-time differential correction, using the corrections from a coastguard beacon in Annapolis, MD. The resulting differential GPS (DGPS) positions have an accuracy of better than two feet. GPS and EM data were fed simultaneously to a Juniper System Allegro data logger running Trackmaker 61 software by Geomar, Inc. This software allows display of the data coverage in real time to ensure complete site coverage. The EM survey data coverage is displayed in Sheet 12. Each small cross represents an EM measurement station.

Results of the EM-61 MK2 survey are depicted as contours of the individual EM-61 MK2 station measurements in Sheet 12. The EM-61 MK2 records four measurements spaced by time (time gates) after the initial transmit pulse. Gate 1 reads responses from metal targets of all depth and size within the range and sensitivity of the instrument. Gate 2 filters out the smallest targets. Gates 3 and 4 read responses from large targets, with Gate 4 showing the least interference from smaller targets. The purpose of this survey was to detect and delineate remnant structures, buried metallic debris caches, abandoned utilities, and active utilities; therefore, Gate 4 was selected for the best display of possible targets of interest.

EM-61 scanning of the open accessible area of the site (Sheet 12) indicated an elevated EM response over the majority of the survey area. Analysis of the data indicates the presence of two suspected former above ground storage tank foundations, as well as numerous suspected buried utility lines in the northern corner of the survey area which are also shown of Sheet 8 without the color contours. Unfortunately, the elevated response over the majority of the survey area (primarily in the southern area) made identifying individual utilities difficult if not impossible. Additionally, several of the linear anomalies may be related to building foundations and other structural features rather than abandoned underground utility lines.
