### **Operation, Maintenance, and Monitoring Manual**

# **Operation, Maintenance, and Monitoring Manual Building No. 2 – Boiler Room Subslab Soil and Interior Concrete Surfaces (AOC 3)**

## **Hudson County Chromate Site 156 Metropolis Towers**

270-280 Luis Munoz Marin Boulevard  
Jersey City, New Jersey

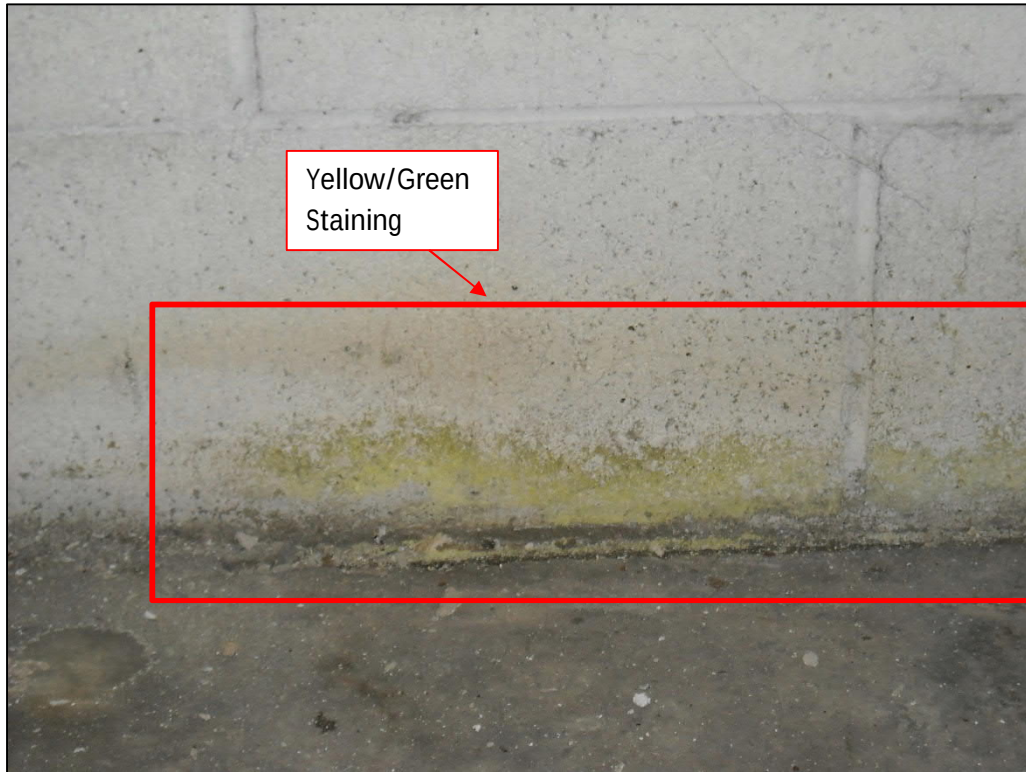
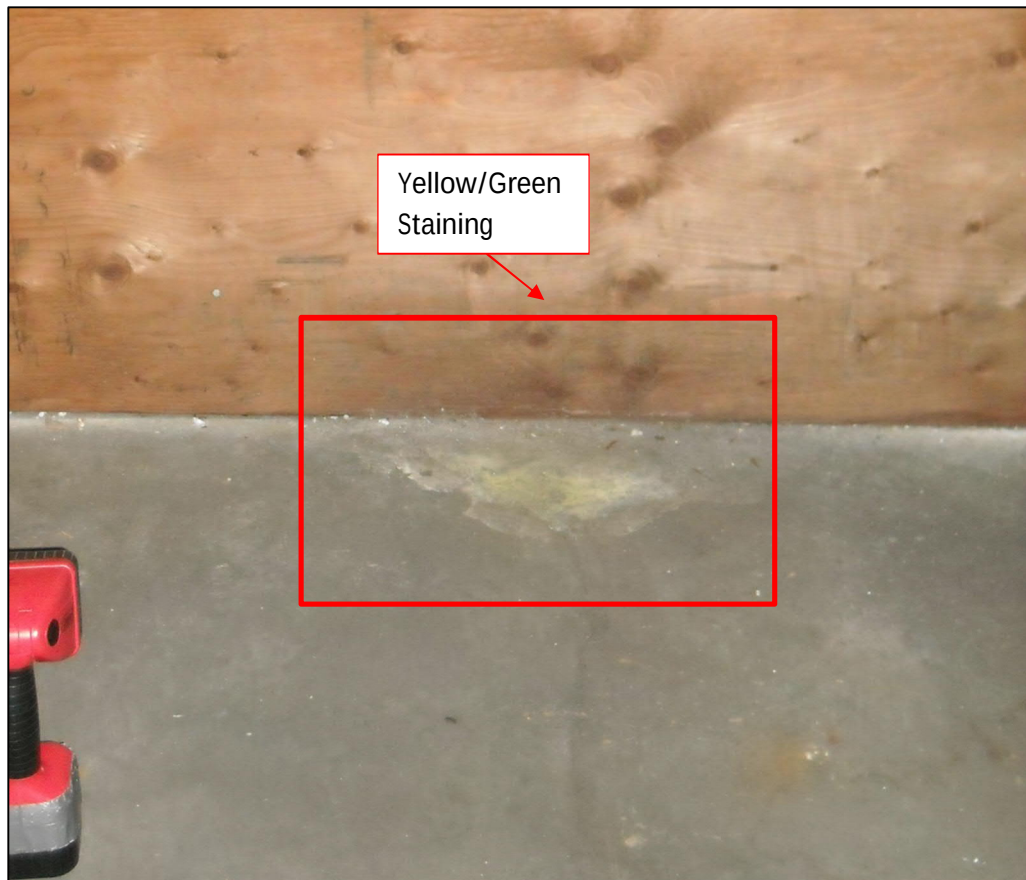
**Attachment B**  
**Representative Photographs of Yellow/Green Staining**

### **Representative Photographs of Green/Yellow Staining**

As a measure of engineering control performance, visual inspections of the engineering controls for the presence of damage, deterioration, or  $\text{Cr}^{+6}$  blooms will be conducted during scheduled inspection events. Routine sampling to demonstrate ongoing compliance with remediation standards is not required. However, confirmation sampling of areas suspected as having potential  $\text{Cr}^{+6}$  blooms will be conducted.
