AECOM

Date: 2/13/2019 FIGURE 5-1

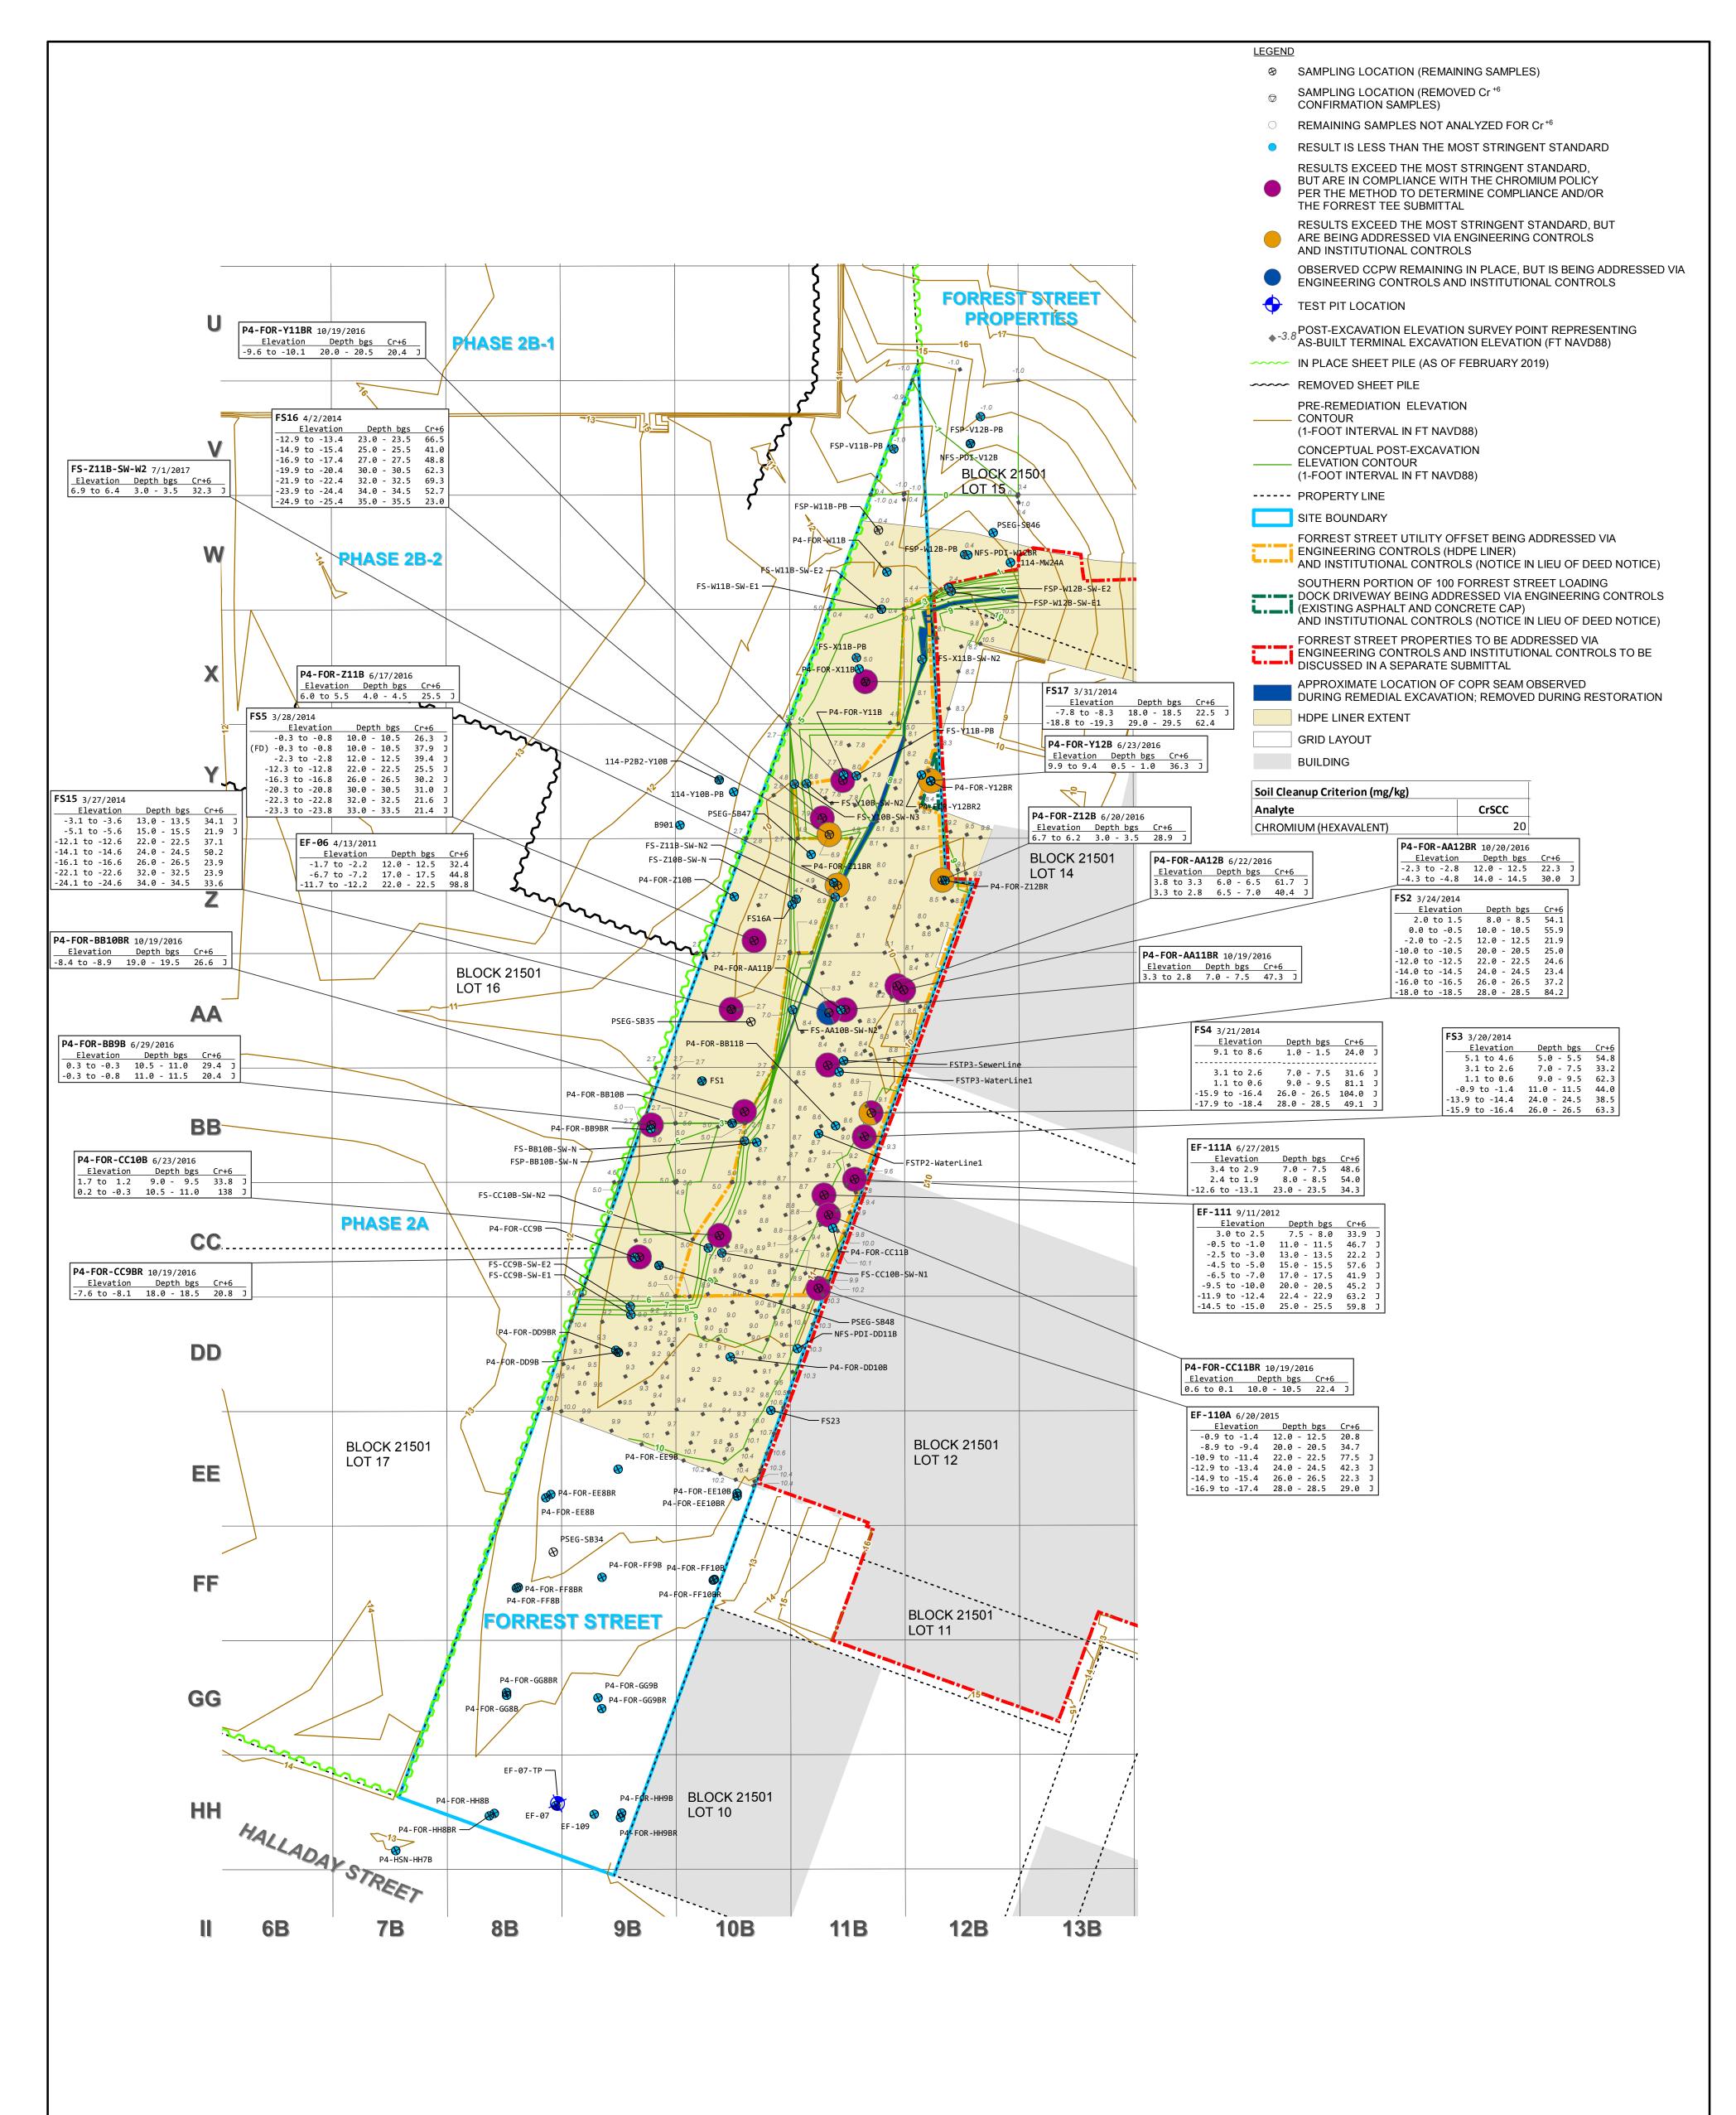
- G1. The hexavalent chromium data associated with the sample locations shown on this figure are provided in Table 5-1. Data presented in call out boxes on this figure are outliers (i.e., data points that require further explanation). When a single location is represented with both an orange and purple symbol (i.e., FS4), the orange indicates "results exceed the most stringent standard, but are being addressed via engineering controls and institutional controls," which applies to the shallower samples at that location (above the horizontal dashed line in the call out box). The purple indicates "results exceed the most stringent standard, but are in compliance with the Chromium Policy per the Method to Determine Compliance and/or the Forrest TEE Submittal," which applies to deeper samples at that location (below the horizontal dashed line in the call out box). Specific notes on how the NJDEP's remedial standards are being met and/or how remedial

- completion is being achieved/completed for each outlier sample are provided in the Specific Notes in Table 5-1 G2. "Elevation" refers to the sample elevation based on the pre-remediation surface elevation for samples collected from the pit bottom, and the surface elevation of the sample location when the sample was collected via boring or test pit.

- G6. This figure presents data for locations within the Site boundary that have samples remaining in place. In addition, locations from outside the Site boundary and/or removed samples may be shown to demonstrate compliance with the remediation objectives. The Specific Notes on Table 5-1 include discussion of these situations, if necessary.

- S3. Conceptual post-excavation elevation contours were generated using professional judgment based on post-excavation elevation survey points and knowledge of excavation practices utilized during remedial excavation (i.e., excavation conducted on a 30 ft by 30 ft basis). S4. In Grids FF8B, FF10B, W11B, and Y12B, two sample locations are located adjacent; therefore, the sampling location symbols overlap on the figure.

- \$5. Remediation was not required in the portions of Grids DD8B, DD9B, DD10B, DD11B, EE8B, EE9B, EE10B, FF8B, FF9B, FF10B, GG7B, GG8B, GG9B, GG10B, HH7B, HH8B, and HH9B in Forrest Street as per the Forrest TEE Submittal. Sub-grade excavation was conducted in Grids DD8B, DD9B, DD10, DD11B, EE9B, and EE10B for restoration only.
