Remedial Investigation Report/Remedial Action Work Plan/Remedial Action Report, Final Building No. 2 – Boiler Room Subslab Soil and Interior Concrete Surfaces (AOC 3) PPG, Jersey City, New Jersey

Appendix I

Feasibility Study Reports -Mueser Rutledge Consulting Engineers

> Re: Removal of Boiler Room Structural Slab Site 156 – Metropolis Towers Boiler Room 270 and 280 Louis Munoz Marin Boulevard Jersey City, NJ MRCE File 11857

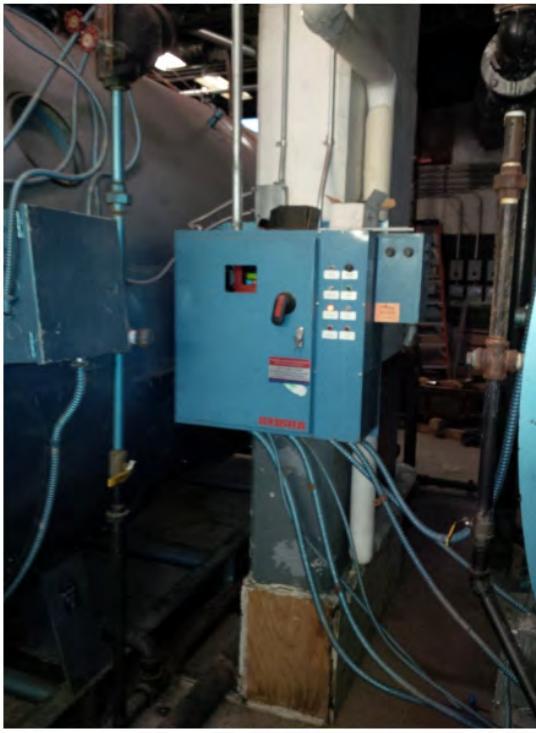
Photo 1.jpg

This alternative would have minor impact on MEP equipment immediately adjacent to or attached to the column (see Photos 1 through 5 in Appendix A). There is relatively small risk to adjacent structural elements and the operating boilers would not be impacted. This alternative does not require heavy equipment. We estimate this alternative could be completed in two weeks and the relative cost would be approximately \$60,000.

This alternative would require high impact on MEP equipment immediately adjacent to or attached to the column (See Photos 1 through 5). This alternative requires sequential demolition of the concrete slab to expose the top of the pile cap which remains in place and which will support a transfer frame to temporarily unload the concrete column. A temporary steel jacking frame will transfer load from column to pile cap while contaminated concrete in the column is removed and replaced. The impacted portion of the column cross section would be chipped out with a jackhammer: damaged reinforcement replaced by doweling into the column and pile cap. The column repair would then be formed to place new concrete.

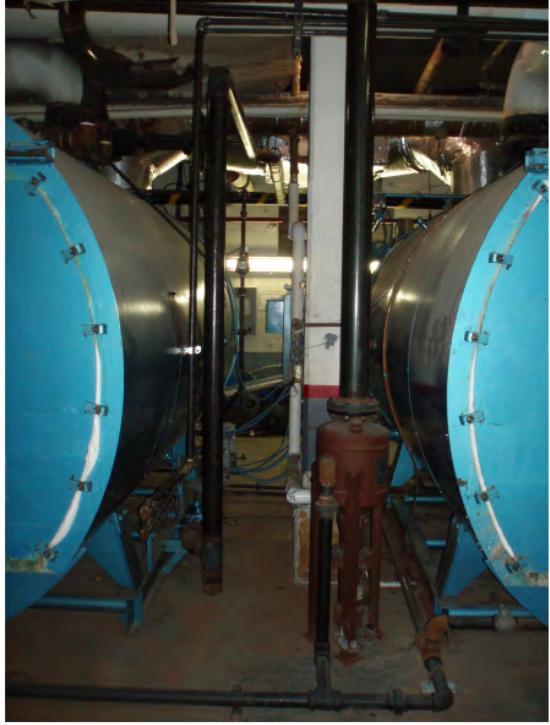
Photo 8.JPG

- There is limited access to the boiler room; there are double doors (5'10" wide by 6'10" tall) that lead directly to stairs down to floor level (See photos 8 and 9 in Appendix A). Getting a forklift and structural steel into basement will take planning and possible building modifications.
- Construction activities have to consider space restrictions in the boiler room (See Figure 1 and the provided photographs in Appendix A) as well as being coordinated with routine maintenance operations in the boiler room.

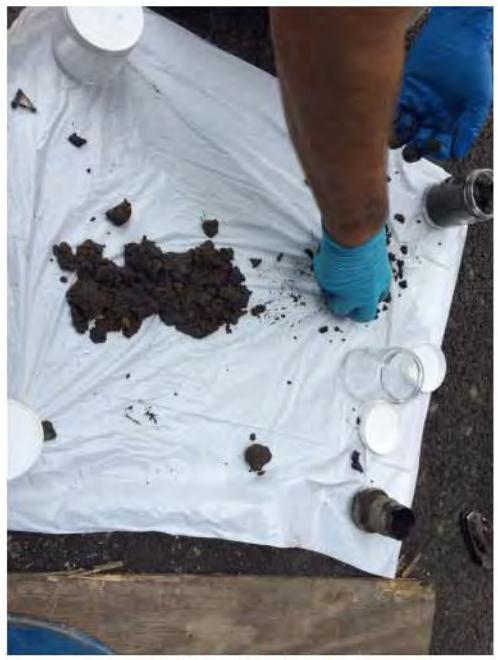
IMG\_5492.JPG

IMG\_5493.JPG PILE CAP INVESTIGATION OF CCPW- SEPTEMBER 3 - 9, 2014

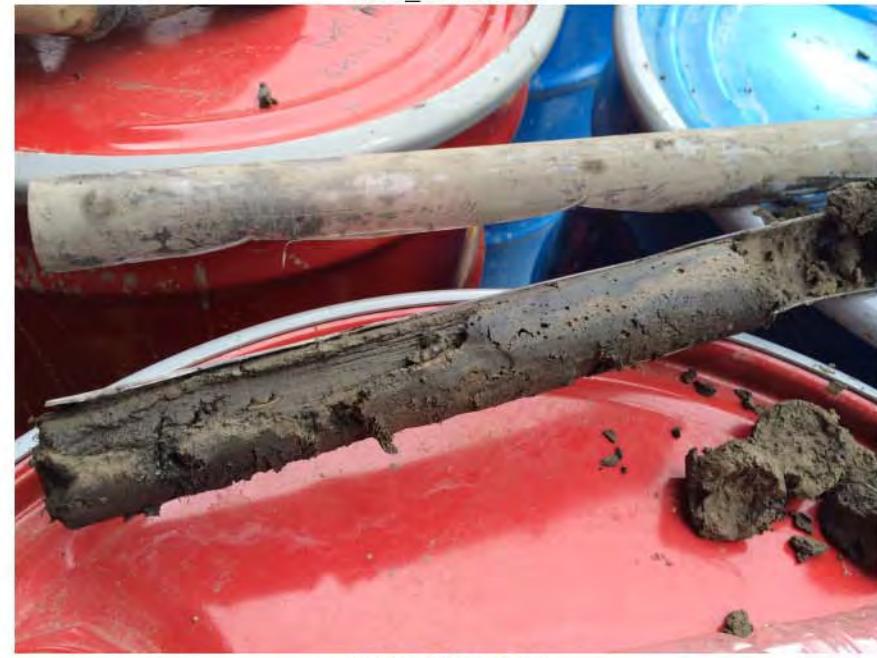
IMG\_5494.JPG BOILER ROOM METROPOLIS TOWERS- BLDG 2
