## **Appendix F**

### **Borehole Geophysical Logging Results**

**BOREHOLE GEOPHYSICAL LOGGING – DATA REPORT  
BOREHOLES 114-MW4D DEEPENED, 114-MW61D DEEPENED,  
114-MW66D DEEPENED, 114-MW71D, & 114-MW72D  
PPG SITE 114 – GARFIELD AVENUE GROUP SITES  
JERSEY CITY, NEW JERSEY**

File 19RG66  
February 2022

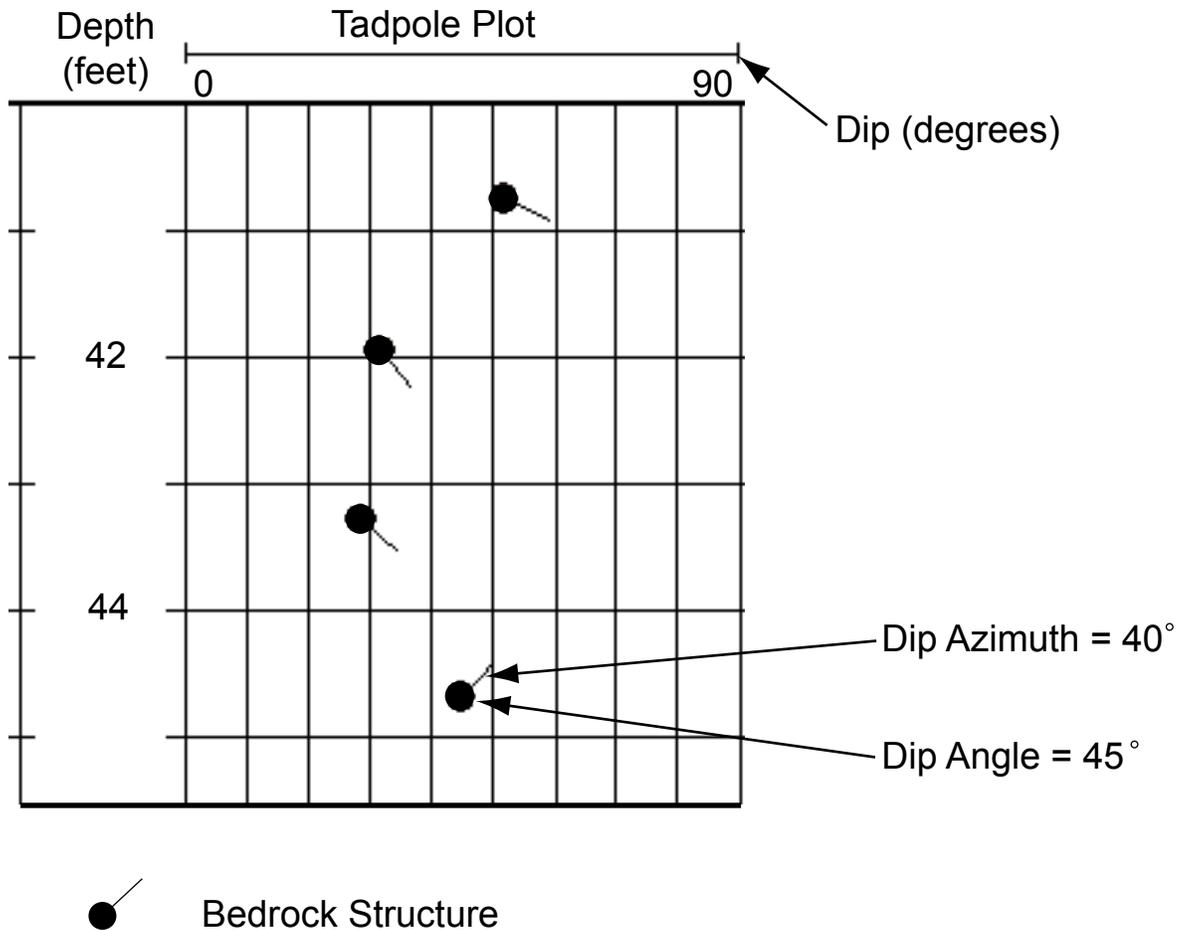
**Figure 2.** Tadpole plot explanation. The orientation of the bedrock structures is graphically displayed by a tadpole consisting of a circle, the head, and a line, the tail. The position of the head, left to right on the tadpole plot, gives the dip angle of the structure. The left side of the track indicates a dip angle of  $0^\circ$ , and the right side of the track indicates a dip angle of  $90^\circ$  from horizontal. The orientation of the tail gives the dip azimuth of the structure and can be read like a compass. The tail pointing directly up is  $0^\circ$ , north.

- Figure 2. Tadpole plot explanation figure

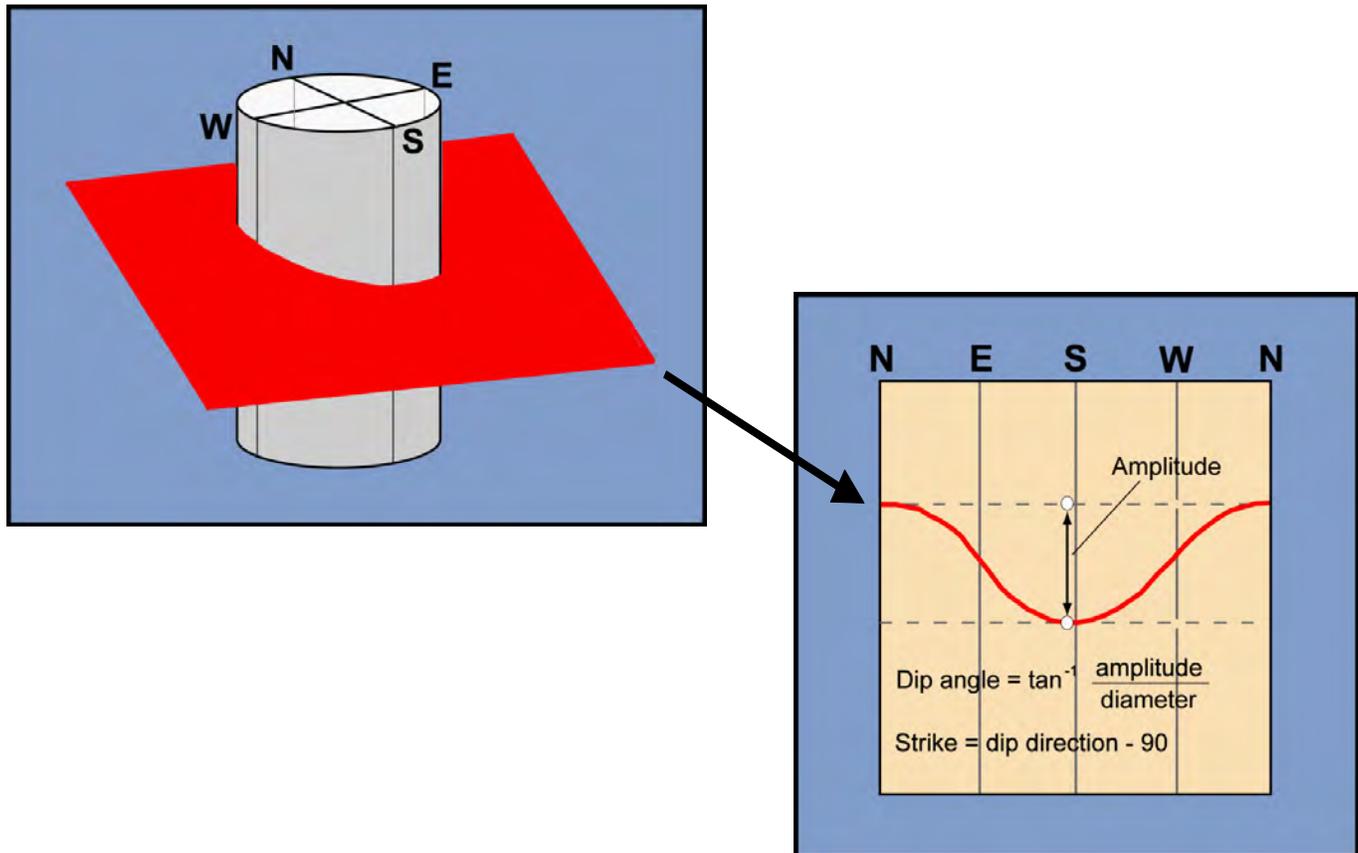
**Figure 3.** Televiewer explanation. The image on the left depicts a planar structure in red, such as a fracture or bedding plane, intersected by a borehole. The image on the right depicts the same structure unwrapped as it would be displayed in an optical televiewer (OTV) or acoustic televiewer (ATV) log.

- Figure 3. Televiwer explanation figure

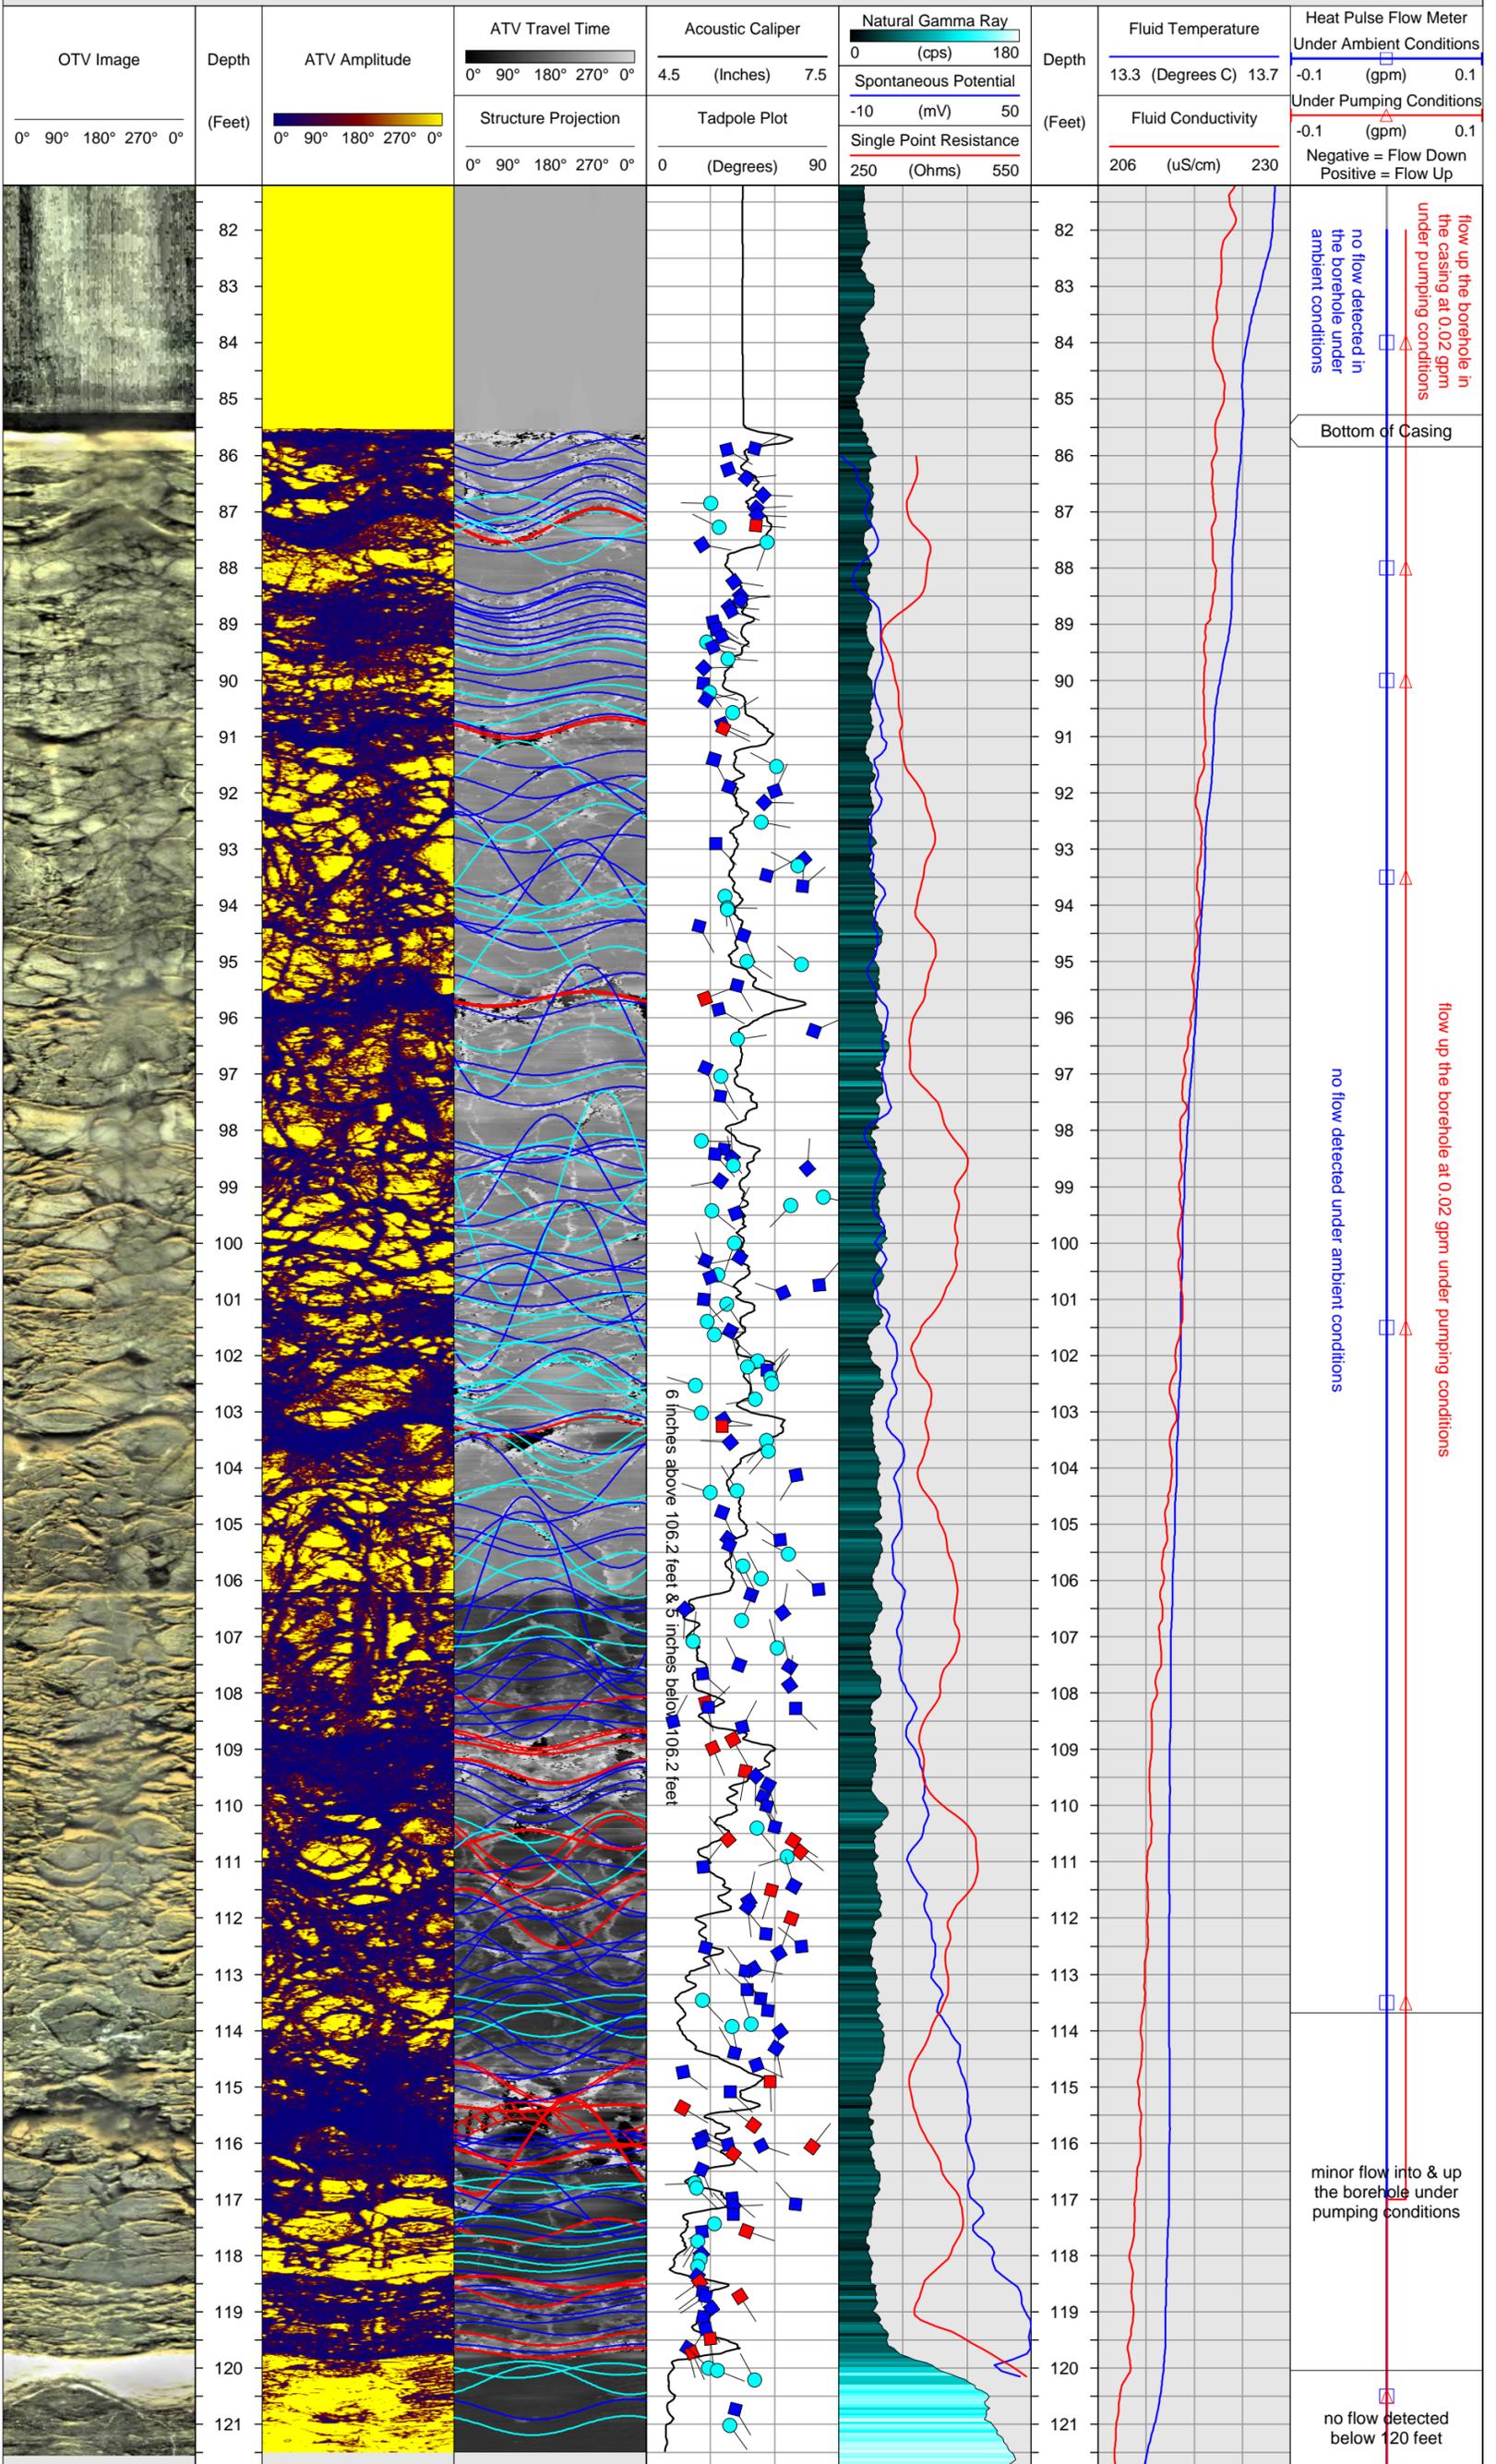
### 114-MW4D - Borehole Geophysical Logs

CLIENT: AECOM  
PROJECT: PPG Site 114 - Garfield Avenue Group Sites  
LOCATION: Jersey City, New Jersey  
LOGGING GEOPHYSICIST(S): Nick DeCristofaro & Mikko Aarnio  
PROJECT REP(S) ON-SITE: Tina Miller  
LOGS PROCESSED BY: Robert Garfield, P.G. & Nick DeCristofaro

HRGS FILE: 19RG66  
LOG DATUM: Top of the 6-Inch Steel Casing  
TOP OF CASING: 0.1 Feet Below the Ground Surface  
ORIENTATION REFERENCE: True North (Magnetic Declination = 12.8° West)  
BOREHOLE DIAMETER: 6 Inches to 106.2 Feet; 5 Inches 106.2 - 121.9 Feet  
WATER LEVEL DEPTH: 40.6 Feet

<u>Track #</u>	<u>Log &amp; Description</u>
1.	OTV Image
2.	Depth
3.	ATV Amplitude
4.	ATV Travel Time
	Structure Projection – bedrock structure interpretation plotted in projection view
5.	Acoustic Caliper – borehole diameter in inches
	Tadpole Plot – bedrock structure interpretation plotted as tadpoles
6.	Natural Gamma Ray, SP, & SPR
7.	Depth
8.	Fluid Temperature & Fluid Conductivity
9.	HPFM Under Ambient & Pumping Conditions
	Borehole Flow Interpretation

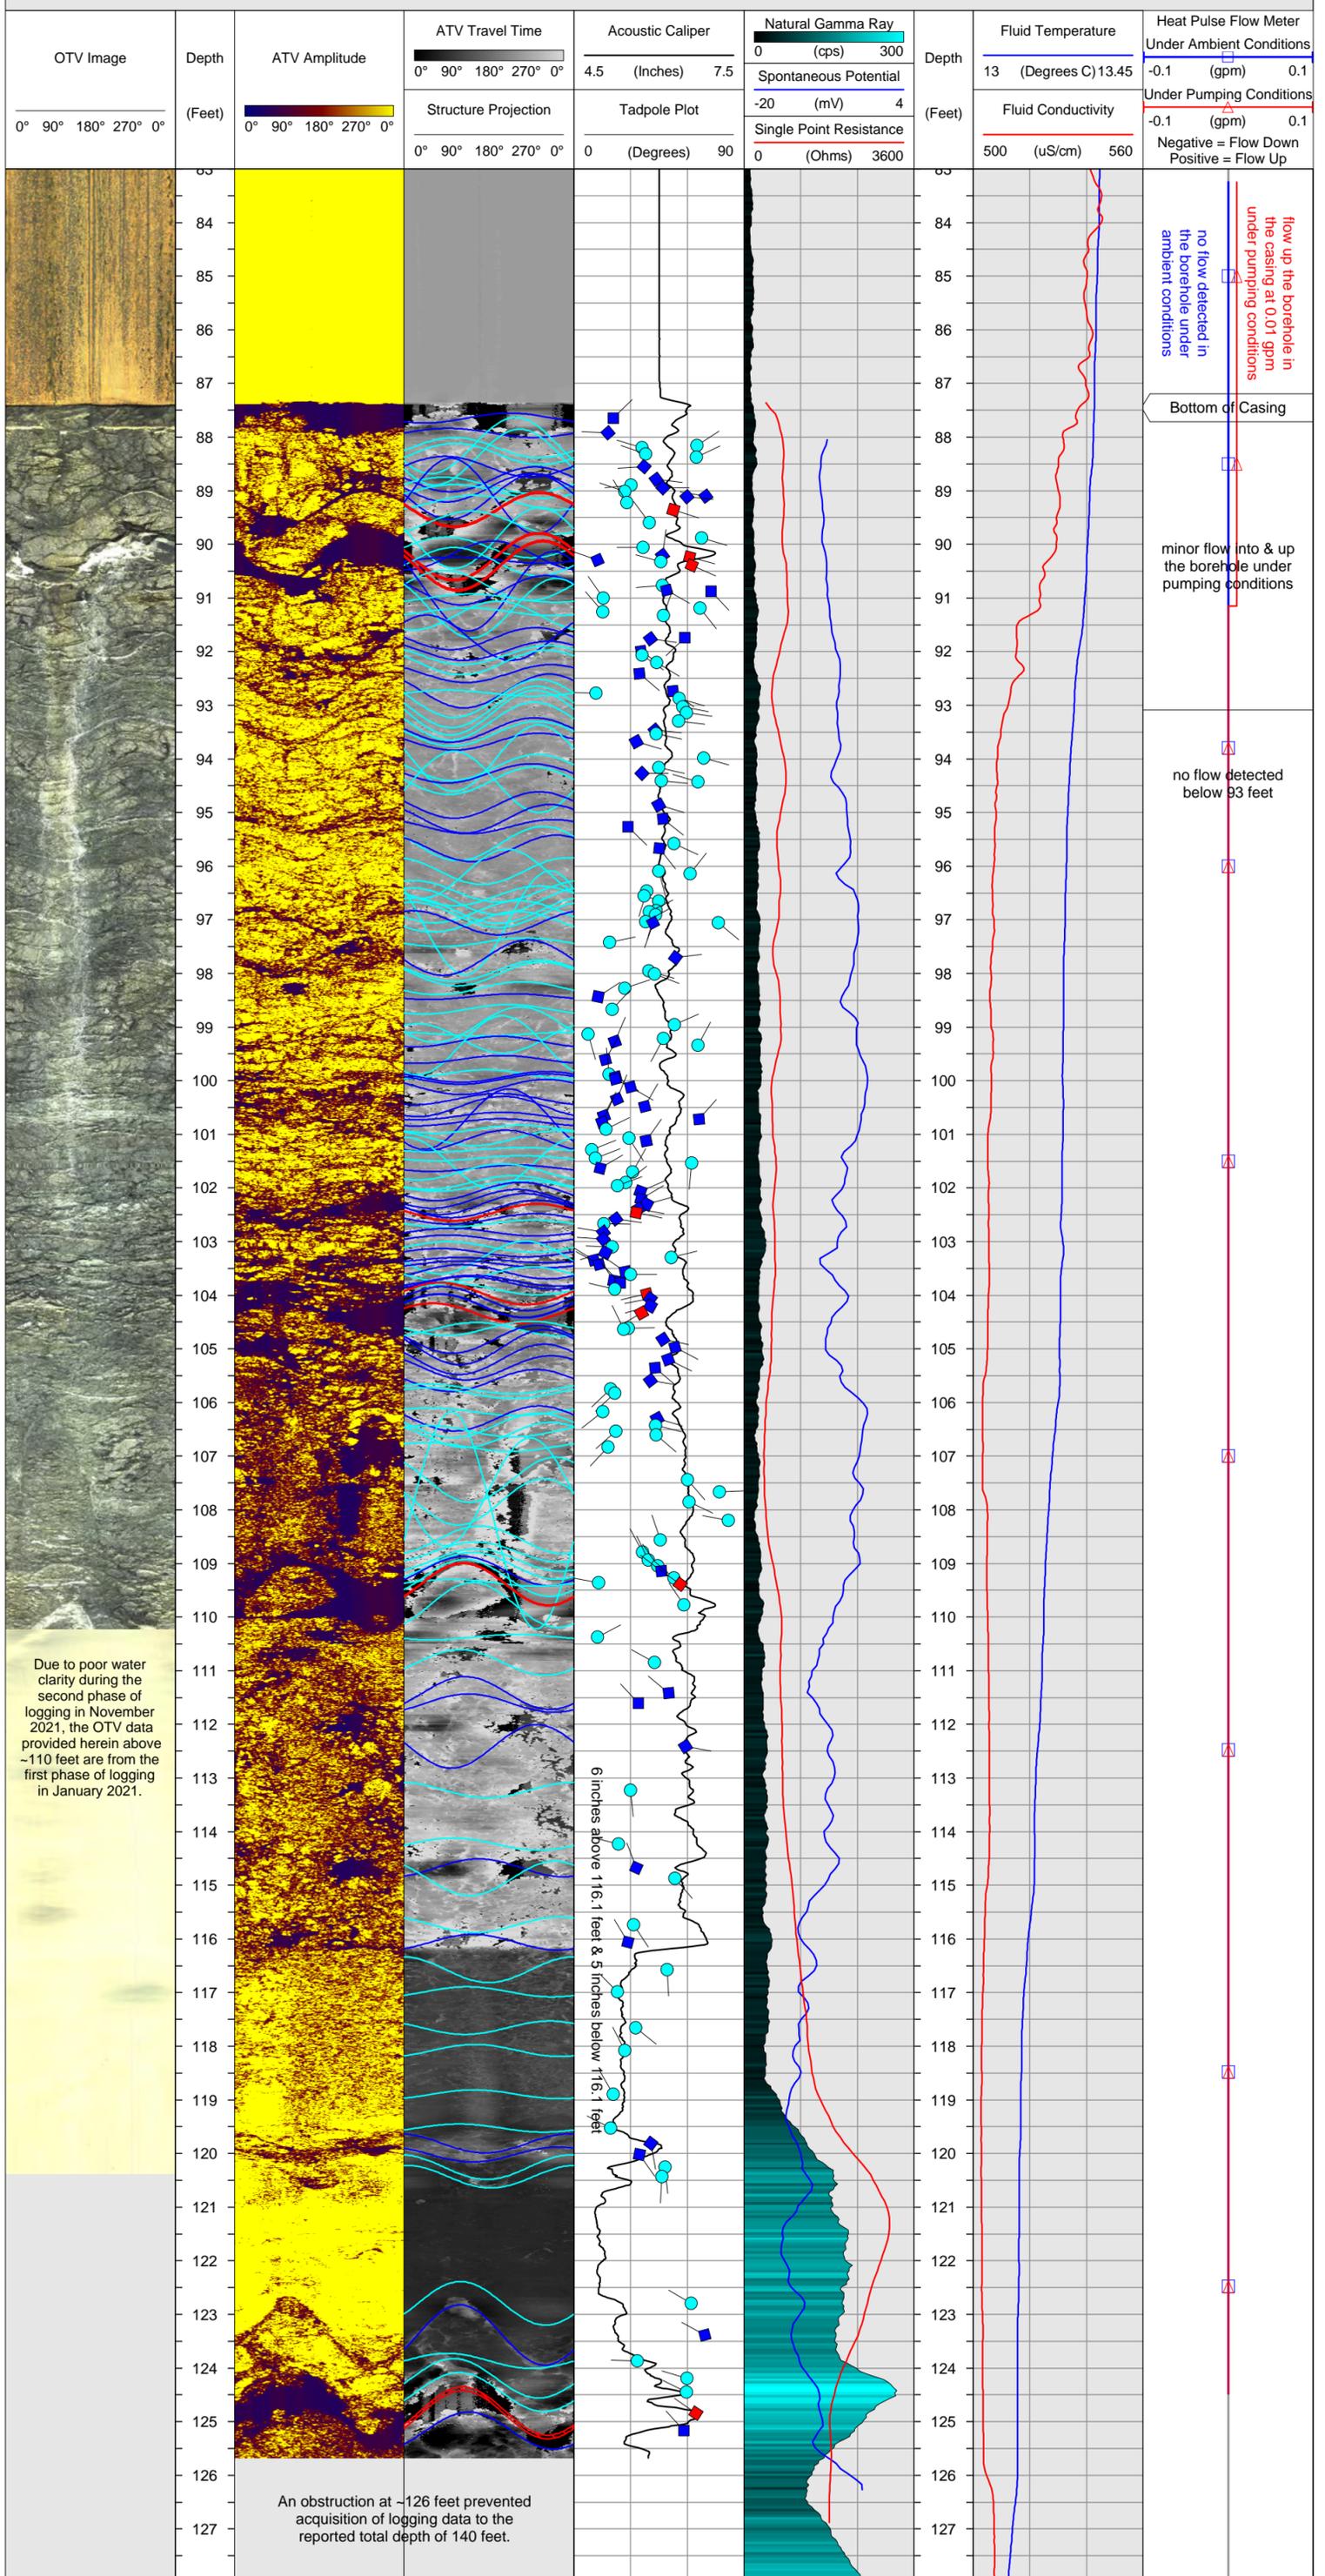
114-MW61D - Borehole Geophysical Logs

CLIENT: AECOM  
PROJECT: PPG Site 114 - Garfield Avenue Group Sites  
LOCATION: Jersey City, New Jersey  
LOGGING GEOPHYSICIST(S): Nick DeCristofaro & Mikko Aarnio  
PROJECT REP(S) ON-SITE: Tina Miller  
LOGS PROCESSED BY: Robert Garfield, P.G. & Nick DeCristofaro

HRGS FILE: 19RG66  
LOG DATUM: Top of the 6-Inch Steel Casing (on January 15, 2021)  
TOP OF CASING: 2.3 Feet Above the Ground Surface  
ORIENTATION REFERENCE: True North (Magnetic Declination = 12.8° West)  
BOREHOLE DIAMETER: 6 Inches to 116.1 Feet; 5 Inches 116.1 - 128.0 Feet  
WATER LEVEL DEPTH: 13.2 Feet

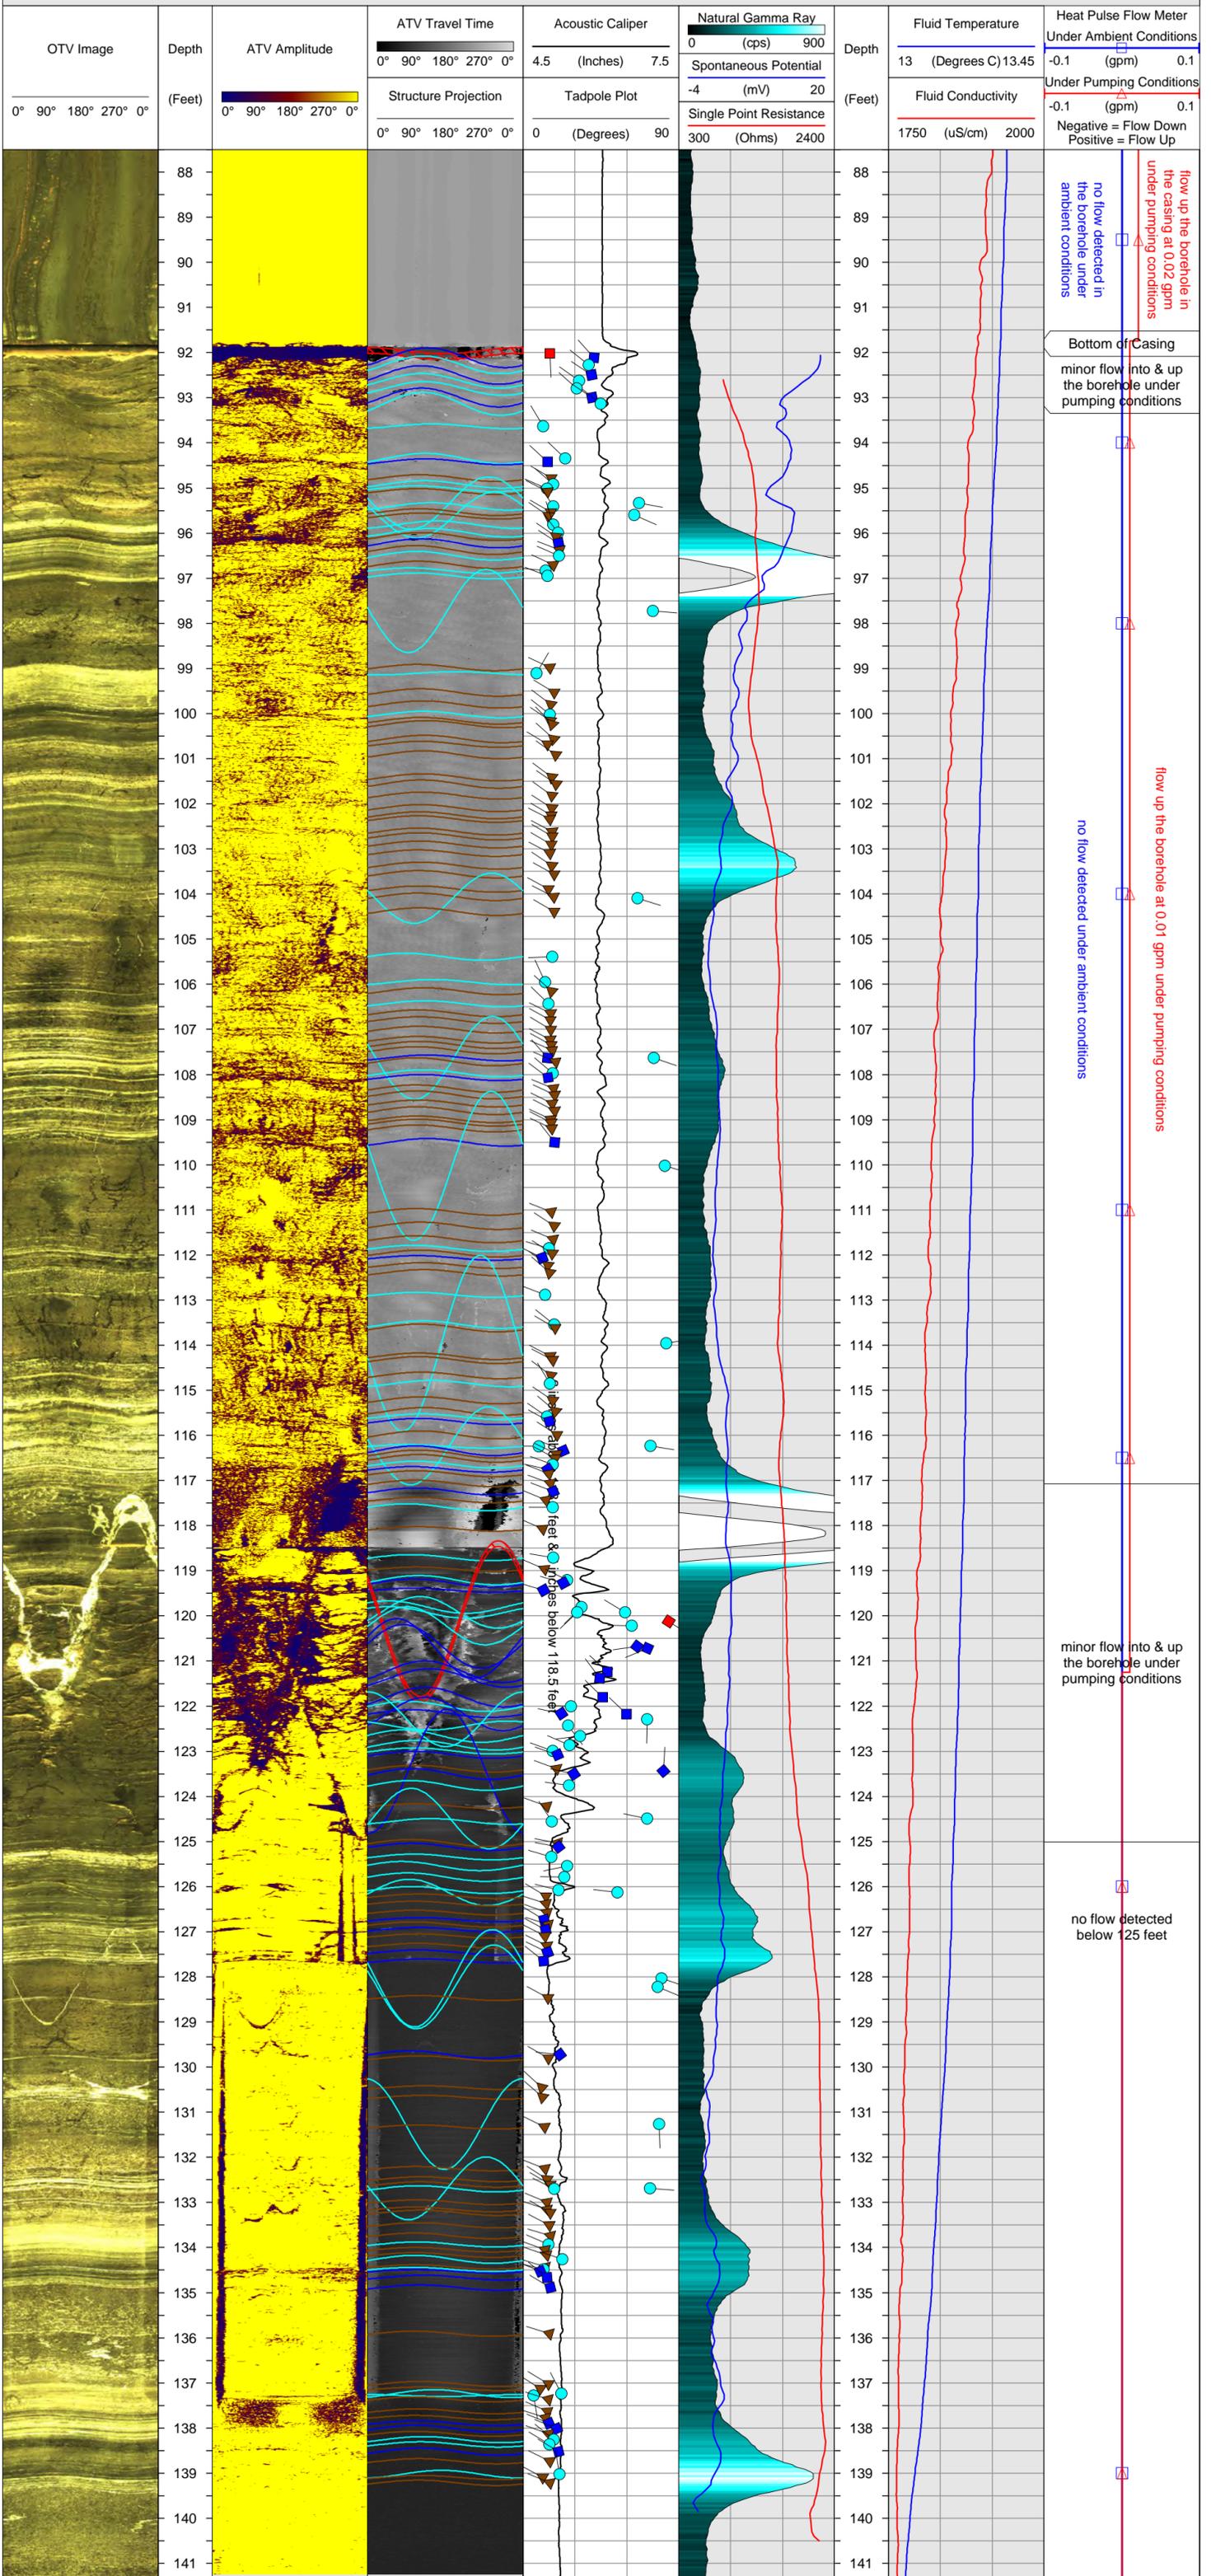
114-MW66D - Borehole Geophysical Logs

CLIENT: AECOM  
PROJECT: PPG Site 114 - Garfield Avenue Group Sites  
LOCATION: Jersey City, New Jersey  
LOGGING GEOPHYSICIST(S): Nick DeCristofaro & Mikko Aarnio  
PROJECT REP(S) ON-SITE: Tina Miller  
LOGS PROCESSED BY: Robert Garfield, P.G. & Nick DeCristofaro

HRGS FILE: 19RG66  
LOG DATUM: Top of the 6-Inch Steel Casing  
TOP OF CASING: 2.2 Feet Above the Ground Surface  
ORIENTATION REFERENCE: True North (Magnetic Declination = 12.8° West)  
BOREHOLE DIAMETER: 6 Inches to 118.5 Feet; 5 Inches 118.5 - 141.4 Feet  
WATER LEVEL DEPTH: 8.5 Feet

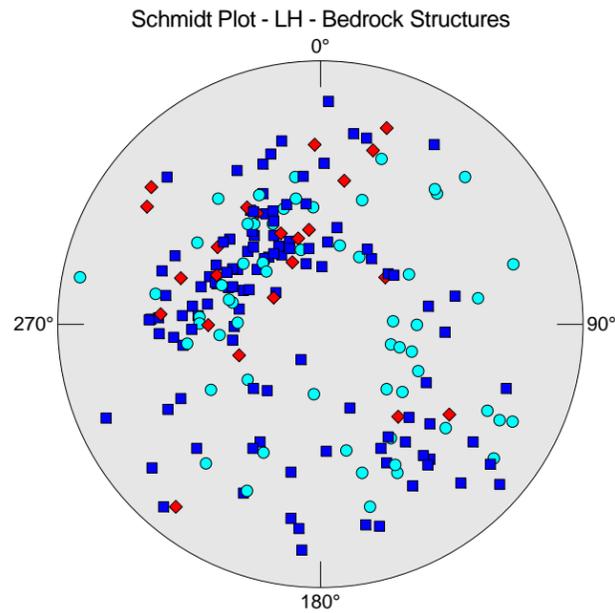
Stereogram - Lower Hemisphere  
of Bedrock Fractures

Counts	Dip[deg]	Azi[deg]
Mean	194	43.22	127.61
■	112	43.55	116.56
●	59	42.37	183.58
◆	23	43.82	143.26

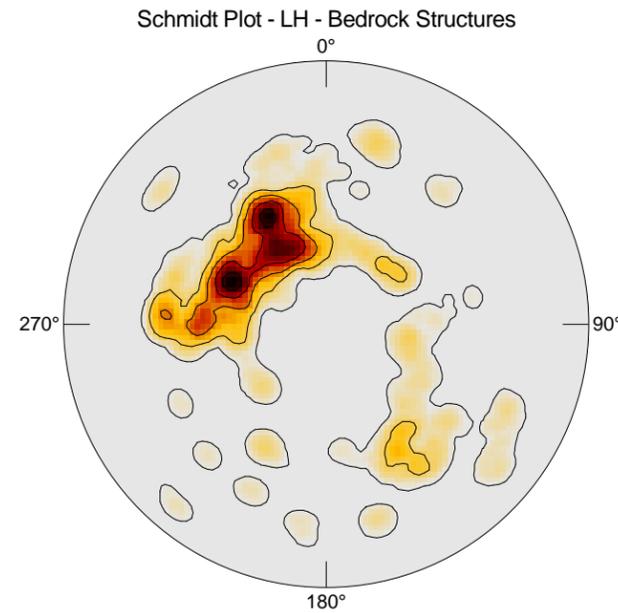
Contoured Stereogram - Lower Hemisphere  
of Bedrock Fractures

Counts	Dip[deg]	Azi[deg]
Mean	194	43.22	127.61
■	112	43.55	116.56
●	59	42.37	183.58
◆	23	43.82	143.26

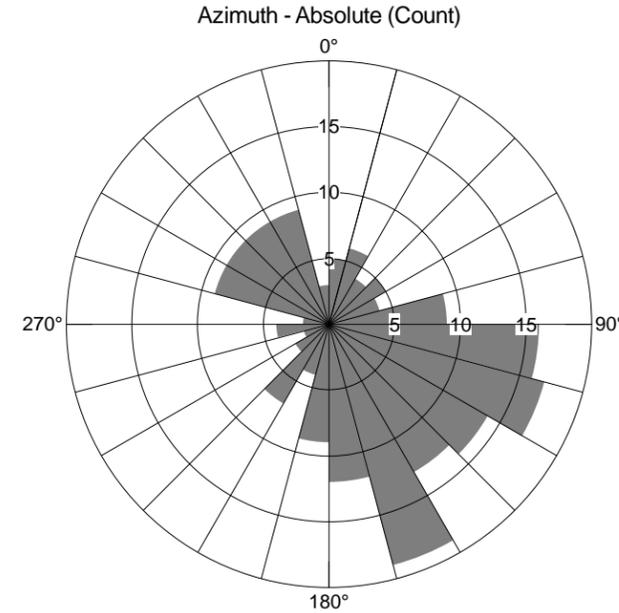
Dip Azimuth Rose Diagram  
of Bedrock Fractures

Components:	Azimuth
Counts:	194.00
Mean (2D):	127.61
Std.Dev.:	93.59
Min:	4.79
Max:	357.38

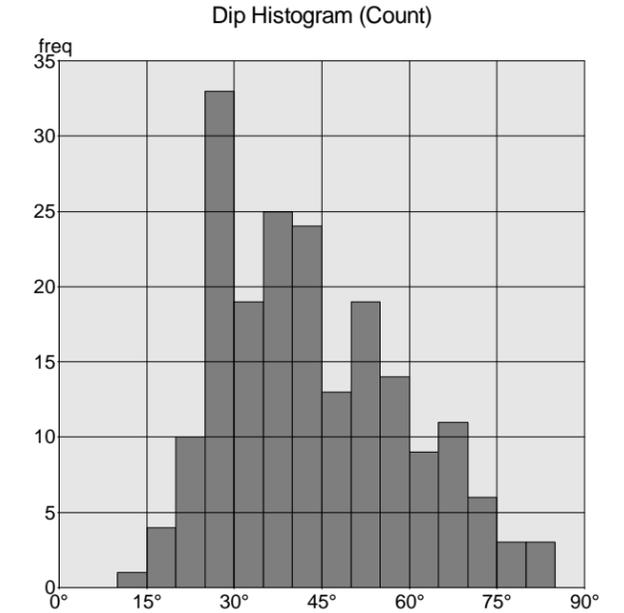
Dip Angle Histogram  
of Bedrock Fractures

Counts:	194.00
Mean (2D):	43.22
Std.Dev.:	15.54
Min:	12.56
Max:	82.76

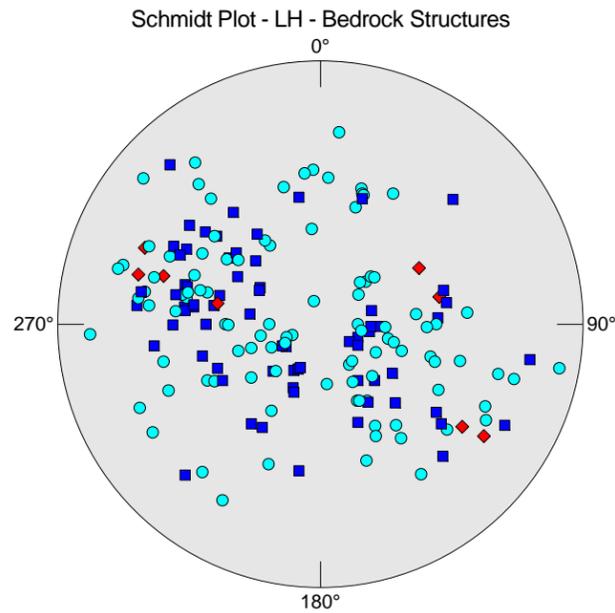
Stereogram - Lower Hemisphere  
of Bedrock Fractures

Counts	Dip[deg]	Azi[deg]
Mean	177	38.84	78.49
■	69	36.56	73.55
●	100	39.47	83.37
◆	8	50.50	155.23

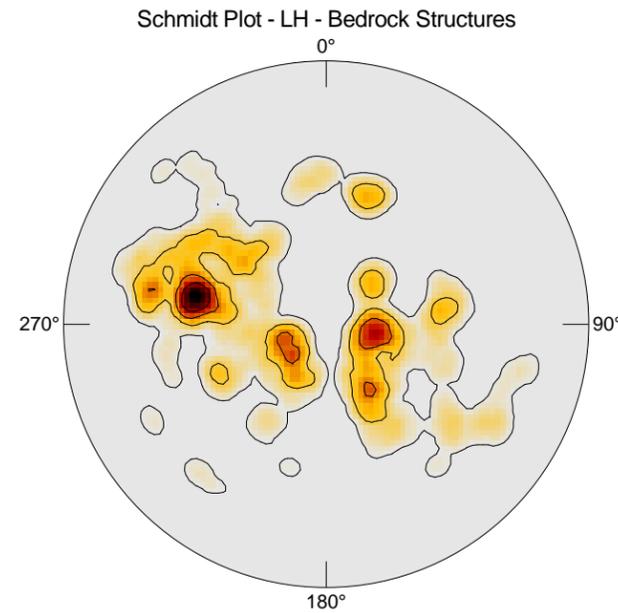
Contoured Stereogram - Lower Hemisphere  
of Bedrock Fractures

Counts	Dip[deg]	Azi[deg]
Mean	177	38.84	78.49
■	69	36.56	73.55
●	100	39.47	83.37
◆	8	50.50	155.23

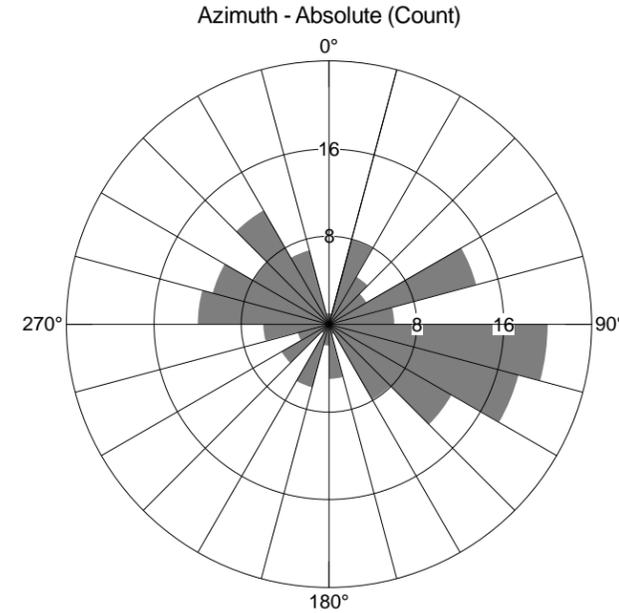
Dip Azimuth Rose Diagram  
of Bedrock Fractures

Components:	Azimuth
Counts:	177.00
Mean (2D):	78.49
Std.Dev.:	110.44
Min:	8.43
Max:	353.78

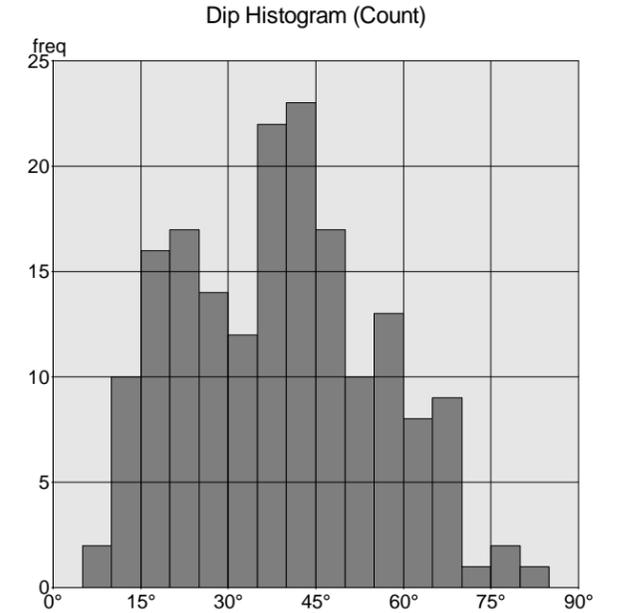
Dip Angle Histogram  
of Bedrock Fractures

Counts:	177.00
Mean (2D):	38.84
Std.Dev.:	16.77
Min:	7.53
Max:	81.75

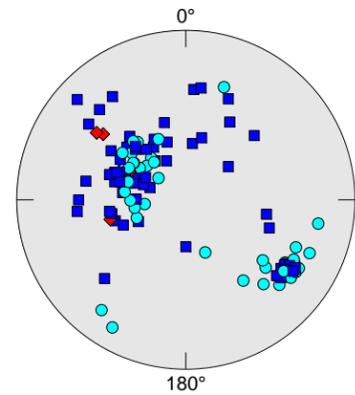
Stereogram - Lower Hemisphere  
of Fractures

Counts	Dip[deg]	Azi[deg]
Mean	114	43.08	118.47
■	64	41.59	126.40
◆	5	41.54	111.67
●	45	45.40	52.23

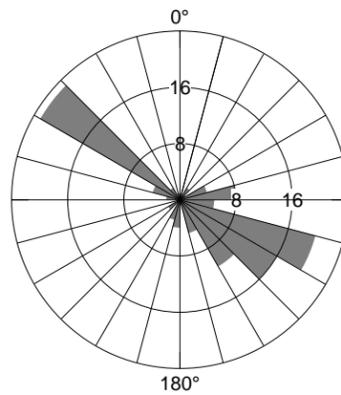
Dip Azimuth Rose Diagram  
of Fractures

Components:	Azimuth
Counts:	114.00
Mean (2D):	118.47
Std.Dev.:	90.20
Min:	30.13
Max:	359.78

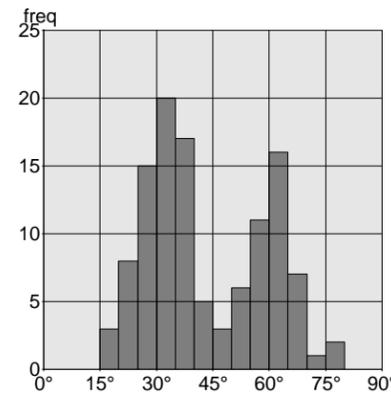
Dip Angle Histogram  
of Fractures

Counts:	114.00
Mean (2D):	43.08
Std.Dev.:	15.85
Min:	16.97
Max:	76.54

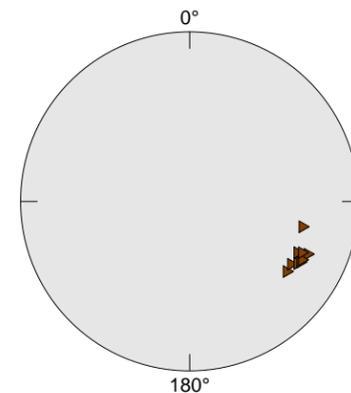
Stereogram - Lower Hemisphere  
of Bedding

Counts	Dip[deg]	Azi[deg]
Mean	9	61.92	296.74
▼	9	61.92	296.74

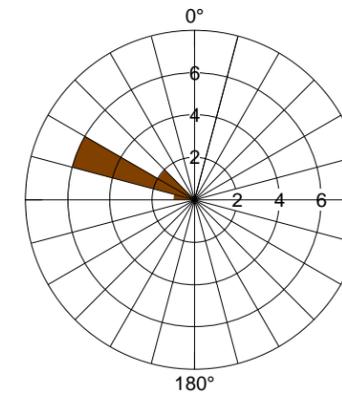
Dip Azimuth Rose Diagram  
of Bedding

Components:	Azimuth
Counts:	9.00
Mean (2D):	296.74
Std.Dev.:	6.12
Min:	282.57
Max:	305.93

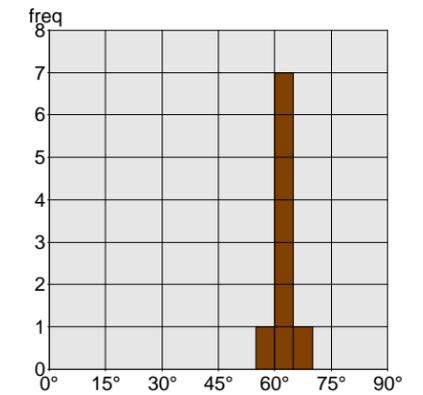
Dip Angle Histogram  
of Bedding

Counts:	9.00
Mean (2D):	61.92
Std.Dev.:	2.30
Min:	57.93
Max:	65.48

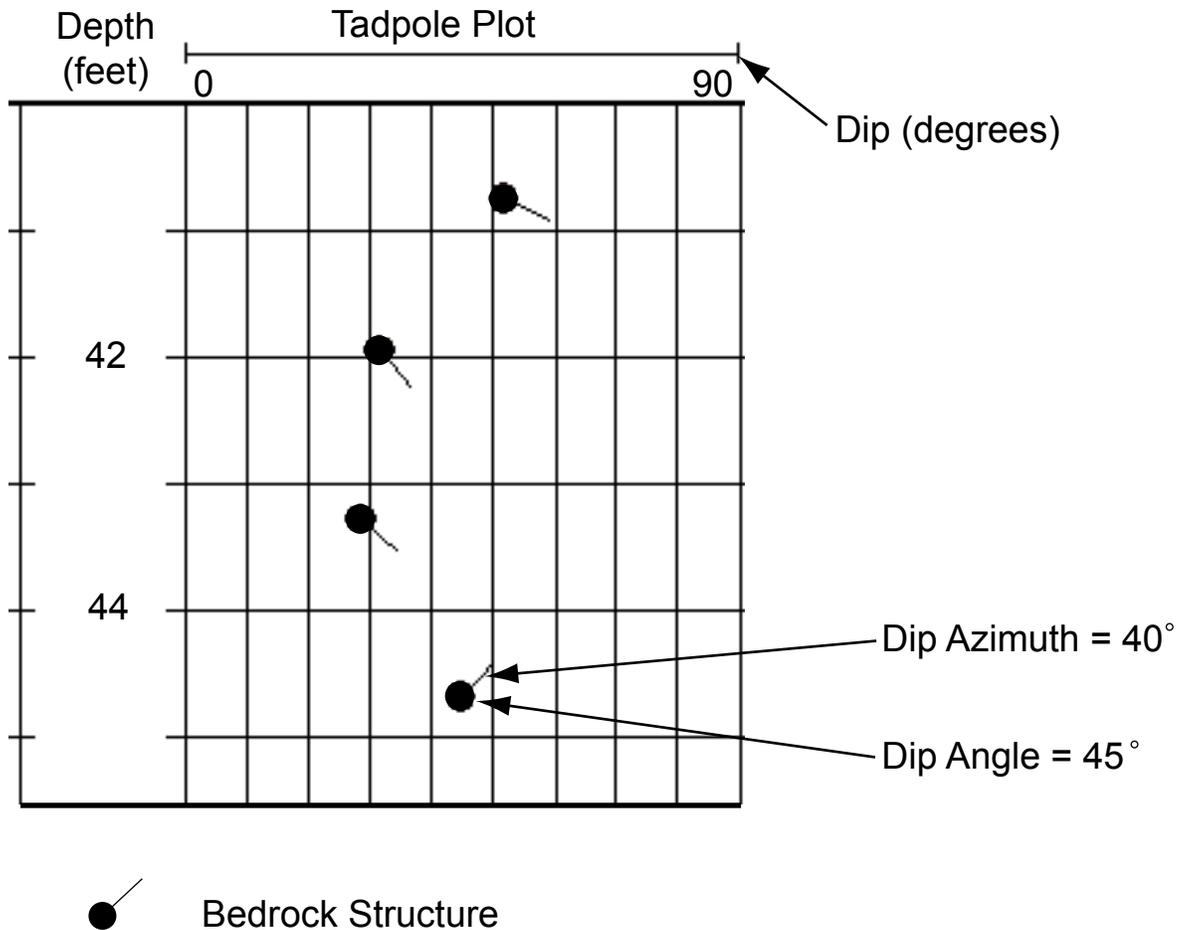
**Figure 2.** Tadpole plot explanation. The orientation of the bedrock structures is graphically displayed by a tadpole consisting of a circle, the head, and a line, the tail. The position of the head, left to right on the tadpole plot, gives the dip angle of the structure. The left side of the track indicates a dip angle of  $0^\circ$ , and the right side of the track indicates a dip angle of  $90^\circ$  from horizontal. The orientation of the tail gives the dip azimuth of the structure and can be read like a compass. The tail pointing directly up is  $0^\circ$ , north.

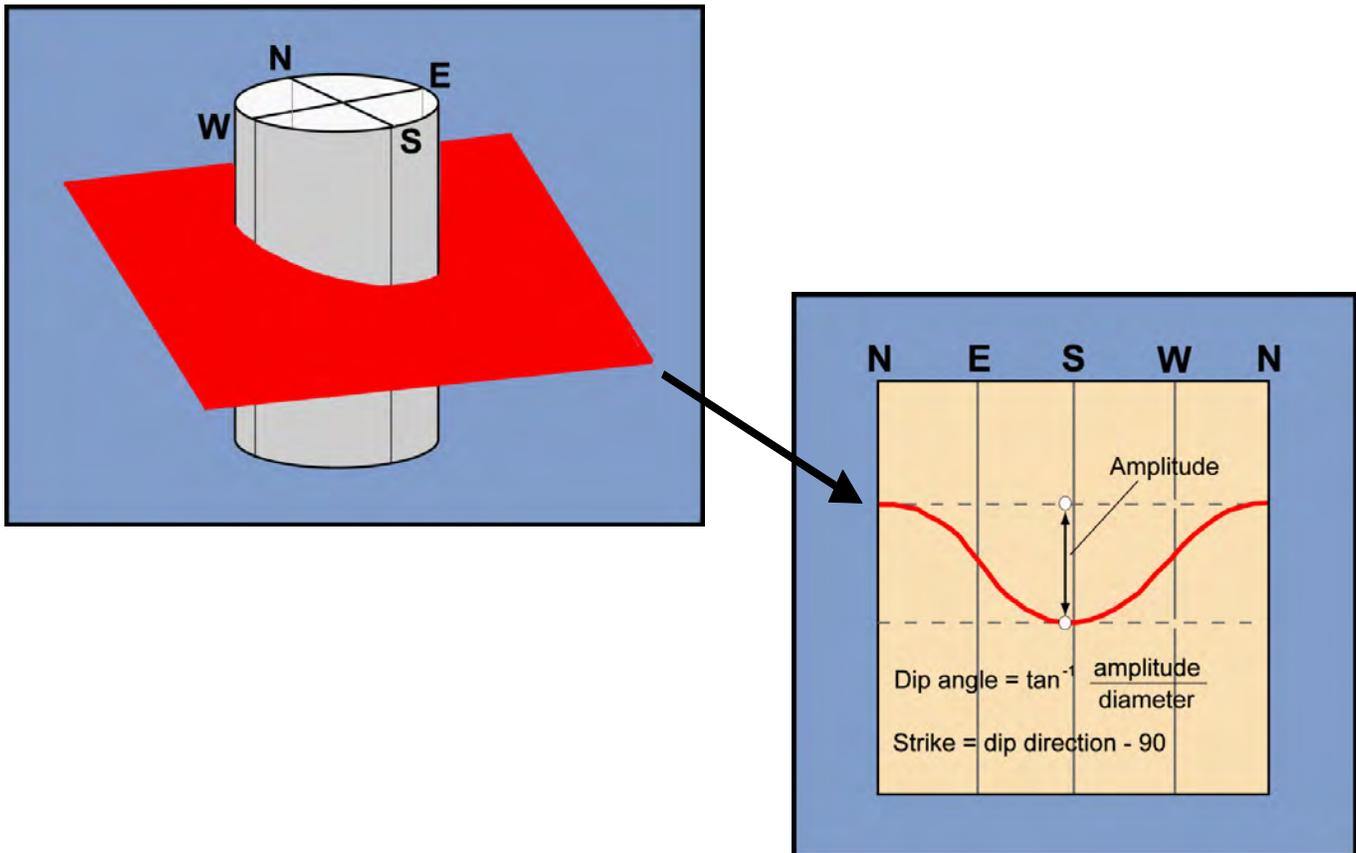
**Figure 3.** Televiewer explanation. The image on the left depicts a planar structure in red, such as a fracture or bedding plane, intersected by a borehole. The image on the right depicts the same structure unwrapped as it would be displayed in an optical televiewer (OTV) or acoustic televiewer (ATV) log.
