## **Appendix F**

### **Borehole Geophysical Logging Results**

**BOREHOLE GEOPHYSICAL LOGGING – DATA REPORT  
BOREHOLES 114-MW4D DEEPENED, 114-MW61D DEEPENED,  
114-MW66D DEEPENED, 114-MW71D, & 114-MW72D  
PPG SITE 114 – GARFIELD AVENUE GROUP SITES  
JERSEY CITY, NEW JERSEY**

File 19RG66  
February 2022

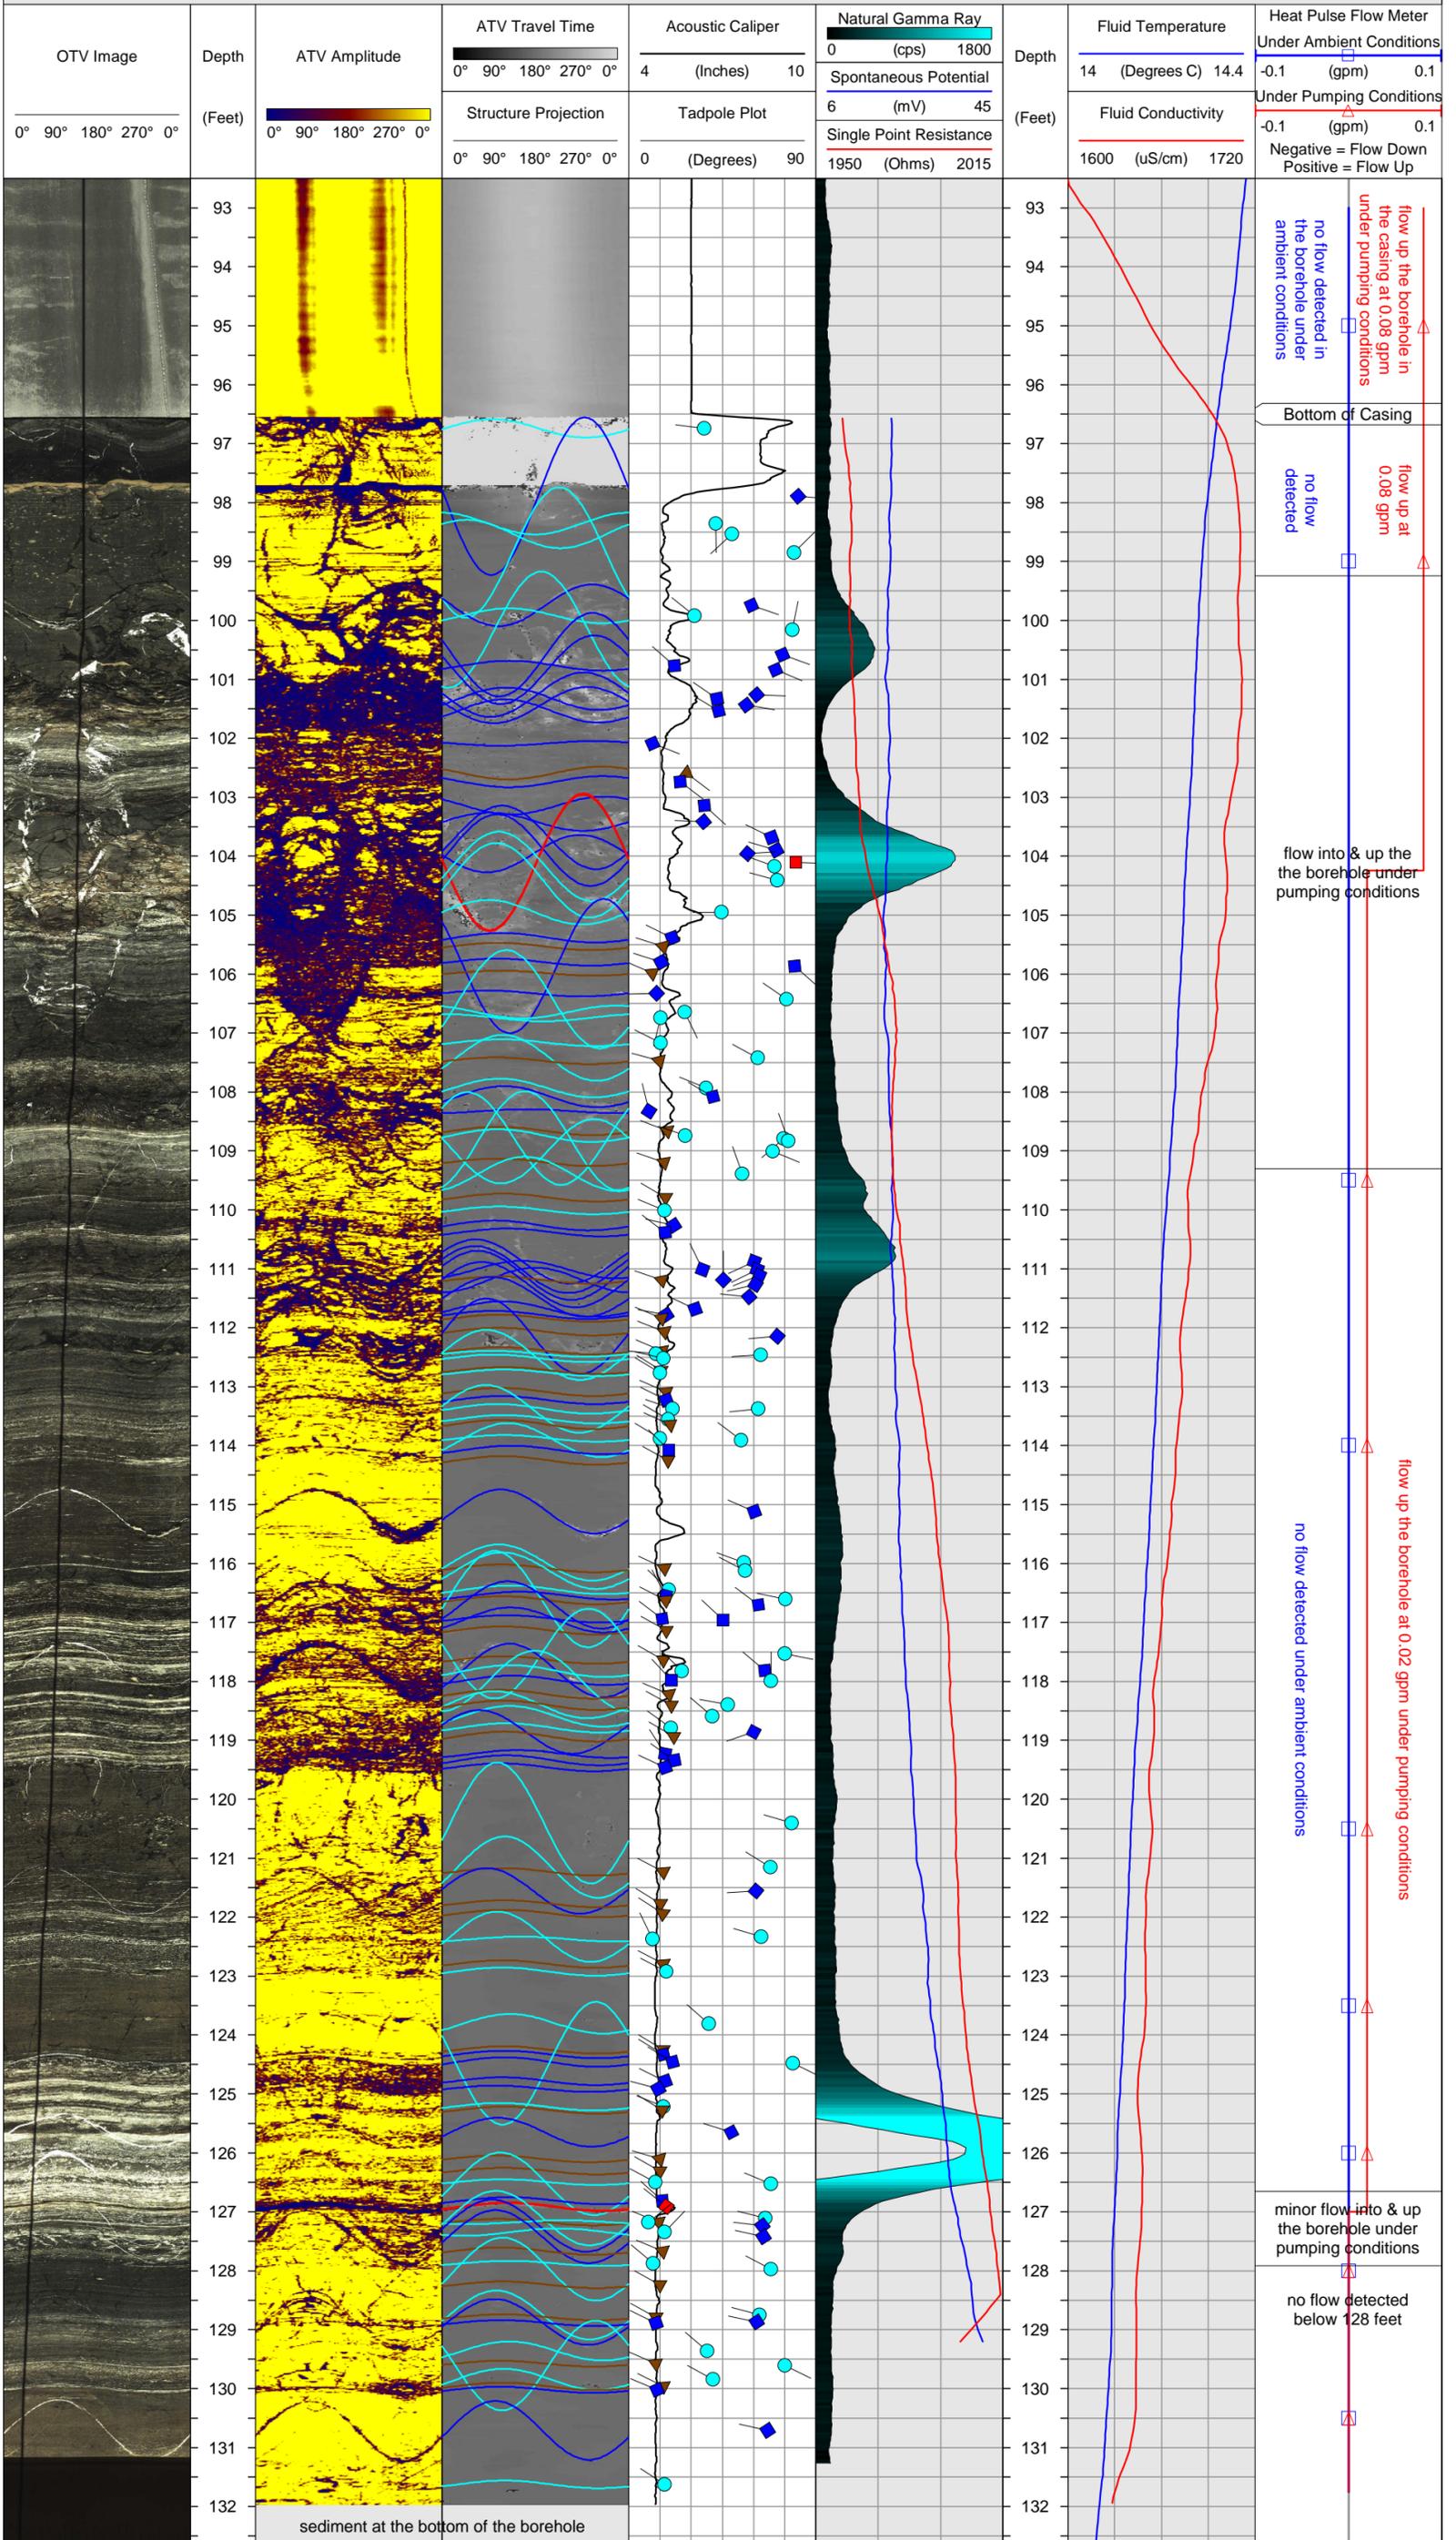
114-MW74D - Borehole Geophysical Logs

CLIENT: AECOM  
PROJECT: PPG Site 114 - Garfield Avenue Group Sites  
LOCATION: Jersey City, New Jersey  
LOGGING GEOPHYSICIST(S): Nick DeCristofaro & Alex Collier  
PROJECT REP(S) ON-SITE: Zach Bartram  
LOGS PROCESSED BY: Robert Garfield, P.G. & Nick DeCristofaro

HRGS FILE: 19RG66  
LOG DATUM: Top of the 6-Inch Steel Casing  
TOP OF CASING: 0.9 Feet Above the Ground Surface  
ORIENTATION REFERENCE: True North (Magnetic Declination = 13° West)  
BOREHOLE DIAMETER: 5 Inches  
WATER LEVEL DEPTH: 6.7 Feet

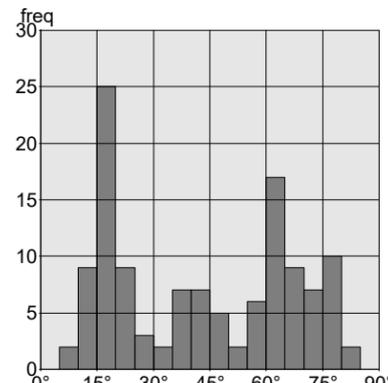
<table border="1"> <thead> <tr> <th>Components:</th> <th>Azimuth</th> </tr> </thead> <tbody> <tr> <td>Counts:</td> <td>122.00</td> </tr> <tr> <td>Mean (2D):</td> <td>296.76</td> </tr> <tr> <td>Std.Dev.:</td> <td>57.73</td> </tr> <tr> <td>Min:</td> <td>0.25</td> </tr> <tr> <td>Max:</td> <td>359.54</td> </tr> </tbody> </table>	Components:	Azimuth	Counts:	122.00	Mean (2D):	296.76	Std.Dev.:	57.73	Min:	0.25	Max:	359.54	<p>Dip Histogram (Count)</p>

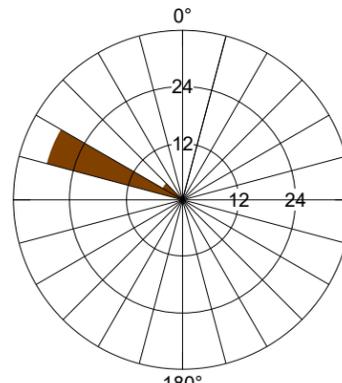
<table border="1"> <thead> <tr> <th></th> <th>Counts</th> <th>Dip[deg]</th> <th>Azi[deg]</th> </tr> </thead> <tbody> <tr> <td>Mean</td> <td>36</td> <td>16.87</td> <td>295.04</td> </tr> <tr> <td>▼</td> <td>36</td> <td>16.87</td> <td>295.04</td> </tr> </tbody> </table>		Counts	Dip[deg]	Azi[deg]	Mean	36	16.87	295.04	▼	36	16.87	295.04	<p>Azimuth - Absolute (Count)</p>

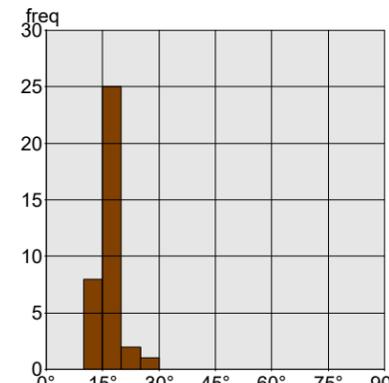
<table border="1"> <thead> <tr> <th>Components:</th> <th>Azimuth</th> </tr> </thead> <tbody> <tr> <td>Counts:</td> <td>36.00</td> </tr> <tr> <td>Mean (2D):</td> <td>295.04</td> </tr> <tr> <td>Std.Dev.:</td> <td>19.86</td> </tr> <tr> <td>Min:</td> <td>126.83</td> </tr> <tr> <td>Max:</td> <td>303.07</td> </tr> </tbody> </table>	Components:	Azimuth	Counts:	36.00	Mean (2D):	295.04	Std.Dev.:	19.86	Min:	126.83	Max:	303.07	<p>Dip Histogram (Count)</p>

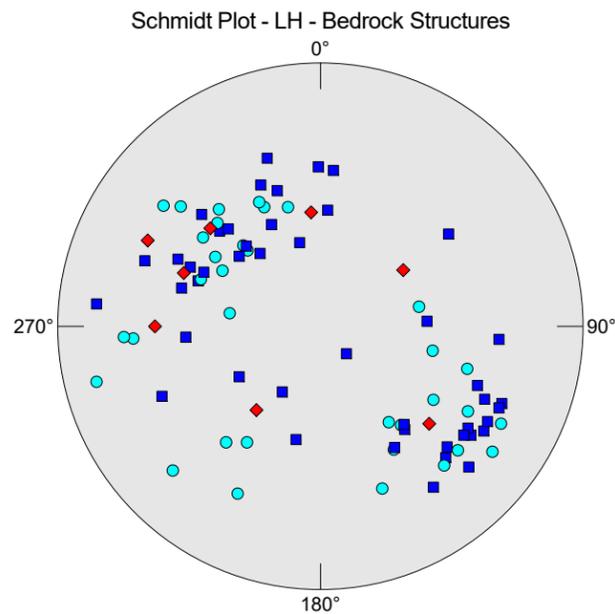
Stereogram - Lower Hemisphere  
of Bedrock Fractures

Counts	Dip[deg]	Azi[deg]
Mean	88	48.09	100.42
■	46	47.91	181.55
◆	8	44.47	120.17
●	34	49.20	72.46

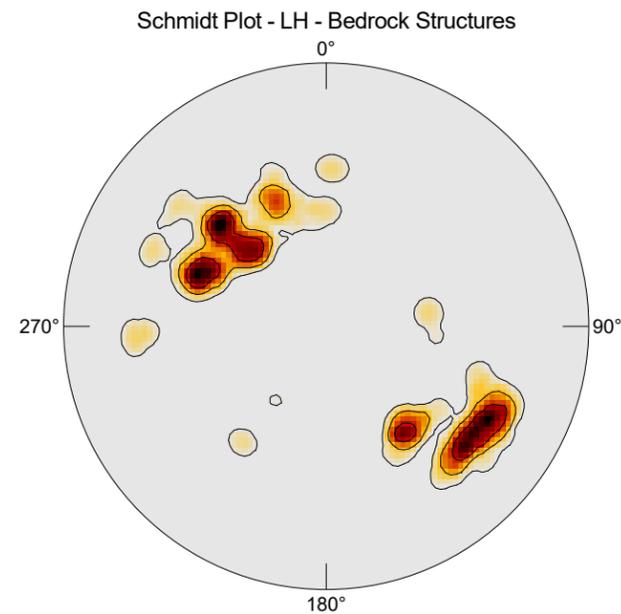
Contoured Stereogram - Lower Hemisphere  
of Bedrock Fractures

Counts	Dip[deg]	Azi[deg]
Mean	88	48.09	100.42
■	46	47.91	181.55
◆	8	44.47	120.17
●	34	49.20	72.46

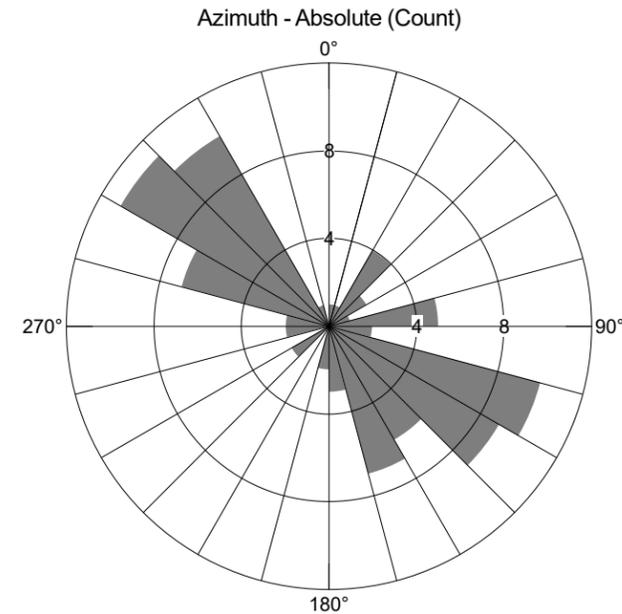
Dip Azimuth Rose Diagram  
of Bedrock Fractures

Components:	Azimuth
Counts:	88.00
Mean (2D):	100.42
Std.Dev.:	125.03
Min:	12.43
Max:	339.00

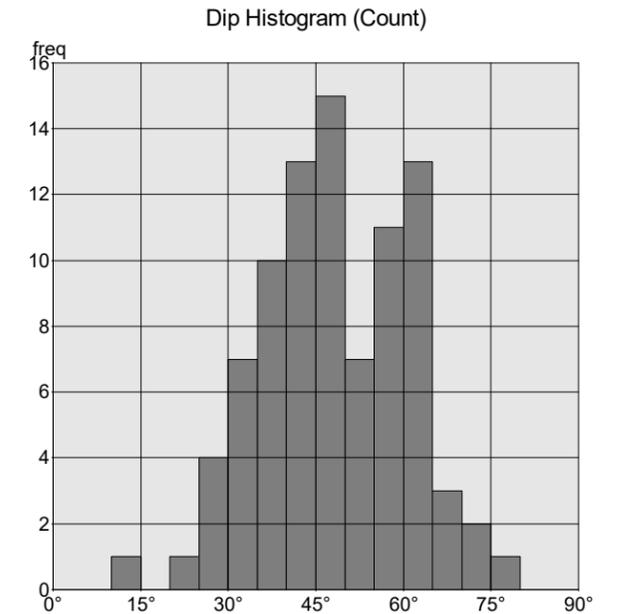
Dip Angle Histogram  
of Bedrock Fractures

Counts:	88.00
Mean (2D):	48.09
Std.Dev.:	12.58
Min:	11.75
Max:	77.02

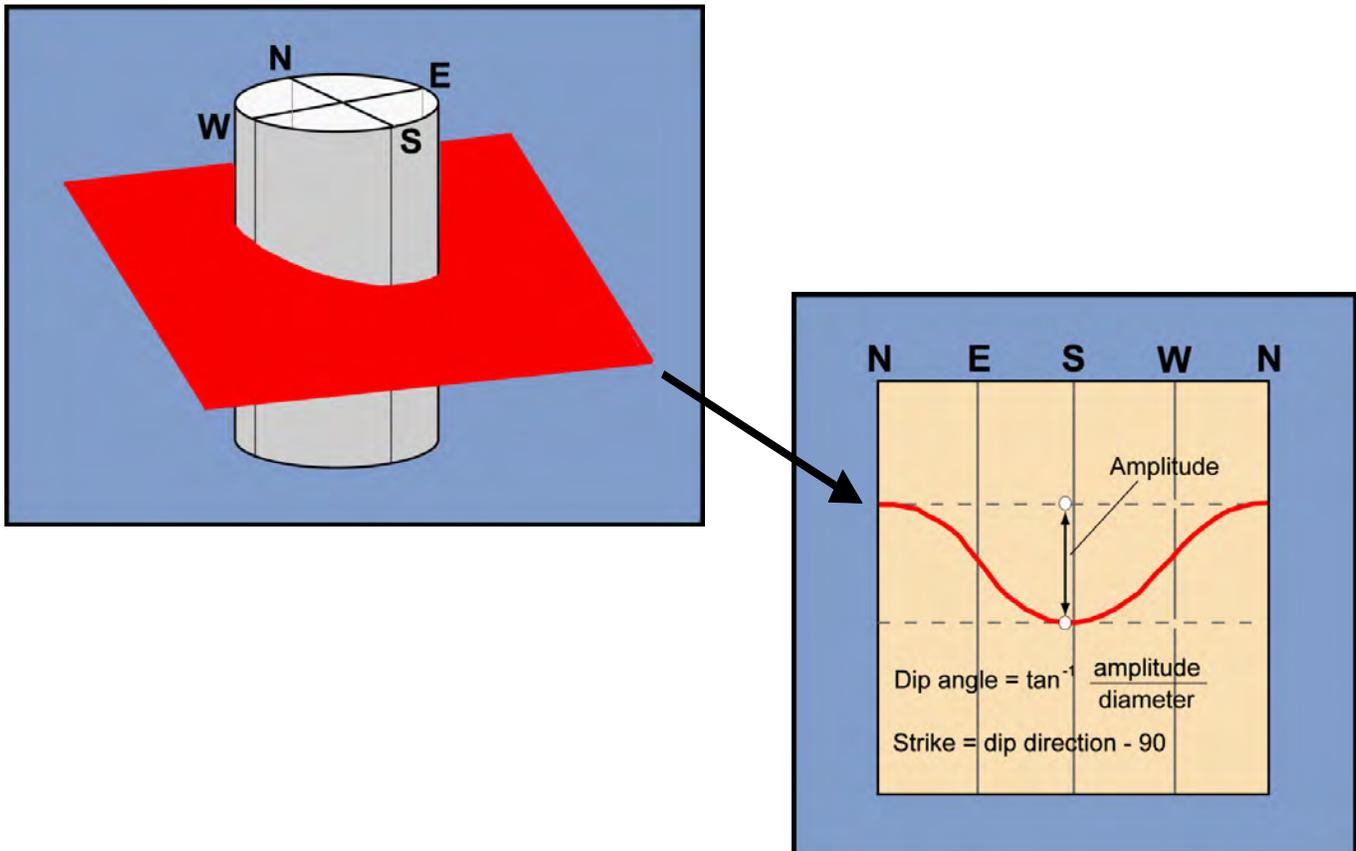
**Figure 3.** Televiewer explanation. The image on the left depicts a planar structure in red, such as a fracture or bedding plane, intersected by a borehole. The image on the right depicts the same structure unwrapped as it would be displayed in an optical televiewer (OTV) or acoustic televiewer (ATV) log.

**Figure 3.** Televiewer explanation. The image on the left depicts a planar structure in red, such as a fracture or bedding plane, intersected by a borehole. The image on the right depicts the same structure unwrapped as it would be displayed in an optical televiewer (OTV) or acoustic televiewer (ATV) log.

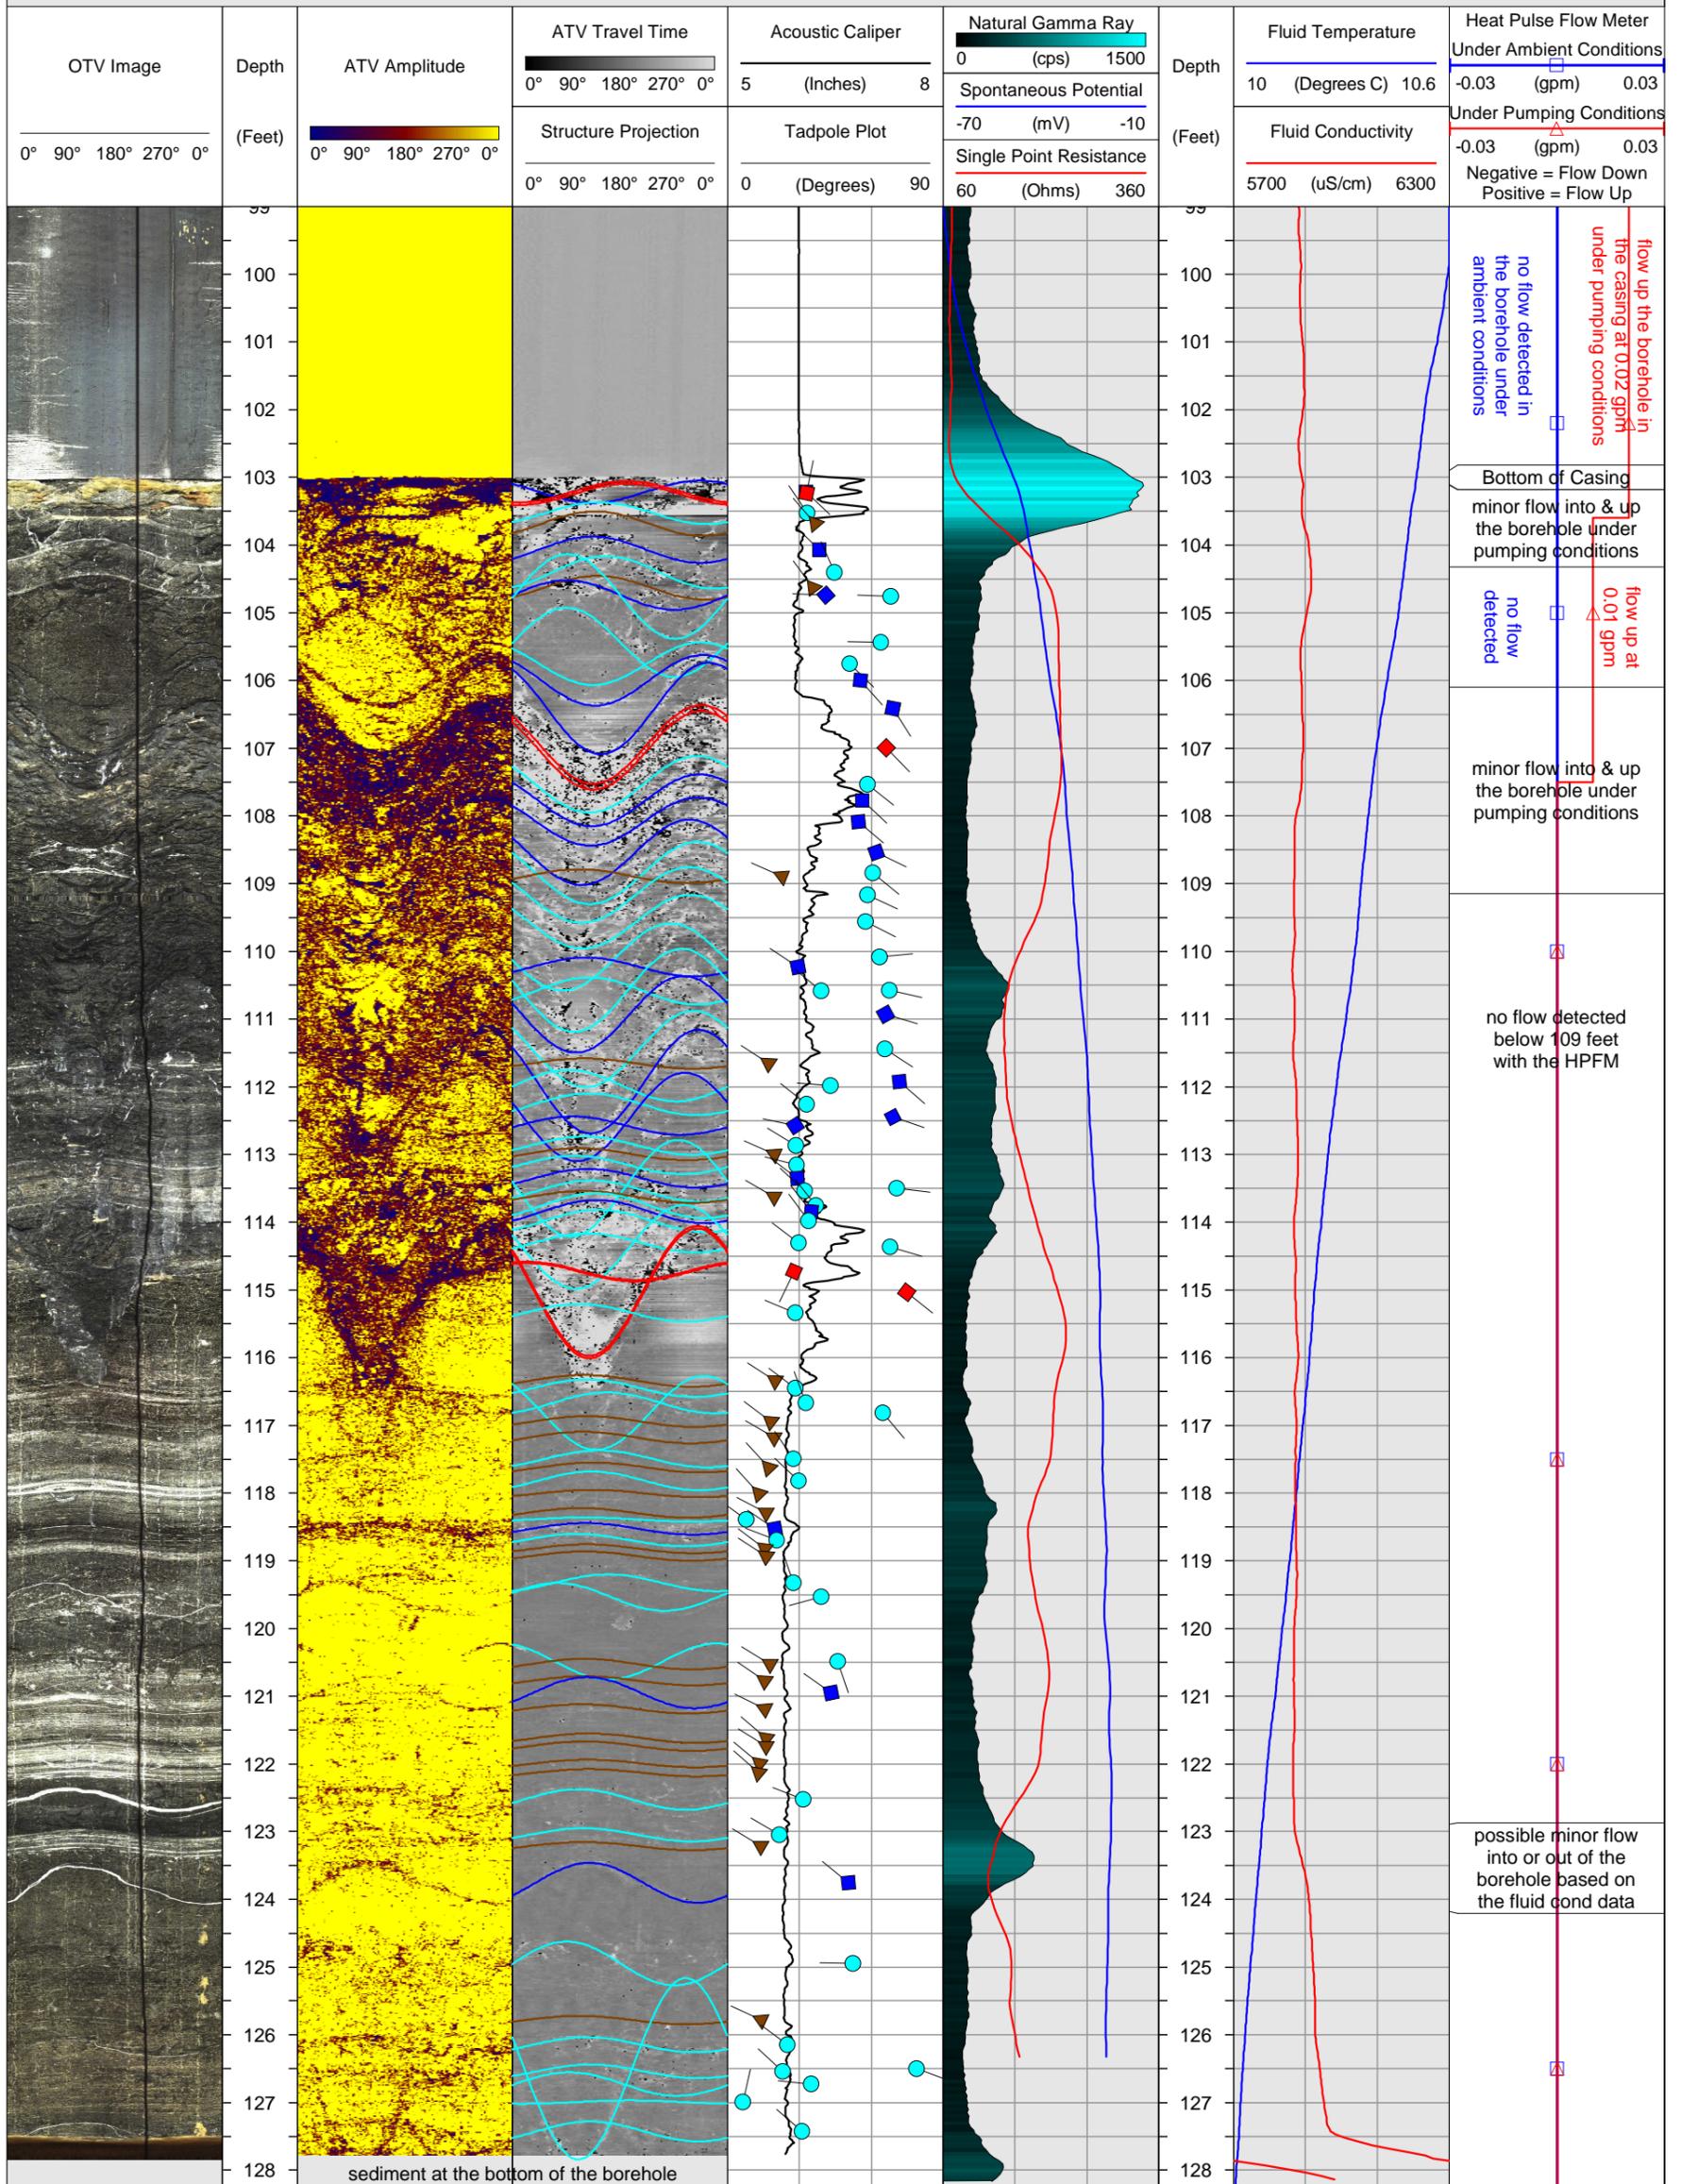
### 114-MW81D - Borehole Geophysical Logs

<u>Track #</u>	<u>Log &amp; Description</u>
1.	OTV Image
2.	Depth
3.	ATV Amplitude
4.	ATV Travel Time
	Structure Projection – bedrock structure interpretation plotted in projection view
5.	Acoustic Caliper – borehole diameter in inches
	Tadpole Plot – bedrock structure interpretation plotted as tadpoles
6.	Natural Gamma Ray, SP, & SPR
7.	Depth
8.	Fluid Temperature & Fluid Conductivity
9.	HPFM Under Ambient & Pumping Conditions
	Borehole Flow Interpretation

The structure projection plots, sinusoidal curves in the log track labeled Structure Projection, display the depth, orientation, and category of the bedrock structures detected in the televiewer data. Bedrock structures are essentially planar for short distances such as the intersection of the open borehole and the bedrock structure. The intersection of a plane, the bedrock structure, with a cylinder, the borehole, is a circle on the plane. When the circle is unwrapped and plotted as it is in the structure projection plots, the circle plots as a sine wave as shown in the Televiewer Explanation Figure (Figure 3). The structures plotted in the structure projection plots are not corrected for borehole deviation, the structure projection plots represent the apparent orientations (that is, *apparent* dip angles and *apparent* dip azimuths) of the bedrock structures. The correction of the bedrock structure orientations from apparent to true orientations (that is, *true* dip angles and *true* dip azimuths) is then made using the borehole deviation data acquired by the televiewer probes, and these corrected/true orientations are reported in the tadpole plots, bedrock structure statistics plots, and bedrock structure tables.

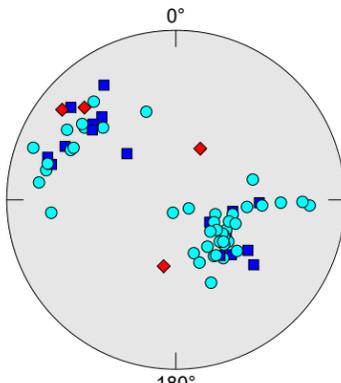
Stereogram - Lower Hemisphere of Fractures	Dip Azimuth Rose Diagram of Fractures	Dip Angle Histogram of Fractures	Stereogram - Lower Hemisphere of Bedding	Dip Azimuth Rose Diagram of Bedding	Dip Angle Histogram of Bedding																																																																																				
<p>Schmidt Plot - LH - Bedrock Structures</p>

<table border="1"> <thead> <tr> <th></th> <th>Counts</th> <th>Dip[deg]</th> <th>Azi[deg]</th> </tr> </thead> <tbody> <tr> <td>Mean</td> <td>65</td> <td>43.70</td> <td>306.44</td> </tr> <tr> <td>■</td> <td>18</td> <td>47.25</td> <td>210.24</td> </tr> <tr> <td>◆</td> <td>4</td> <td>50.36</td> <td>135.21</td> </tr> <tr> <td>●</td> <td>43</td> <td>41.59</td> <td>310.14</td> </tr> </tbody> </table>		Counts	Dip[deg]	Azi[deg]	Mean	65	43.70	306.44	■	18	47.25	210.24	◆	4	50.36	135.21	●	43	41.59	310.14	<p>Azimuth - Absolute (Count)</p>

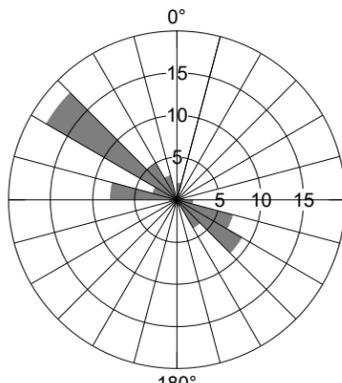
<table border="1"> <thead> <tr> <th>Component</th> <th>Azimuth</th> <th>Counts</th> <th>Mean (2D)</th> <th>Std.Dev.</th> <th>Min</th> <th>Max</th> </tr> </thead> <tbody> <tr> <td>Fractures</td> <td>Azimuth</td> <td>65.00</td> <td>306.44</td> <td>101.99</td> <td>11.01</td> <td>341.46</td> </tr> </tbody> </table>	Component	Azimuth	Counts	Mean (2D)	Std.Dev.	Min	Max	Fractures	Azimuth	65.00	306.44	101.99	11.01	341.46	<p>Dip Histogram (Count)</p>

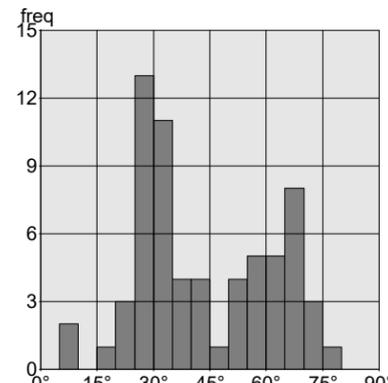
<table border="1"> <thead> <tr> <th>Statistic</th> <th>Value</th> </tr> </thead> <tbody> <tr> <td>Counts</td> <td>65.00</td> </tr> <tr> <td>Mean (2D)</td> <td>43.70</td> </tr> <tr> <td>Std.Dev.</td> <td>17.87</td> </tr> <tr> <td>Min</td> <td>6.40</td> </tr> <tr> <td>Max</td> <td>79.06</td> </tr> </tbody> </table>	Statistic	Value	Counts	65.00	Mean (2D)	43.70	Std.Dev.	17.87	Min	6.40	Max	79.06	<p>Schmidt Plot - LH - Bedrock Structures</p>

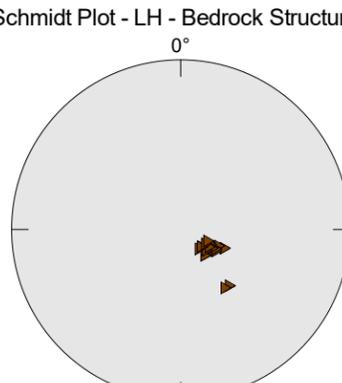
<table border="1"> <thead> <tr> <th></th> <th>Counts</th> <th>Dip[deg]</th> <th>Azi[deg]</th> </tr> </thead> <tbody> <tr> <td>Mean</td> <td>23</td> <td>18.29</td> <td>304.87</td> </tr> <tr> <td>▼</td> <td>23</td> <td>18.29</td> <td>304.87</td> </tr> </tbody> </table>		Counts	Dip[deg]	Azi[deg]	Mean	23	18.29	304.87	▼	23	18.29	304.87	<p>Azimuth - Absolute (Count)</p>

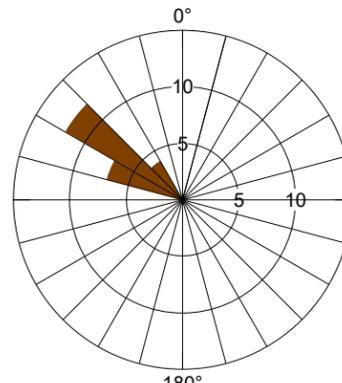
<table border="1"> <thead> <tr> <th>Component</th> <th>Azimuth</th> <th>Counts</th> <th>Mean (2D)</th> <th>Std.Dev.</th> <th>Min</th> <th>Max</th> </tr> </thead> <tbody> <tr> <td>Bedding</td> <td>Azimuth</td> <td>23.00</td> <td>304.87</td> <td>8.07</td> <td>293.59</td> <td>322.96</td> </tr> </tbody> </table>	Component	Azimuth	Counts	Mean (2D)	Std.Dev.	Min	Max	Bedding	Azimuth	23.00	304.87	8.07	293.59	322.96	<p>Dip Histogram (Count)</p>

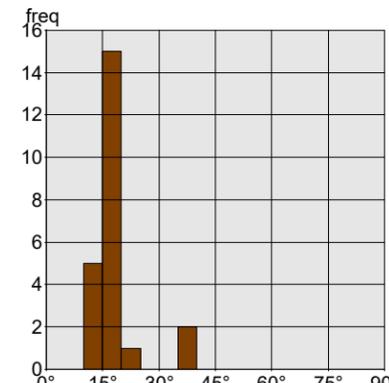
<table border="1"> <thead> <tr> <th>Statistic</th> <th>Value</th> </tr> </thead> <tbody> <tr> <td>Counts</td> <td>23.00</td> </tr> <tr> <td>Mean (2D)</td> <td>18.29</td> </tr> <tr> <td>Std.Dev.</td> <td>5.99</td> </tr> <tr> <td>Min</td> <td>12.93</td> </tr> <tr> <td>Max</td> <td>36.46</td> </tr> </tbody> </table>	Statistic	Value	Counts	23.00	Mean (2D)	18.29	Std.Dev.	5.99	Min	12.93	Max	36.46
