Remedial Action Report – Halladay Street North (AOC HSN-1A) and a Portion of the Former Halsted Corporation
Property (AOC HSD-1B) Soil
Garfield Avenue Group
PPG, Jersey City, New Jersey

Appendix A

Historical Water Table Elevations

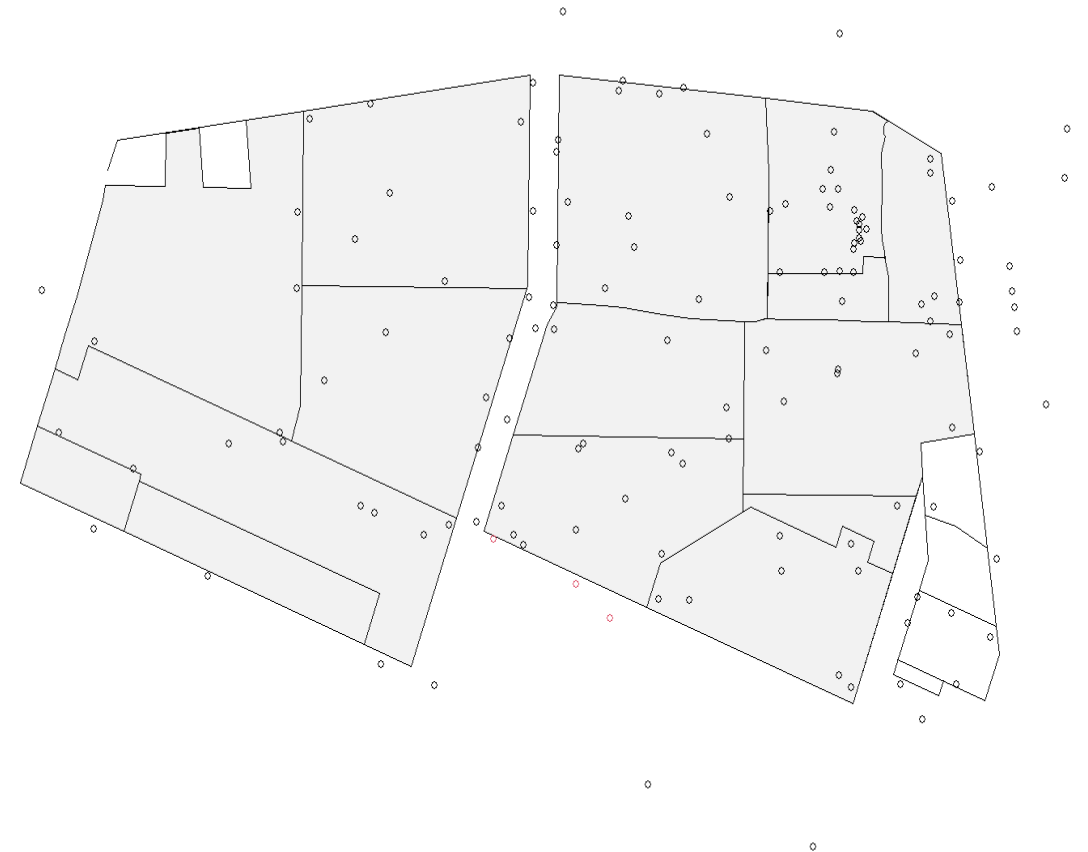
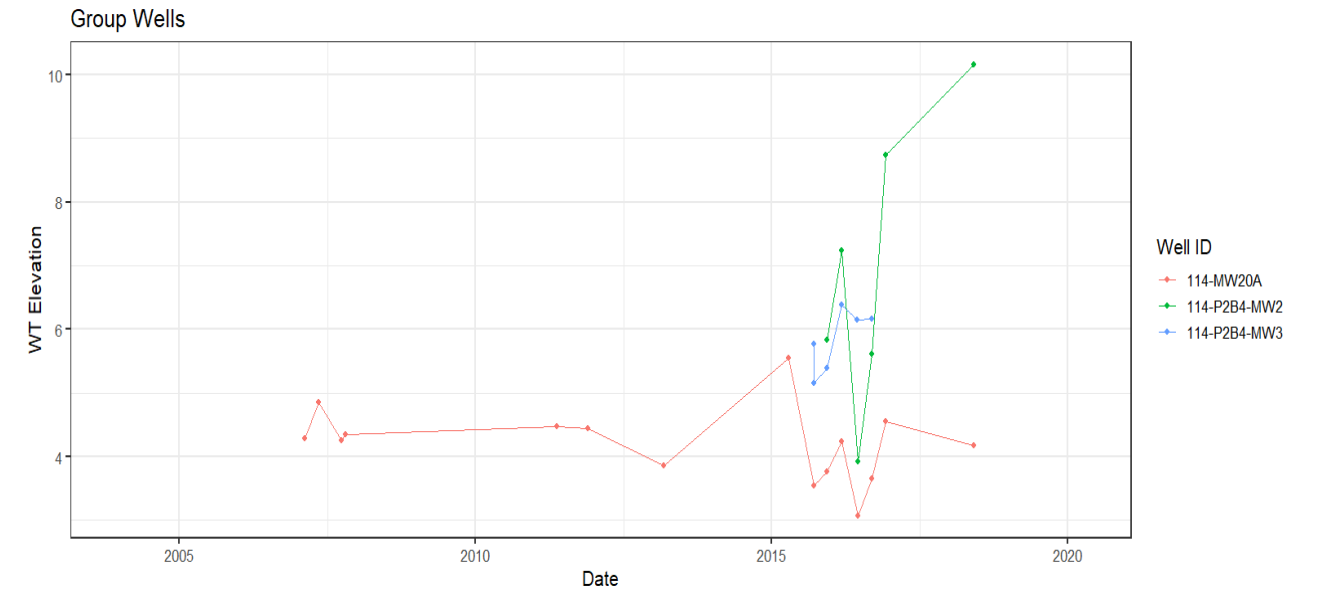
Pinned Wells
(shown in red on map)

114-MW20A 114-P2B4-MW3
114-P2B4-MW2

Group Water Table Elevation Percentiles

Percentile	Elevation (ft)
50%	4.6
60%	5.3
70%	5.7
80%	6.1
90%	7.1
100%	10.2
