**Hexavalent Chromium Results for Concrete Samples Obtained Above the Column IRM, (Samples Collected: 2013)**

PPG  
 Site 156 - Metropolis Towers  
 Jersey City, Hudson County, New Jersey

PROJ#: 60290456      DATE: 10/16/2017      DRAWN BY: huntc      **FIGURE 8**

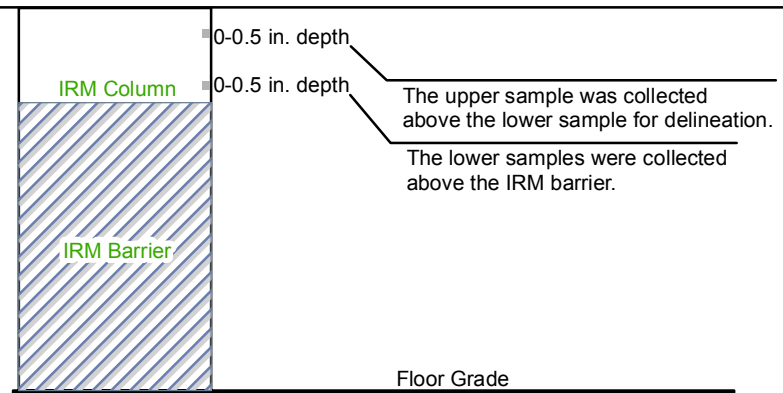
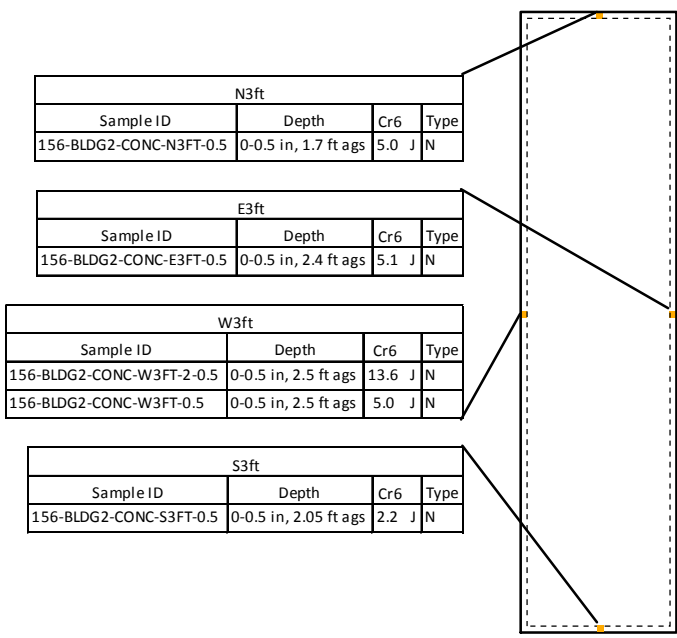
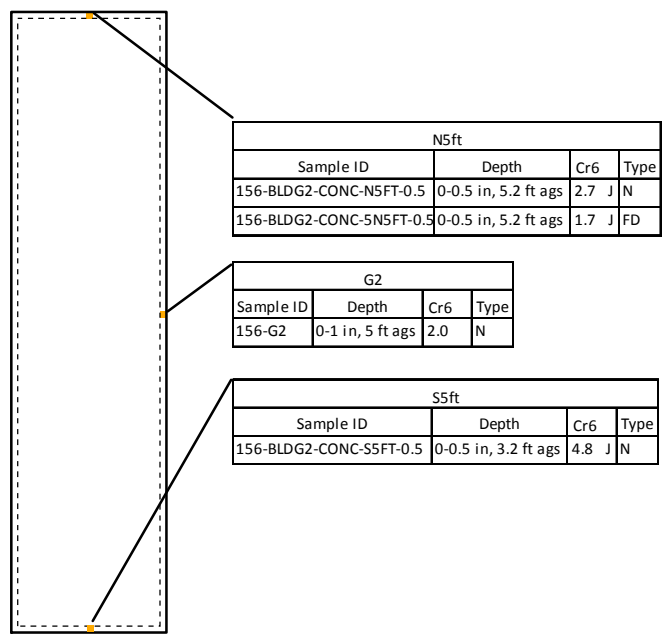
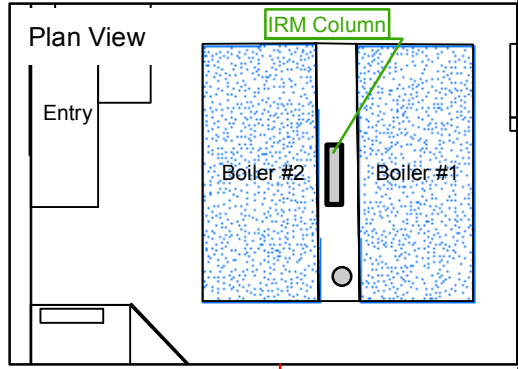
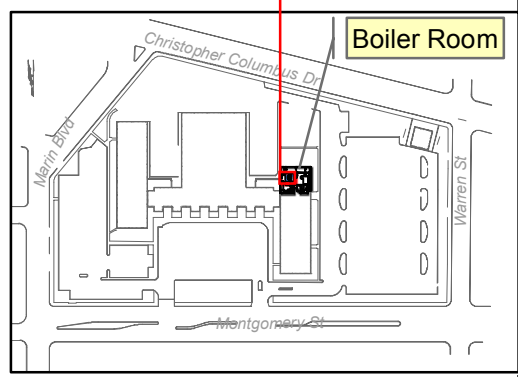
**Plan View Cross-Sections of IRM Column**

**Hexavalent Chromium Results (mg/kg)**

Lower Samples      Upper Samples
